Assessment of Affects on Fish Passage at Tide Gates Using DIDSON Technology

Prepared for
Tasman District Council

Strickland R, Quarterman A 2007. Assessment of Affects on Fish Passage at Tide Gates Using DIDSON Technology.
Prepared for Tasman District Council. Cawthron Report No. 1260. 12 p.

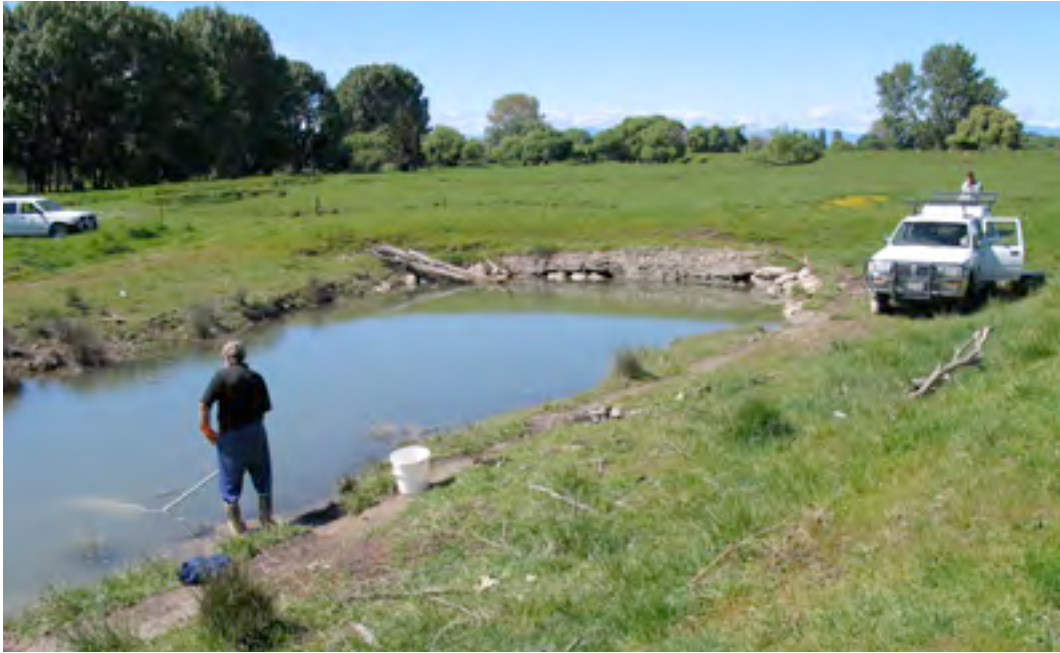
Figure 2. Small tidal arm in the Motueka estuary draining DOC owned reserve. Whitebaiting was occurring within 20 metres of the tide gate.

Apart from increasing whitebait vulnerability to predators, the tide gate appeared to have negligible effect on whitebait passage for most of the seven hours that the gate remained open, as there was a steady stream of whitebait exiting the top end of the culvert. Given the number of whitebait successfully reaching the remnant parcel of wetland above the culvert, there appeared to be insufficient habitat and protection for these fish to grow on to maturity. There

is a lot of scope for improving the remnant wetland and increasing its potential as rearing habitat.

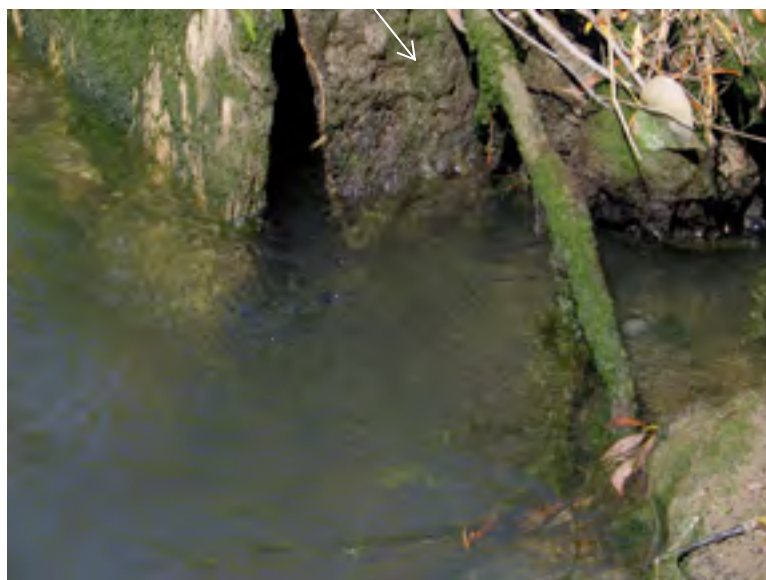
During normal flows the Motueka tide gate holds back very little water from the upstream catchment so that on the dropping tide, gate opening is gradual and the gate remains in a partially open state for just over seven hours (Figure 3). During half tide conditions the flow through the culvert is slow as is the small stream draining the wetland.

Figure 3. Motueka tide gate remains open even at half tide height, allowing about four to six hours on every tide cycle for whitebait to negotiate the culvert.

occur can be calculated from each of the graphs. Based on this, the Motueka tide gate allowed about a four hour gap after 1900 hours until gate closure, though bank-side observation determined successful whitebait passage began at 1530 hours until closure. This was probably due to the slow velocity through the culvert.

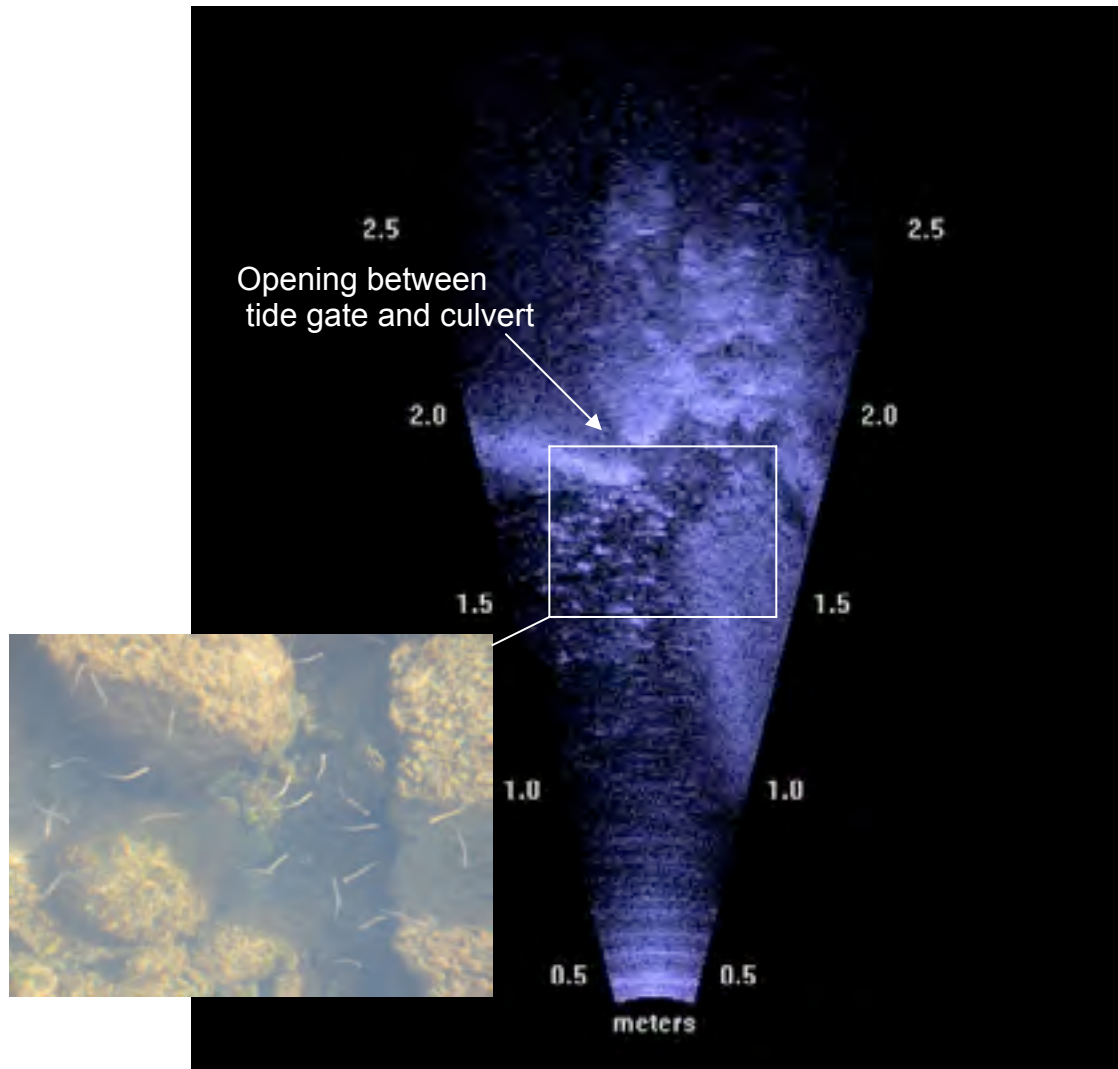
Figure 4. DIDSON underwater plan view of the Motueka tide gate taken of and at the same angle as the image in Figure 3. Inset is actual plan view photo of whitebait congregating at the tide gate entrance.

Water clarity allowed bank side observation of fish behaviour at this structure for most of the tidal cycle except high tide. DIDSON images enabled us to observe what took place during the high tide period when water became turbid and surface scum and debris obscured any chance of seeing into the water. Yelloweye mullet and possibly small kahawai exploited this increased depth as an opportunity to feed on the whitebait shoals accumulating at the closed tide gate. Once the gate opened and water level began dropping, the larger fish retreated from this arm of the estuary and for most of the time that the gate remained open, whitebait could be seen exiting the top end of the culvert and making their way upstream.

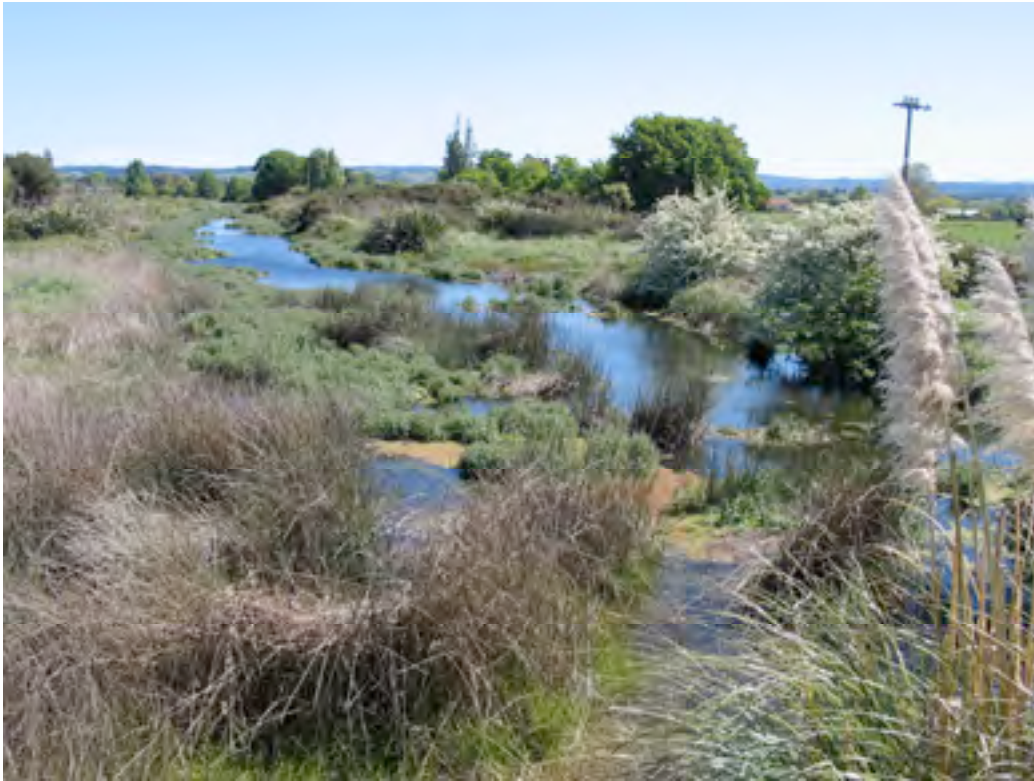
Pearl Creek discharges into the Waimea estuary through a tide gate that drains an important wetland (Figure 5) that is home to several whitebait species including the rare giant kokopu.

Figure 5. Wetland and backed up water created upstream of the Pearl Creek tide gate.

Upstream of the tide gate, Pearl Creek offers good rearing habitat for whitebait and other species, but needs better fish access into and through it to ensure it is fully utilised. The gate itself remains open for a sufficient amount of time during each tidal cycle to allow fish access. The main issue to deal with is the effect of velocity through the culvert and tide gate. There are several ways of overcoming this issue, but on-site discussion with an engineer to work through what is practical and feasible is required before recommendations can be made.

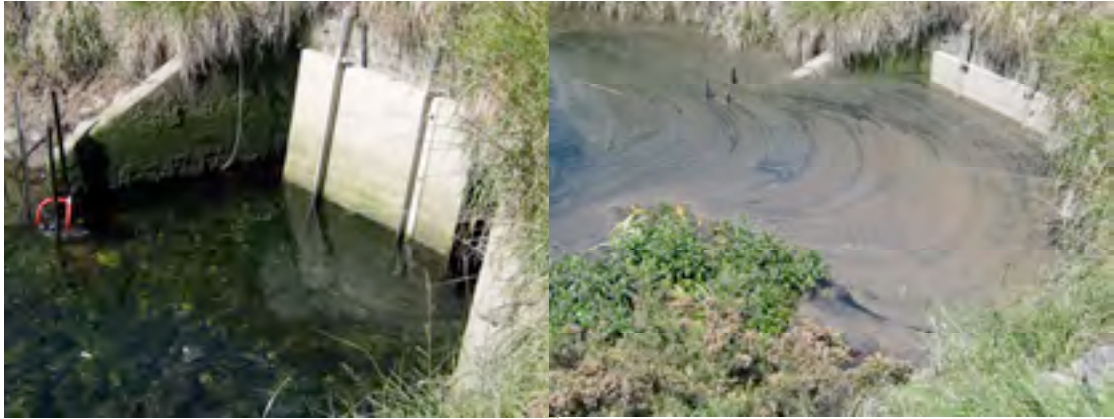
A substantial flow in the creek causes water to back up through the lower section of the wetland when the tide gate closes at high tide. The gate remains closed for about three and a half hours and open for about eight and a half hours on each tidal cycle (Figure 6). Due to the flow in the creek and the water that is impounded during gate closure, a steady velocity above 0.3 metres/sec is created through the gate and possibly persists through the culvert.

Figure 6. Pearl Creek tide gate open at low tide (left) and closed at high tide (right). DIDSON is mounted between three waratahs at left of frames. On the tide monitored, water eventually covered the top of the waratahs and the tide gate.

There appears to be a lot less opportunity at Pearl Creek for successful passage. There was only about a minute at the opening of the gate when the discharge velocity was less than 0.3 m/sec. Neither DIDSON or bank-side observation was able to determine any successful passage past the tide gate, though about ten whitebait were observed at the top side of the culvert prior to monitoring.

From the images and measurements obtained with the DIDSON, combined with our observations above the culvert, it appears that water velocity generated through the culvert and the opening at the gate is more than whitebait can cope with. Despite this a small shoal of whitebait was observed on the upstream side of the culvert. However this small shoal pales beside the thousands of whitebait that were observed accumulating below the tide gate.

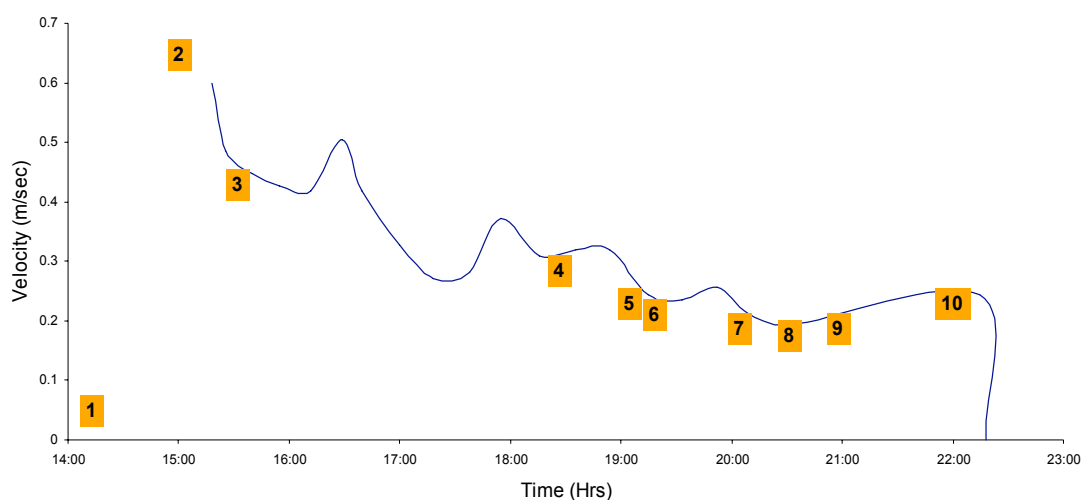
Code	Hours	Comments
1	1421	Gate open, Some whitebait going through opening on DIDSON image and then observed coming out other end of culvert (shoal of approx 50-80).
2	1500	Velocity through opening appeared to have increased and bait attempting to go through the gap were being pushed back out. Velocity measurements from DIDSON unable to be measured until 1518 hours because not positioned properly.
3	1530	Velocity slowed enough to observe whitebait making it through the gap and small shoals observed exiting top end of culvert through until gates closed at 2218.
4	1830	Gate still open, water flowing out.
5	1905	Smaller numbers of whitebait still milling around gate, few getting through gate.
6	1911	Larger fish seen at gate (seem to be galaxiids).
7	2006	More larger fish seen at gate (DIDSON), gate still open, flow slowing (gap decreased), shoals of whitebait still seen at upstream end of culvert.
8	2030	Same as previous.

9	2100	600mm eel seen at TR side of tide gate (out of view of DIDSON), small shoal of whitebait at upstream end of culvert.
10	2200	Whitebait and small galaxiids still milling around gate, eel not seen since first observation, gate still open with reasonable flow.
	2215	Gate closed.

Figure 7. Velocities and observations at a Motueka tide gate during October 2006.

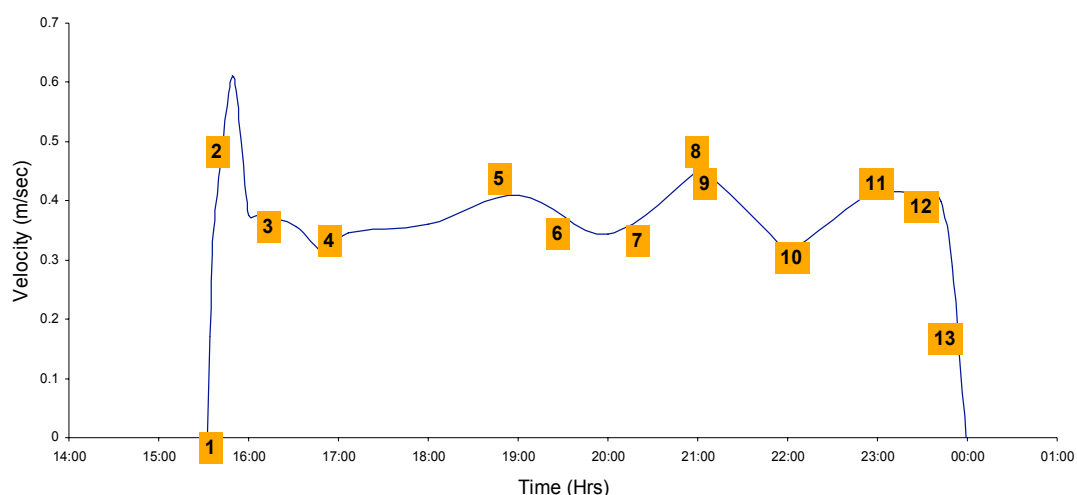
Code	Hours	Comments
1	1533	Gate opens, velocity steadily increasing. Whitebait accumulate in corner of culvert and occasionally attempt to head into the culvert but don't appear to cope with the velocity.
2	1543	Gate fully open.
3	1620	No whitebait appearing at the upstream end of culvert.
4	1700	Flow still too strong above and below culvert to allow whitebait passage upstream – still bundled up at downstream entrance.
5	1851	Dog in water near DIDSON.
6	1927	Whitebait seen 3 m downstream of gate, none observed above gate.
7	2023	Whitebait starting to accumulate around gate - flow still seems too strong for them to go through the gate.
8	2100	Eel passes through the gate (heading downstream).
9	2109	Still a lot of flow through gate, no fish seen in DIDSON.
10	2211	Gate still open, large fish splashing downstream approx 15-20 m.
11	2303	Large eel goes downstream through gate.
12	2331	Large eel goes upstream through gate.

13	2354	Gate beginning to close.
	0000	Gate closed.

Figure 8. Velocities and observations at the Pearl Creek tide gate during October 2006.

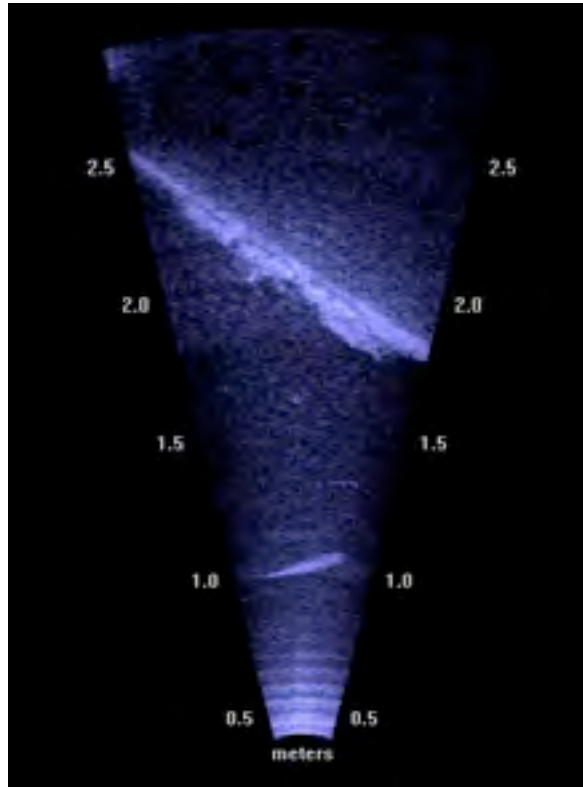
Fewer predatory fish visited the tide gates during gate closure at night. A single large fish briefly swam into view at the Motueka tide gate (Figure 9) and a small eel was active in the area for a short time but did not come into view on the DIDSON.

Figure 9. A 31 cm fish (either kahawai or trout) did several passes through the beam after dark at high water and during tide gate closure. Very few whitebait remained or were active in the beam after dark.
