Assessment of Affects on Fish Passage at Tide Gates Using DIDSON Technology

Prepared for
Tasman District Council

Strickland R, Quarterman A 2007. Assessment of Affects on Fish Passage at Tide Gates Using DIDSON Technology.
Prepared for Tasman District Council. Cawthron Report No. 1260. 12 p.

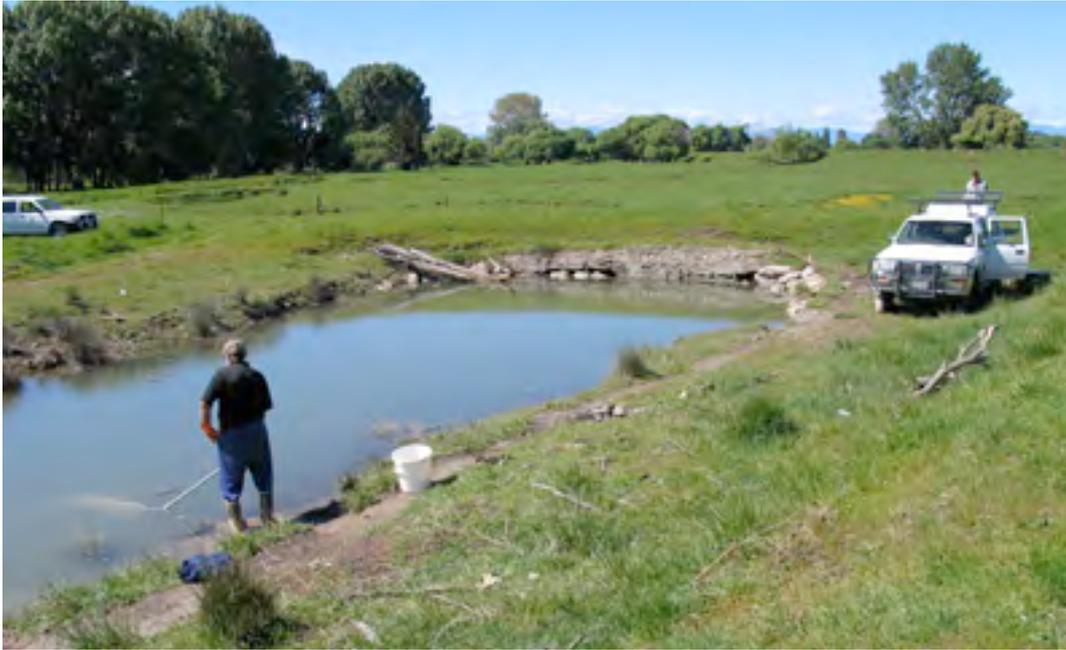
The tide gate on one of the Motueka estuary tributaries, referred to in this report as the Motueka tide gate, cuts off tidal influence into a small modified wetland and drains system (Figure 1). There is a second control gate about 100 metres upstream of this tide gate that allows drainage of dairy pasture from behind a stop bank. The area immediately upstream of the Motueka tide gate (Figure 2) is leased from the Department of Conservation to graze dairy cows.

Figure 2. Small tidal arm in the Motueka estuary draining DOC owned reserve. Whitebaiting was occurring within 20 metres of the tide gate.

is a lot of scope for improving the remnant wetland and increasing its potential as rearing habitat.

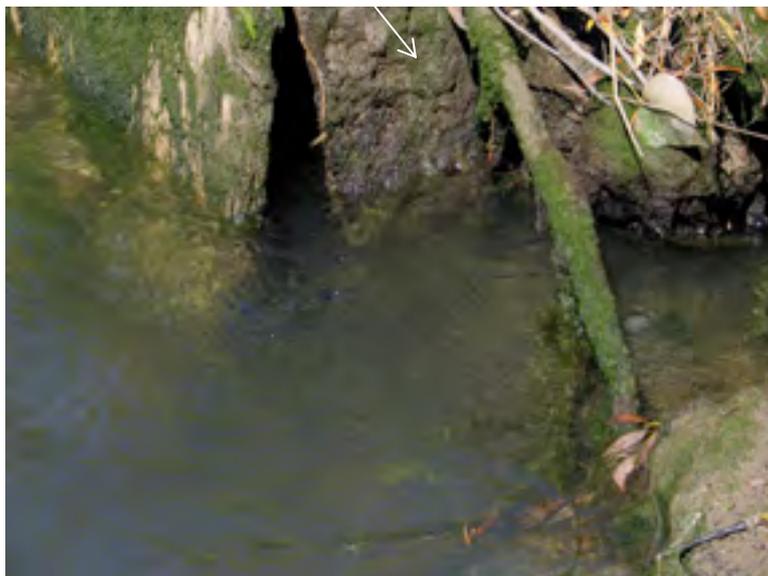
During normal flows the Motueka tide gate holds back very little water from the upstream catchment so that on the dropping tide, gate opening is gradual and the gate remains in a partially open state for just over seven hours (Figure 3). During half tide conditions the flow through the culvert is slow as is the small stream draining the wetland.

Figure 3. Motueka tide gate remains open even at half tide height, allowing about four to six hours on every tide cycle for whitebait to negotiate the culvert.

Apart from increasing whitebait vulnerability to predators, the tide gate appeared to have negligible effect on whitebait passage for most of the seven hours that the gate remained open, as there was a steady stream of whitebait exiting the top end of the culvert. Given the number of whitebait successfully reaching the remnant parcel of wetland above the culvert, there appeared to be insufficient habitat and protection for these fish to grow on to maturity. There

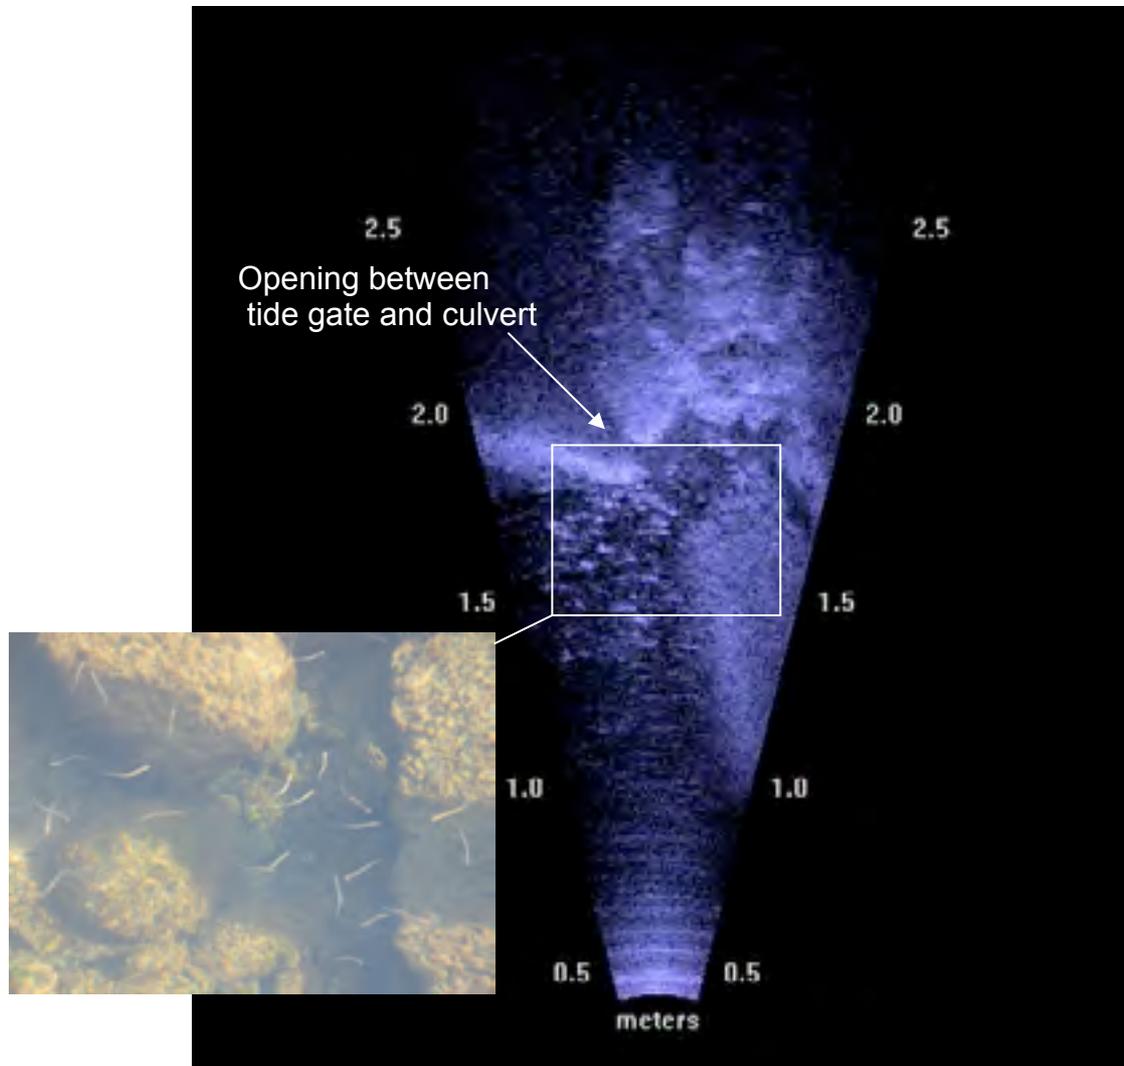
The DIDSON was set up about two metres from the tide gate at an angle sufficient to allow monitoring of fish behaviour through one side of the gate (Figure 4).

Figure 4. DIDSON underwater plan view of the Motueka tide gate taken of and at the same angle as the image in Figure 3. Inset is actual plan view photo of whitebait congregating at the tide gate entrance.

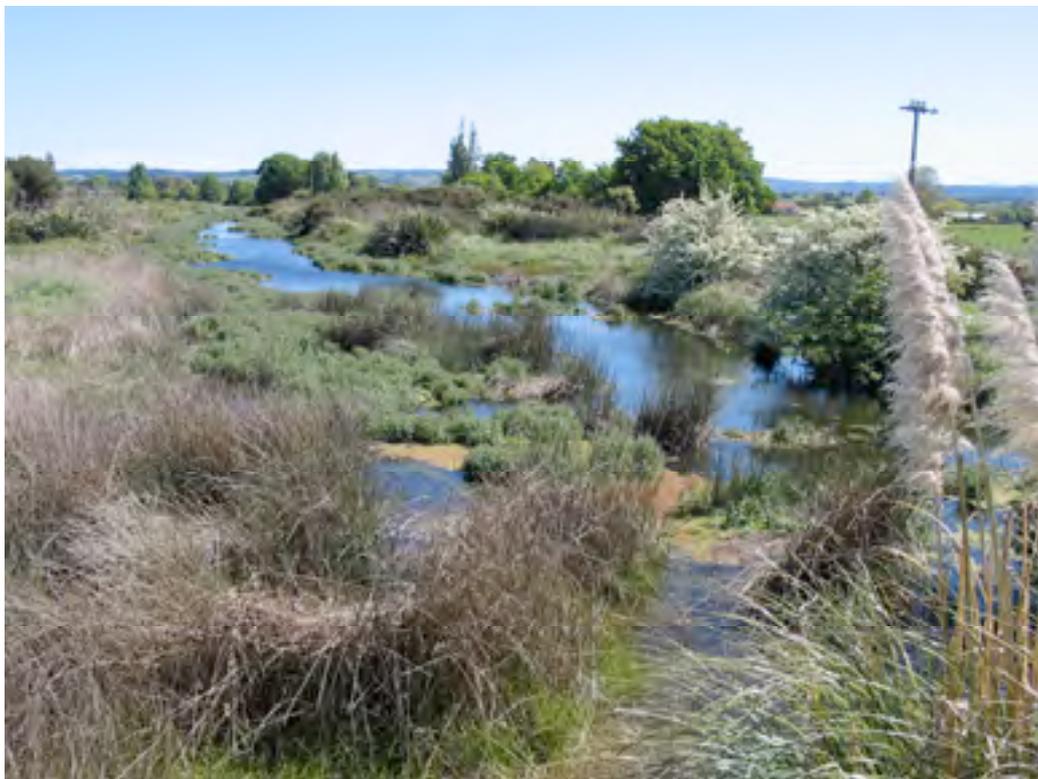
Pearl Creek discharges into the Waimea estuary through a tide gate that drains an important wetland (Figure 5) that is home to several whitebait species including the rare giant kokopu.

Figure 5. Wetland and backed up water created upstream of the Pearl Creek tide gate.

Upstream of the tide gate, Pearl Creek offers good rearing habitat for whitebait and other species, but needs better fish access into and through it to ensure it is fully utilised. The gate itself remains open for a sufficient amount of time during each tidal cycle to allow fish access. The main issue to deal with is the effect of velocity through the culvert and tide gate. There are several ways of overcoming this issue, but on-site discussion with an engineer to work through what is practical and feasible is required before recommendations can be made.

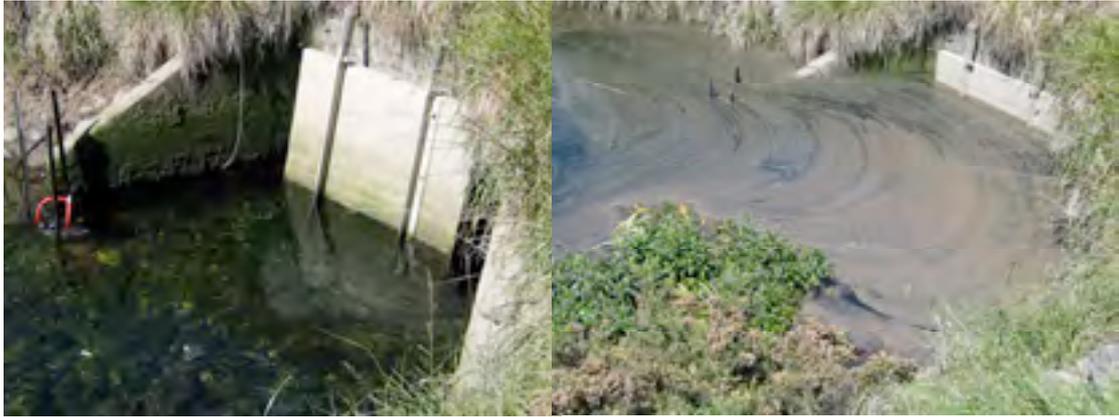
A substantial flow in the creek causes water to back up through the lower section of the wetland when the tide gate closes at high tide. The gate remains closed for about three and a half hours and open for about eight and a half hours on each tidal cycle (Figure 6). Due to the flow in the creek and the water that is impounded during gate closure, a steady velocity above 0.3 metres/sec is created through the gate and possibly persists through the culvert.

Figure 6. Pearl Creek tide gate open at low tide (left) and closed at high tide (right). DIDSON is mounted between three waratahs at left of frames. On the tide monitored, water eventually covered the top of the waratahs and the tide gate.

From the images and measurements obtained with the DIDSON, combined with our observations above the culvert, it appears that water velocity generated through the culvert and the opening at the gate is more than whitebait can cope with. Despite this a small shoal of whitebait was observed on the upstream side of the culvert. However this small shoal pales beside the thousands of whitebait that were observed accumulating below the tide gate.

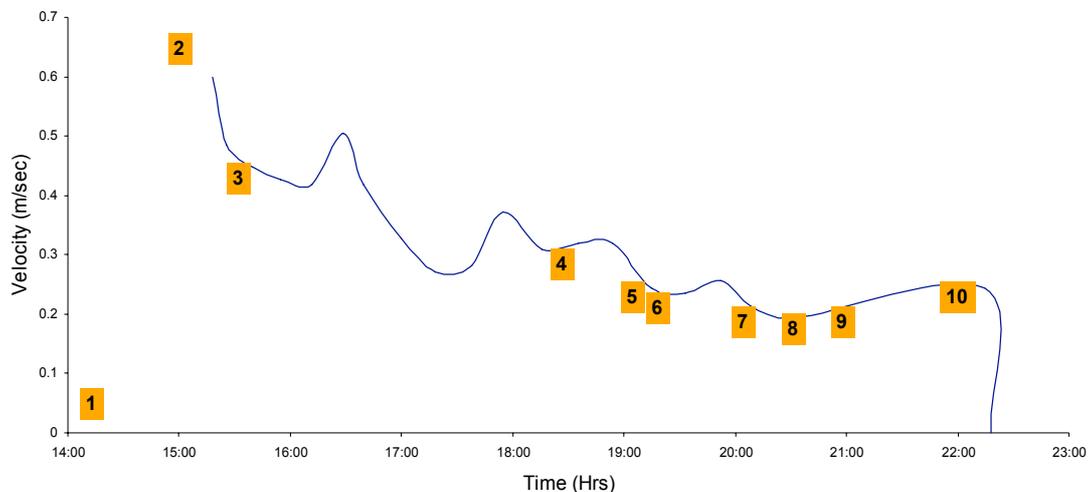
Code	Hours	Comments
1	1421	Gate open, Some whitebait going through opening on DIDSON image and then observed coming out other end of culvert (shoal of approx 50-80).
2	1500	Velocity through opening appeared to have increased and bait attempting to go through the gap were being pushed back out. Velocity measurements from DIDSON unable to be measured until 1518 hours because not positioned properly.
3	1530	Velocity slowed enough to observe whitebait making it through the gap and small shoals observed exiting top end of culvert through until gates closed at 2218.
4	1830	Gate still open, water flowing out.
5	1905	Smaller numbers of whitebait still milling around gate, few getting through gate.
6	1911	Larger fish seen at gate (seem to be galaxiids).
7	2006	More larger fish seen at gate (DIDSON), gate still open, flow slowing (gap decreased), shoals of whitebait still seen at upstream end of culvert.
8	2030	Same as previous.

9	2100	600mm eel seen at TR side of tide gate (out of view of DIDSON), small shoal of whitebait at upstream end of culvert.
10	2200	Whitebait and small galaxiids still milling around gate, eel not seen since first observation, gate still open with reasonable flow.
	2215	Gate closed.

Figure 7. Velocities and observations at a Motueka tide gate during October 2006.

occur can be calculated from each of the graphs. Based on this, the Motueka tide gate allowed about a four hour gap after 1900 hours until gate closure, though bank-side observation determined successful whitebait passage began at 1530 hours until closure. This was probably due to the slow velocity through the culvert.

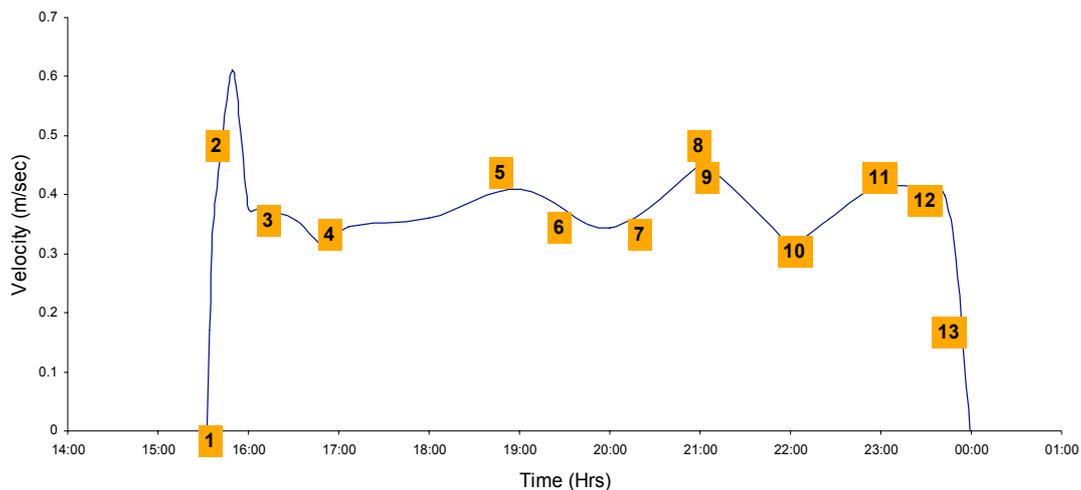
Code	Hours	Comments
1	1533	Gate opens, velocity steadily increasing. Whitebait accumulate in corner of culvert and occasionally attempt to head into the culvert but don't appear to cope with the velocity.
2	1543	Gate fully open.
3	1620	No whitebait appearing at the upstream end of culvert.
4	1700	Flow still too strong above and below culvert to allow whitebait passage upstream – still bundled up at downstream entrance.
5	1851	Dog in water near DIDSON.
6	1927	Whitebait seen 3 m downstream of gate, none observed above gate.
7	2023	Whitebait starting to accumulate around gate - flow still seems too strong for them to go through the gate.
8	2100	Eel passes through the gate (heading downstream).
9	2109	Still a lot of flow through gate, no fish seen in DIDSON.
10	2211	Gate still open, large fish splashing downstream approx 15-20 m.
11	2303	Large eel goes downstream through gate.
12	2331	Large eel goes upstream through gate.

13	2354	Gate beginning to close.
	0000	Gate closed.

Figure 8. Velocities and observations at the Pearl Creek tide gate during October 2006.

There appears to be a lot less opportunity at Pearl Creek for successful passage. There was only about a minute at the opening of the gate when the discharge velocity was less than 0.3 m/sec. Neither DIDSON or bank-side observation was able to determine any successful passage past the tide gate, though about ten whitebait were observed at the top side of the culvert prior to monitoring.

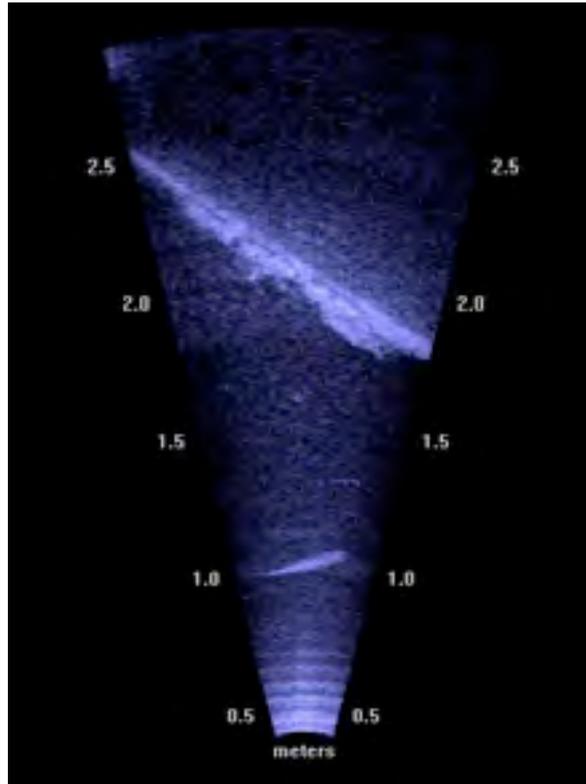
Fewer predatory fish visited the tide gates during gate closure at night. A single large fish briefly swam into view at the Motueka tide gate (Figure 9) and a small eel was active in the area for a short time but did not come into view on the DIDSON.

Figure 9. A 31 cm fish (either kahawai or trout) did several passes through the beam after dark at high water and during tide gate closure. Very few whitebait remained or were active in the beam after dark.
