Hancox, G.T., 2012. Environment Southland Tsunami and Seiche Study – Stage 2: Evaluation of potential earthquake-induced landslide sites where tsunami waves could be generated on Lake Manapouri and Lake Te Anau. *GNS Science Consultancy Report 2012/146*. 54 p.

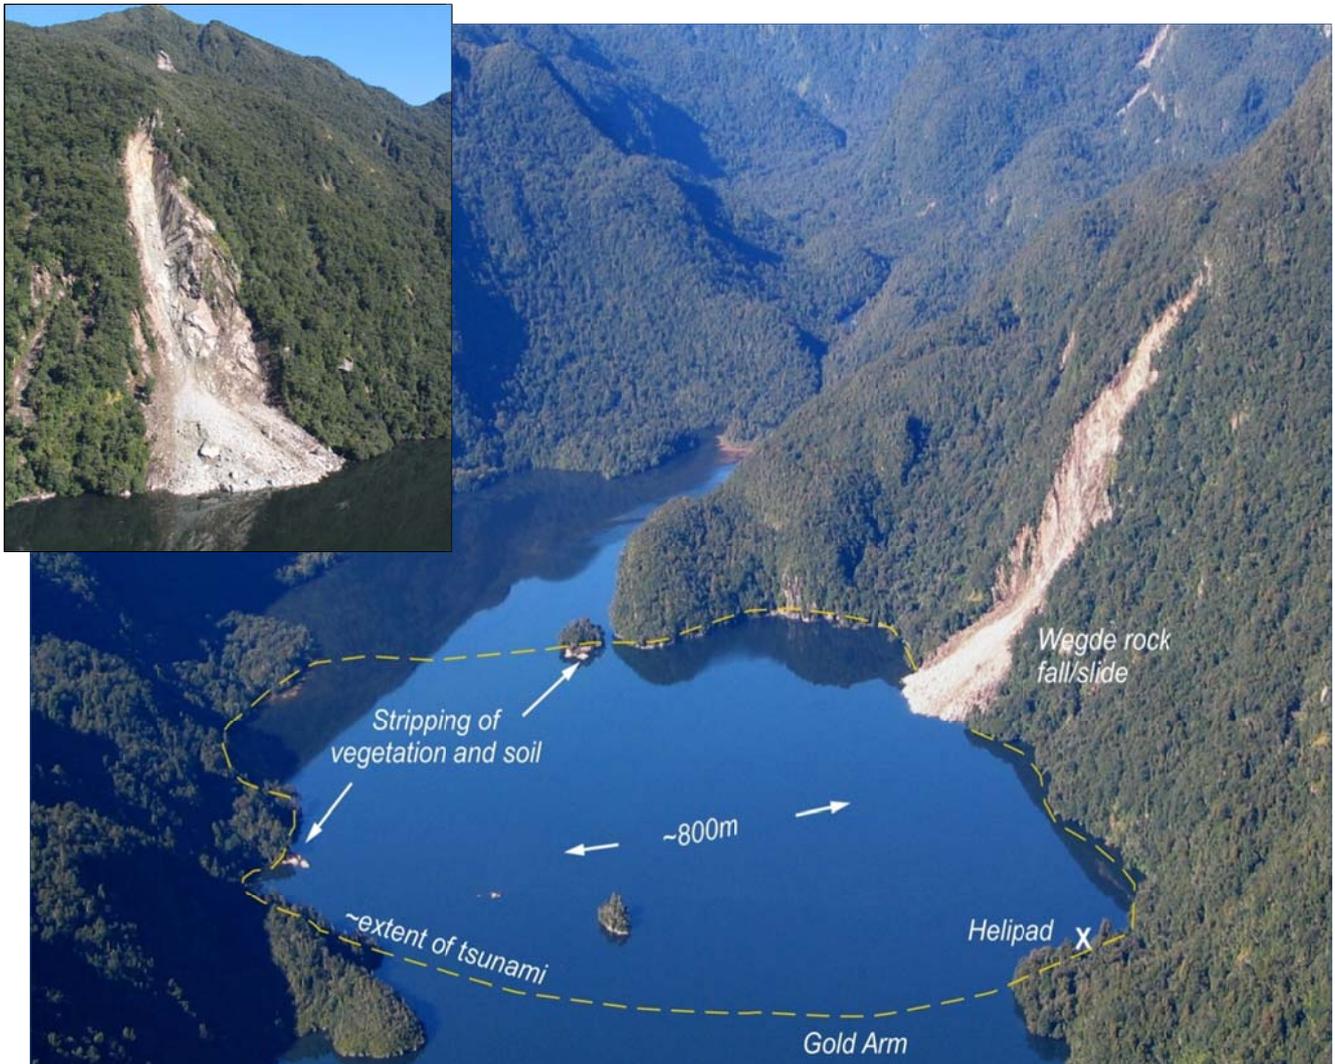
Figure 4. Aerial views of the $\sim 200,000 \text{ m}^3$ rock fall in Gold Arm of Charles Sound which was triggered by the M_w 7.2 Fiordland earthquake in August 2003. The rock fall caused a small tsunami which travelled ~ 800 m across the sound and stripped vegetation and soil 4–5 m above high tide level, and partially stripped vegetation off a small island (centre). The wave also damaged a helipad (lower right) ~ 250 m west of the slide (from Hancox et al. 2003).

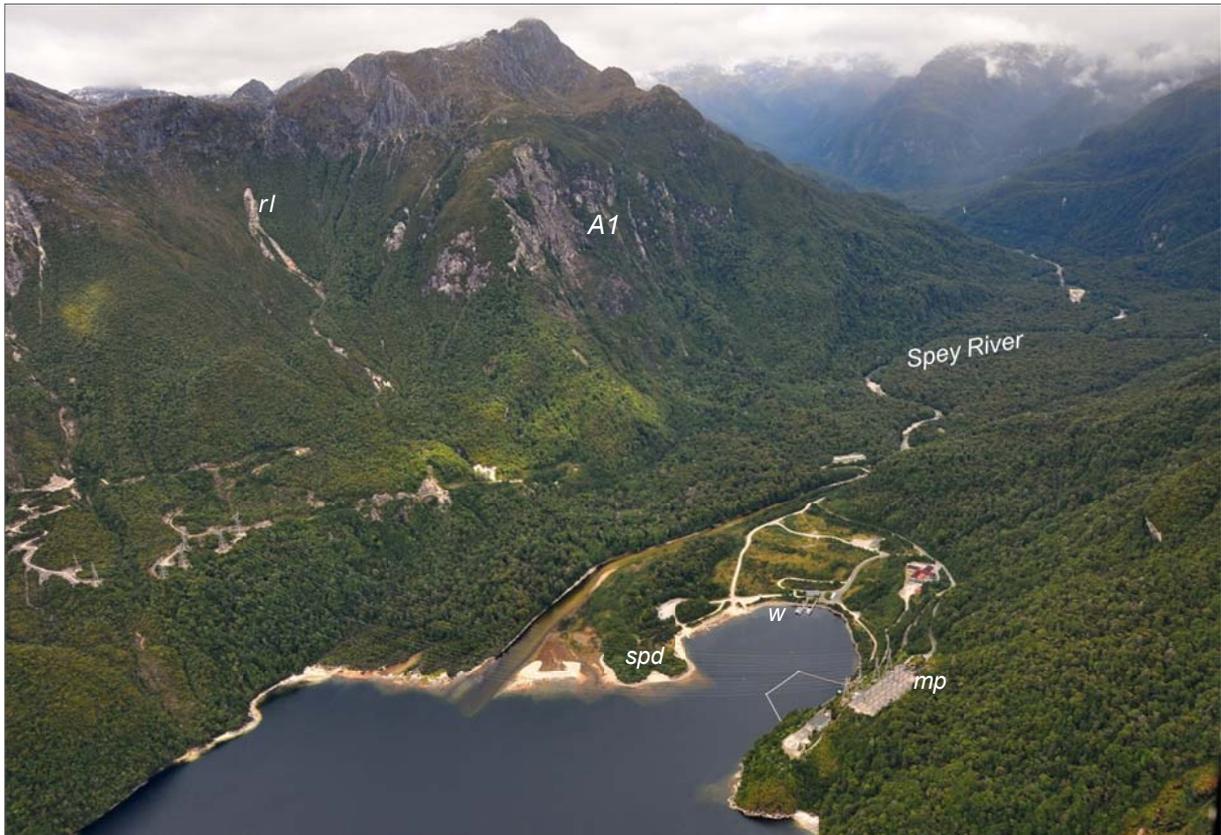
Figure 12. Aerial view of Manapouri power station (*mp*) and wharf (*w*) at the head of West Arm, Lake Manapouri looking up the Spey valley. Potential EIL Site A1 is on the scarp of a large prehistoric landslide (A1) with a recent shallow landslide above the power line access road visible to the left (*rl*). Collapses and lateral spreading of the Spey River delta (*spd*) could affect the powerhouse intake.

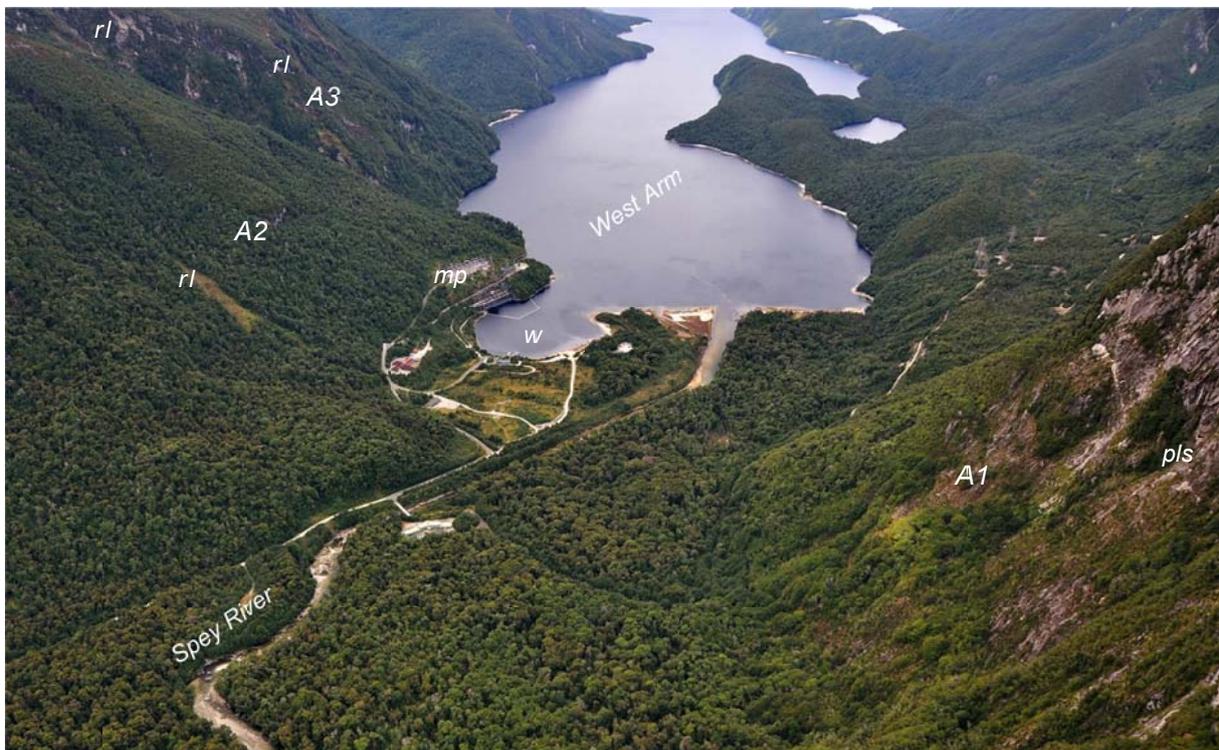
Three potential EIL sites (Site A1, A2, and A3) are identified at the head of West Arm within 1–2 km of the wharf, tourist facilities, and Manapouri Powerhouse. The location of this area is shown on Figure 10a and illustrated by three photos (Figures 12, 13, and 14). Site A1 is located on the very steep (~40-60°) rocky head scarp of a large old (prehistoric) failure on the south side of the Spey River opposite West Arm Hut (Figure 12). Retrogressive reactivation of the source area is likely at this site during MM8-10 earthquake shaking (see Appendix 1), possibly causing a moderate to very large (~10⁴–10⁶ m³) rock fall. Slide debris from such a failure is unlikely to reach the lake because of its cross-valley direction of travel, but it could temporarily dam the river and close the Wilmot Pass road. Site A2 is located near an existing shallow landslide scar on the steep (~25-35°) bush-covered slope above the powerhouse, wharf, and tourist facilities (Figure 14). Small to moderate sized (~10³–10⁴ m³) superficial earthquake-induced landslides at this site are likely to damage these facilities, and debris entering the lake could cause locally damaging waves up to 1 m high (Table 2). Site A3 is located high on the steep rock slope on the north side West Arm about 0.5–1 km north of the powerhouse. Old failure scars on the slope suggests that shallow small to moderate (~10³–10⁴ m³) EIL failures into the lake are likely at this site, which could cause waves about 0.5–1 m high locally (Table 2). Collapses and lateral spreading of the Spey River delta (Figure 12) are likely to occur during MM8-10 earthquake shaking. Unconsolidated sand and silt from a possible future rapid delta collapse could flow into the Manapouri powerhouse water intake on the north side of West Arm about 200 m north of the delta front. Rock falls and debris slides from the slope at Site A2 could directly affect the outdoor station above the water intake structure (Figure 14). A site-specific evaluation would provide a more accurate assessment the landslide, delta collapse, and tsunami hazard to Manapouri powerhouse and the wharf and tourist facilities at the head of West Arm.

Figure 13. Potential EIL Sites A1, A2 and A3 above the Manapouri powerhouse (*mp*) and wharf (*w*) at the head of West Arm. Scars of recent landslides (*rl*), mainly shallow rainfall-induced debris slides, are visible on those slopes. The scarp of the prehistoric landslide above the Spey River can be seen lower right (*pls*).

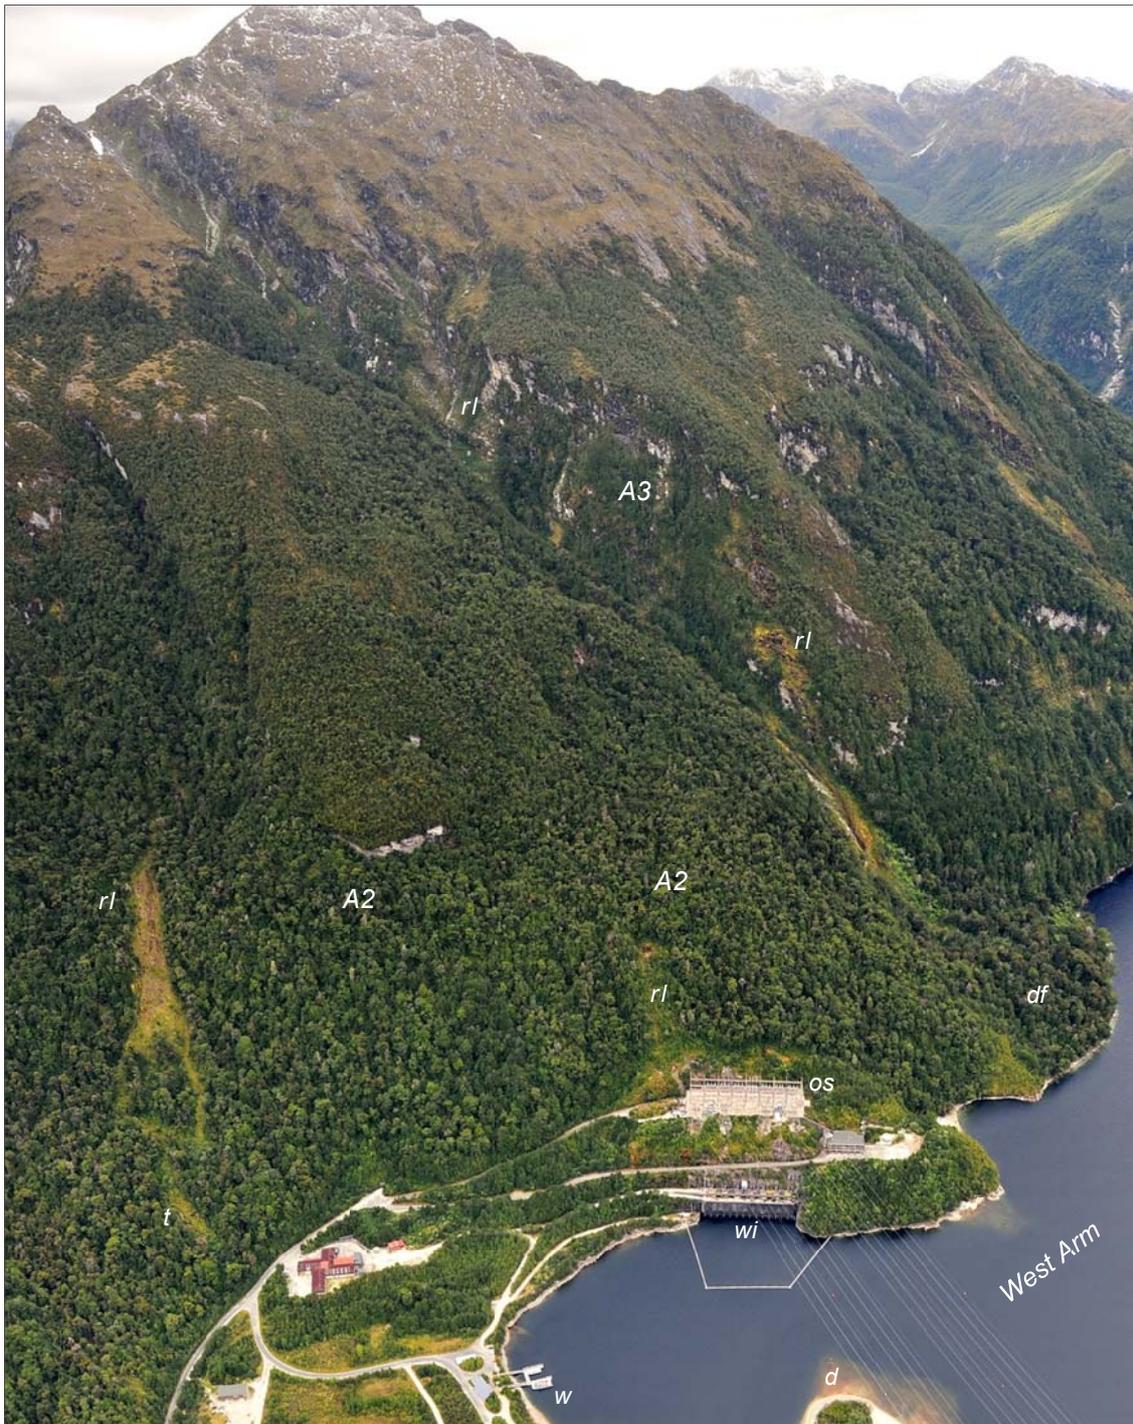
Figure 14. Closer view of sites A2 and A3 on the very steep slopes above the Manapouri powerhouse outdoor station (*os*), water intake (*wi*), and wharf (*w*) facilities to the north at the head of West Arm. Scars of typical recent landslides (*rl*), mainly shallow rainfall-induced debris slides, are visible on these slopes. The toe (*t*) of one recent failure is close to buildings. A large debris fan (*df*) has formed at the mouth of the gully below Site A3. Debris flows are expected to occur at that site during rainstorms and strong earthquake shaking. An earthquake-induced collapse of the Spey River delta (*d*) could affect the powerhouse water intake (*wi*), and rock falls and debris slide could directly affect the outdoor station (*os*) at this site.

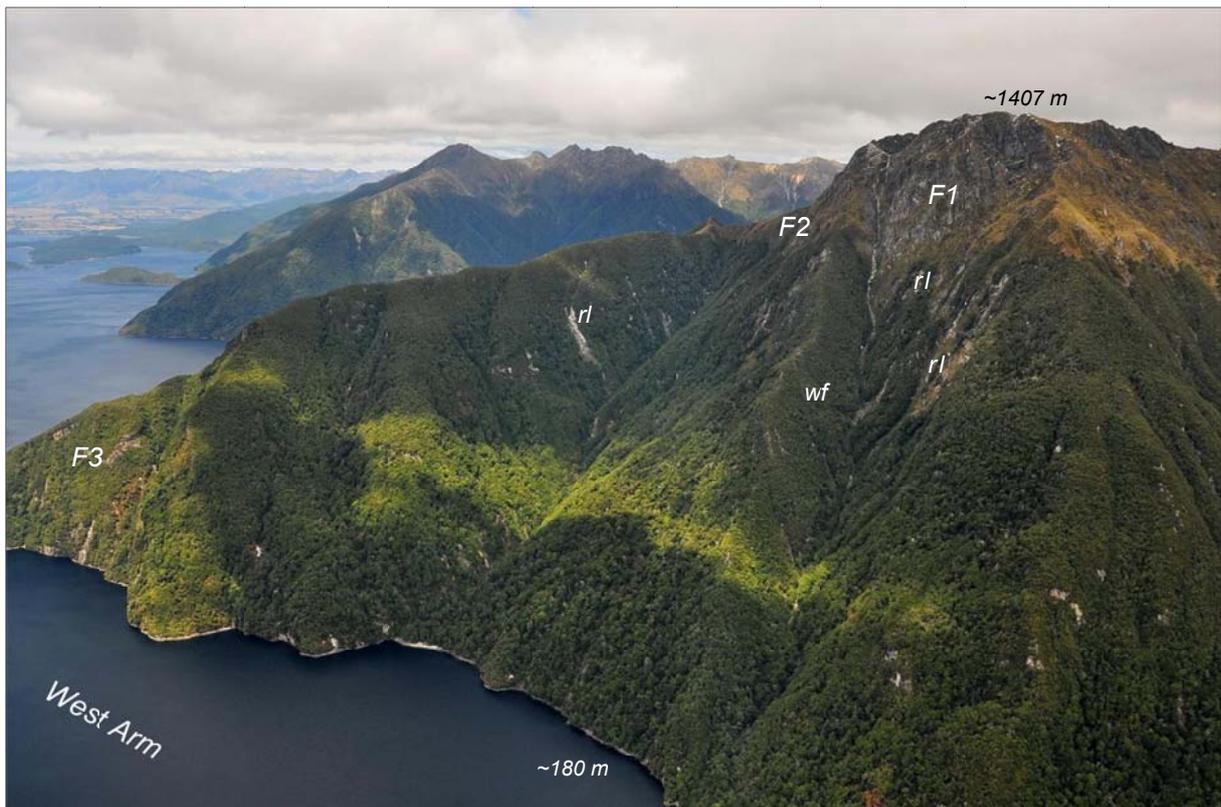
Three potential EIL sites (F1, F2, F3) are identified on very steep slopes ($35 - \geq 45^\circ$) near the bush line $\sim 500\text{--}1200\text{m}$ above the lake (Figure 10a). Sites F1 and F2 are on steep broken rock slopes with recent shallow scars adjacent to an extensive old wedge failure below the 1407 m peak on the southern side of the lake opposite North Arm (Figure 15). Site F3 is on a low-level triangular face scarred by shallow landsliding, about 1 km west of the entrance to South Arm. Precedent evidence suggests that MM8-10 earthquake shaking could trigger shallow small to moderate ($\sim 10^3\text{--}10^4 \text{ m}^3$) rock falls and debris slides at Sites F2 and F3. However, a significantly larger failure, potentially $\sim 5 \times 10^5\text{--}10^6 \text{ m}^3$, similar to the largest during the 2003 earthquake, is possible at Site F1. A landslide of that size rapidly entering the lake from an elevation of $\sim 500\text{--}1000$ m above the lake could potentially generate a wave $\sim 10\text{--}25$ m high within $\sim 1\text{--}5$ km of the site. Freeman Burn Hut at the head of North Arm ~ 8 km to the north, and the powerhouse and wharf facilities ~ 8 km southwest at the head of West Arm could potentially be affected by such a wave, depending on its distribution and rate of attenuation. Tsunami wave modelling would provide a more accurate assessment of the potential landslide-induced wave hazard from this site.

Figure 15. Aerial view of potential landslide sites *F1*, *F2*, and *F3* on the south side of Lake Manapouri opposite North Arm. The most notable of these is site *F1* near the ridge crest and 1407 m peak above an old large wedge failure (*wf*), in an area where there have been several recent shallow landslides (*rl*).

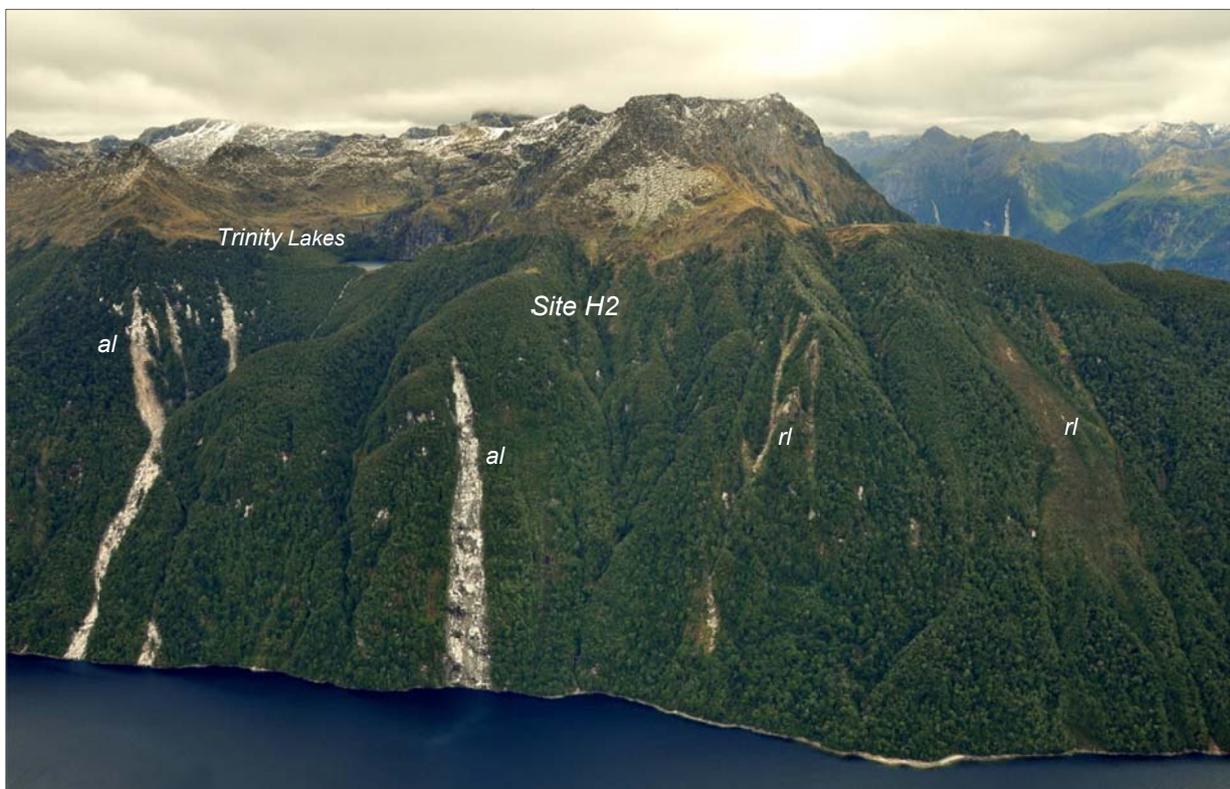
Figure 16. Aerial view of potential landslide *Site H2* in the vicinity of Trinity Lakes on the western side of the entrance to South Arm of Lake Manapouri. Several active shallow landslides (*al*) and recently active slides (*rl*) are present in this area.

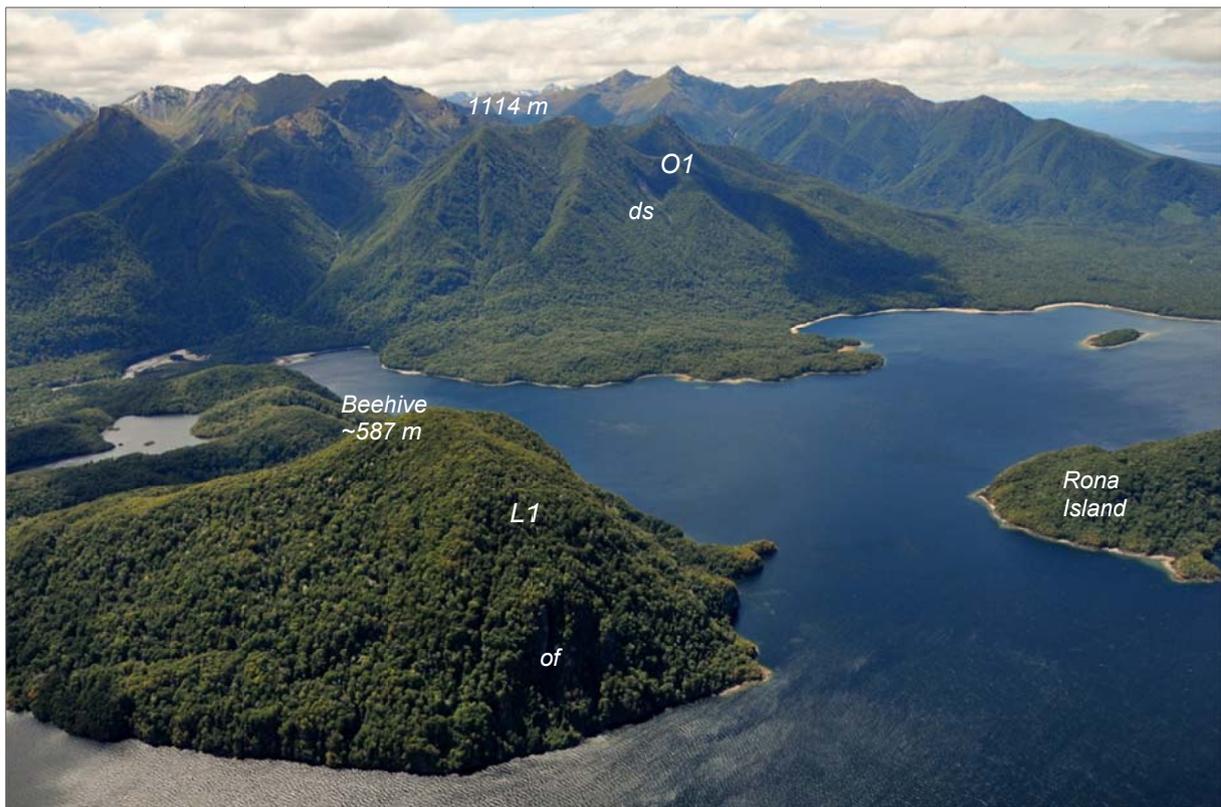
Figure 17. Aerial view of potential EIL areas L and O on the northeast side of Lake Manapouri. An old slope failure (*of*) is visible on the steep face at the end of Beehive point (*Site L1*), and 4 km to the north (*Site O1*) there is a recent debris slide scar (*ds*) in the gully below the 1114 m peak.

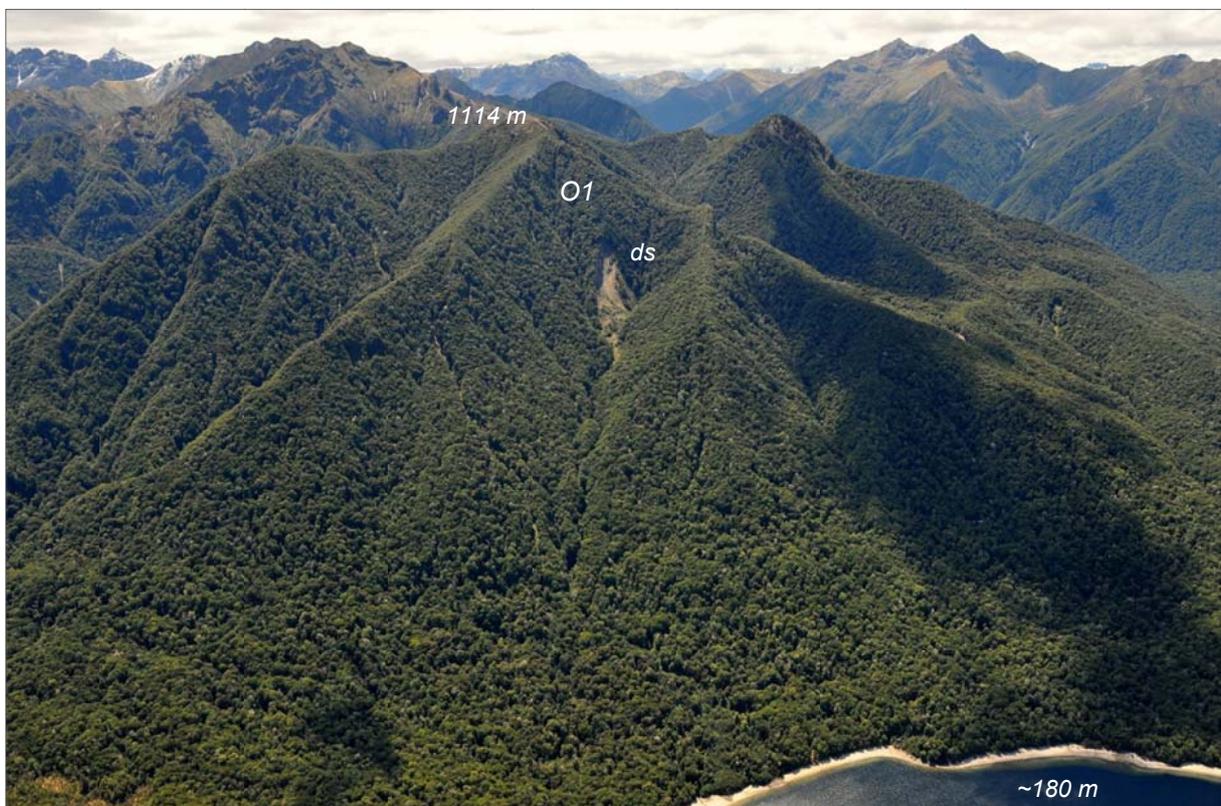
In this area one potential EIL failure site (Site O1) has been identified adjacent to an existing landslide scar in the steep ($\sim 35 - 45^\circ$) head of a gully on the 1114 m peak about ~ 2.5 km north of Calm Bay on the north side of the lake (Figures 10d, 17 and 18). Further small to possibly large ($\sim 10^3$ to $\sim 5 \times 10^5$ m³) debris slides/flows down the gully and into the lake are possible at this site under MM8-10 shaking. Such flows could produce small to moderate ($\sim 1-5$ m high) waves locally, which will probably attenuate to less than ~ 1 m high at Moturau Hut and Manapouri township, about 5 km east and 12 km southeast respectively. There is no evidence that a very large ($\geq 10^6$ m³) failure is likely to occur at this site.

Figure 18. Closer view of *Site O1* showing the recent large debris slide scar (*ds*) at the head of a gully below the 1114 m peak about 6 km west of Moturau Hut on the Kepler track.

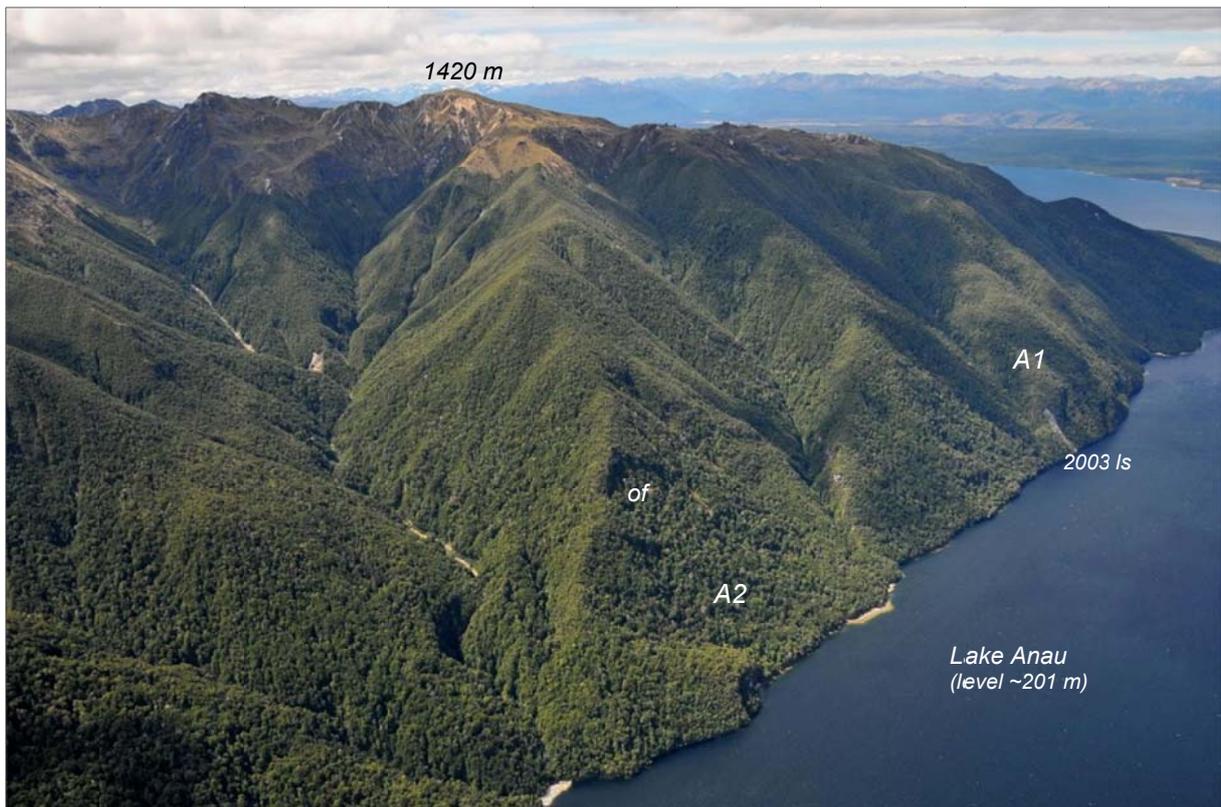
Figure 19. Aerial view of Area A on the north side of South Fiord of Lake Te Anau, about 10 km northwest of Te Anau. An old slope failure scar (*of*) is visible on the bush-covered face at *Site A2*. *Site A1* is ~2 km to the east where a small landslide occurred during the 2003 earthquake.

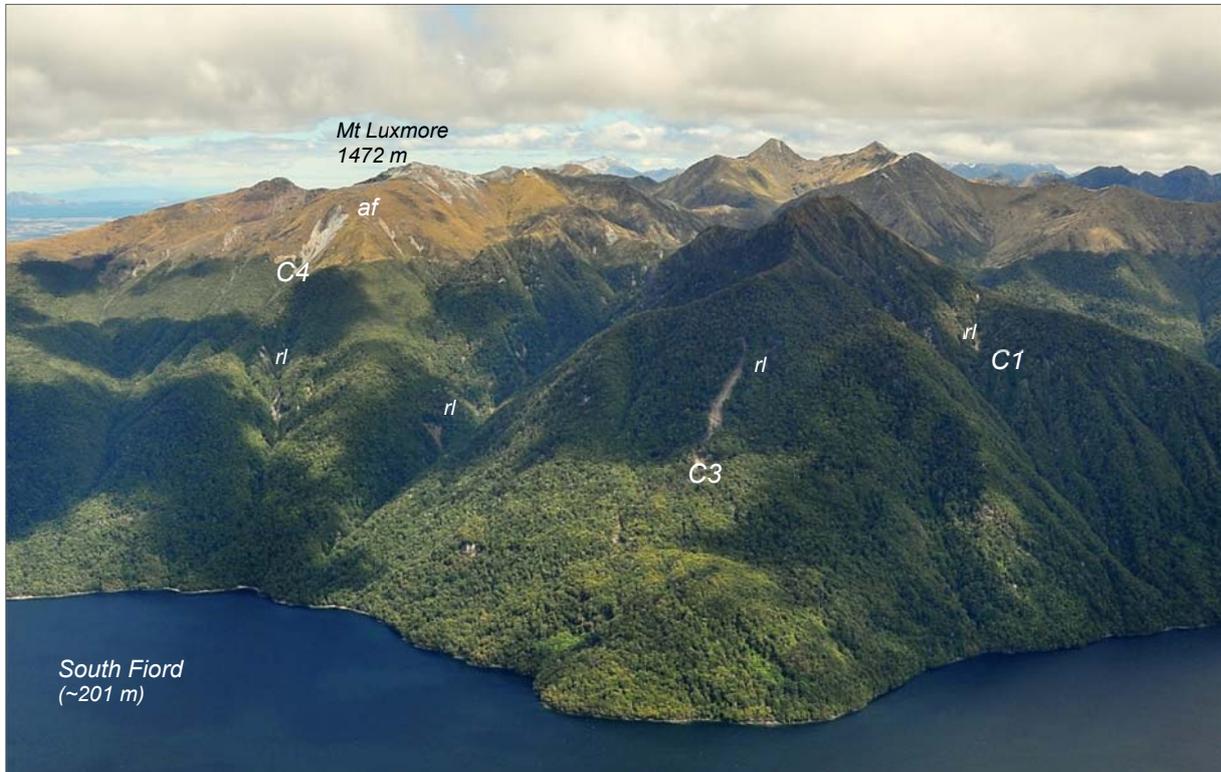
Four potential failure sites (Sites C1, C2, C3, and C4) are identified on the southern side of South Fiord in the heads of moderate to steep (25-40°) gullies where there are a number of recent small to moderate sized shallow landslides ~ 8 –12 km west of the main arm of the lake, and ~ 17 –21 km from Te Anau (Figure 11a and Figure 20). Recent small shallow landslides in these areas, and the scar of a large active landslide on the spur ~ 700 m northeast of Mt Luxmore, suggest that MM8-10 earthquake shaking would trigger small to large ($\sim 10^3$ to 10^5 m³) shallow debris slides at all sites which could reach the lake. Such failures could produce ~ 1 –3 m high waves locally (within ~ 0.5 –1 km), but because of their dominantly cross-fiord movement waves more than a few 10's of cm high will probably not travel beyond the entrance of South Fiord. Facility sites of interest to Environment Southland around the shoreline of Lake Te Anau are unlikely to be affected.

Figure 20. Aerial view of Area C on the south side of South Fiord about 8-12 km west of the main arm of Lake Te Anau. At *Site C4* a large active gully failure (*af*) is visible ~700 m northeast of Mt Luxmore, and there are recent shallow failures (*rl*) at *sites C1, C3, and C4*.

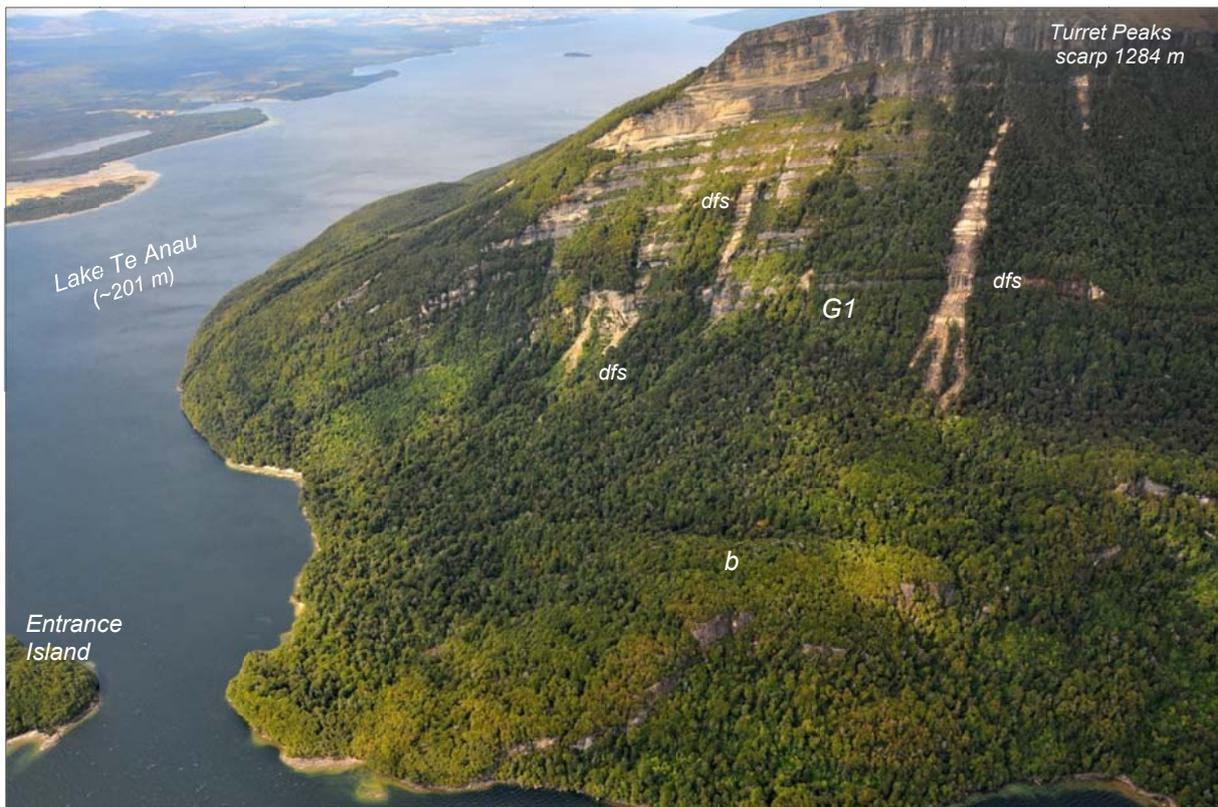
Figure 21. Aerial view of Area G on the Turret Peaks scarp at the entrance to North Fiord. At Site G1 there have been small to moderate prehistoric rock falls on to the bush-covered bench (*b*) above the lake, and small rock and debris falls and slides (*dfs*) occurred during the 2003 earthquake.

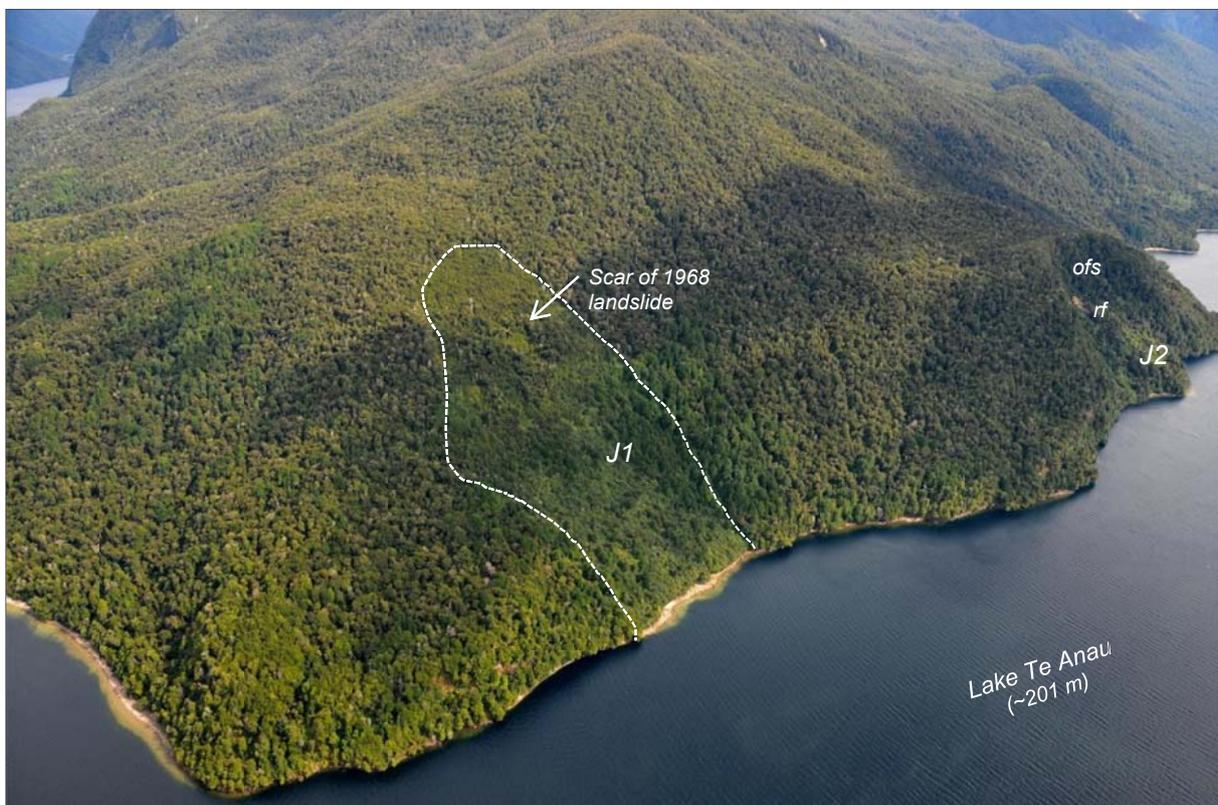
Figure 22. Aerial view of Area J on the west side of Lake Te Anau near the entrance to North Fiord. A large landslide occurred at Site J1 in 1968 (the scar has now revegetated), and there have been small recent falls (*rf*) on an older failure scar (*ofs*) at Site J2 about 1.5 km to the north.

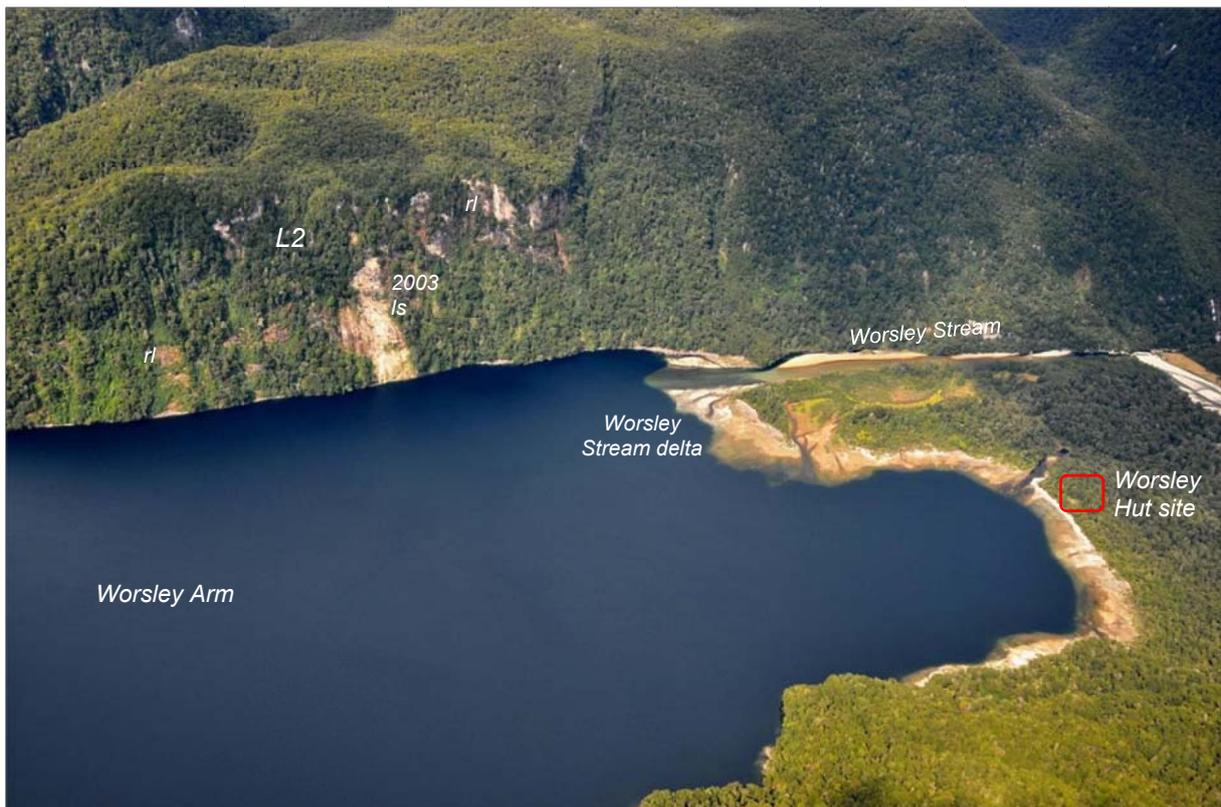
Because of the location of Worsley Hut close to the lake shore and the Worsley Stream delta (Figure 23) there is strong possibility the hut could be affected by lateral spreading, or by a wave generated by collapse of the delta during very strong earthquake shaking. A site-specific evaluation would provide a more accurate assessment the landslide, ground deformation, and tsunami hazard at Worsley Hut.

Figure 23. Aerial view of potential landslide Site L2 at the head of Worsley Arm of Lake Te Anau. Site L2 on the ~300 m high cliffs ~1 km southeast of Worsley Hut. Failures on these cliffs during the 2003 earthquake (*Is*) and more recently (*rl*) indicates their vulnerability to strong earthquake shaking.

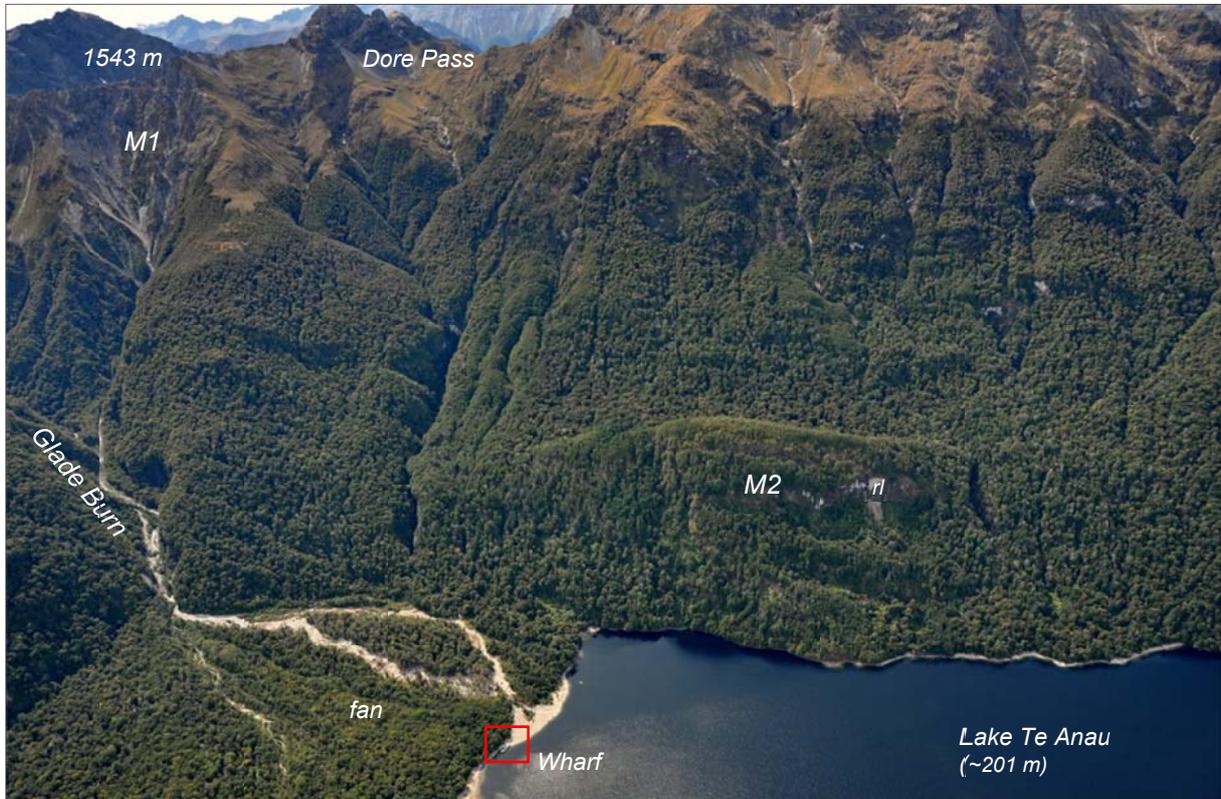
Figure 24. Aerial view of potential landslide Area M at the head of Lake Te Anau. Site M1 is on an eroding 1543 m peak 1 km north of Dore Pass. Debris slides and flows from this peak onto the Glade Burn fan and into the lake pose a direct damage and wave threat to the Glade wharf facility, as do rock falls on the cliffs at Site M2, where there have been small recent failures (*rl*).

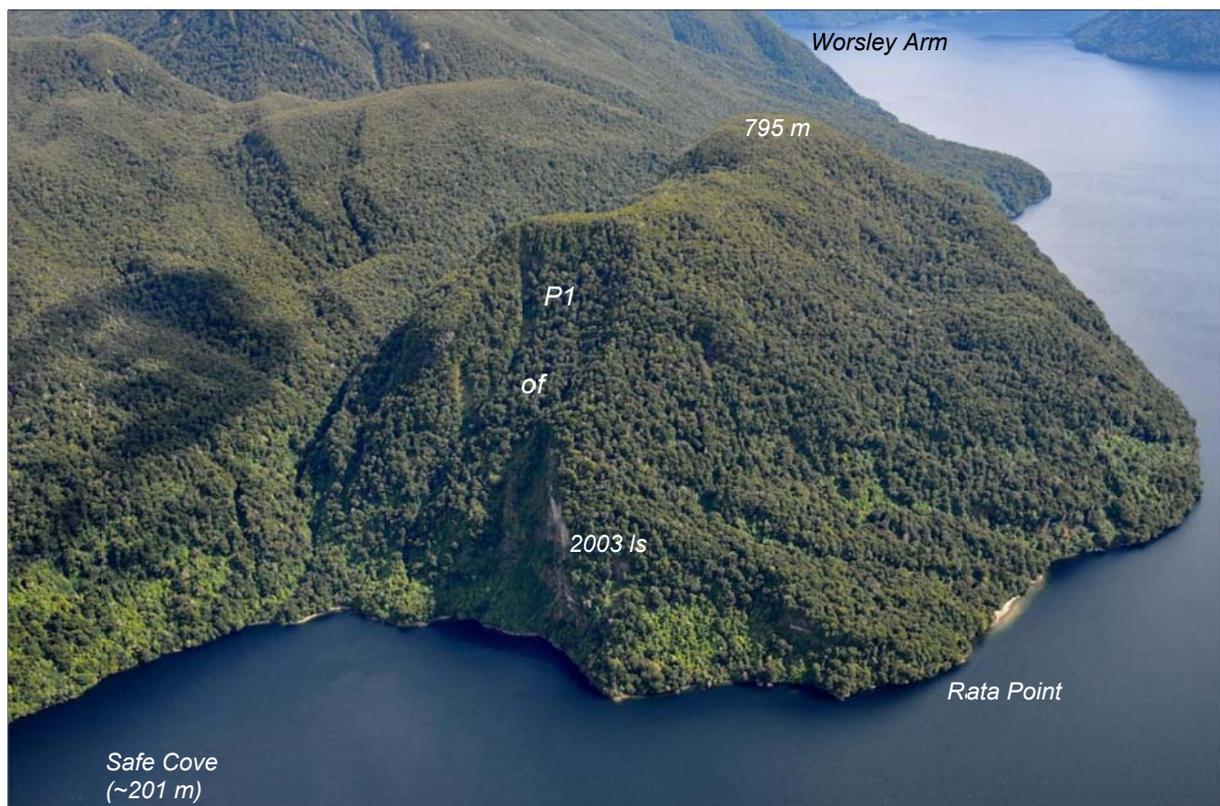
One potential failure site area (Site P1) was identified on the very steep ($\sim 40\text{-}50^\circ$) ~ 500 m high slope on Rata Point at the north end of Safe Cove on the western side of the lake ~ 7 km south of Worsley Arm (Figure 11c and Figure 25). The presence of a small recent (2003) shallow failure scar, together with a larger deep seated old failure on the slope, suggests that MM8-10 earthquake shaking could trigger small to large ($\sim 10^3$ to 10^5 m³) rock falls into the lake. Such falls could produce $\sim 1\text{-}3$ m high waves locally (within 0.5–1 km), which would probably travel south down the main arm of the lake. Waves of that size near the head of the lake are unlikely to affect the Te Anau Downs Boat Harbour ~ 20 km to the south or any other facility sites of interest to Environment Southland.

Figure 25. Aerial view of potential landslide Area P on the north side of Safe Cove on the west side of Lake Te Anau ~ 7 km south of Worsley Arm. Landslide *Site P1* is on an old failure (*of*) on the steep 500 m south face of Rata Point, where a small landslide (*ls*) occurred during the 2003 earthquake.
