River planform and cross-section changes in the Whangamoa River near the Kokorua lowland forest remnant

**Envirolink Advice Grant:
1407-NLCC74**

Landcare Research Contract Report:

LC1674

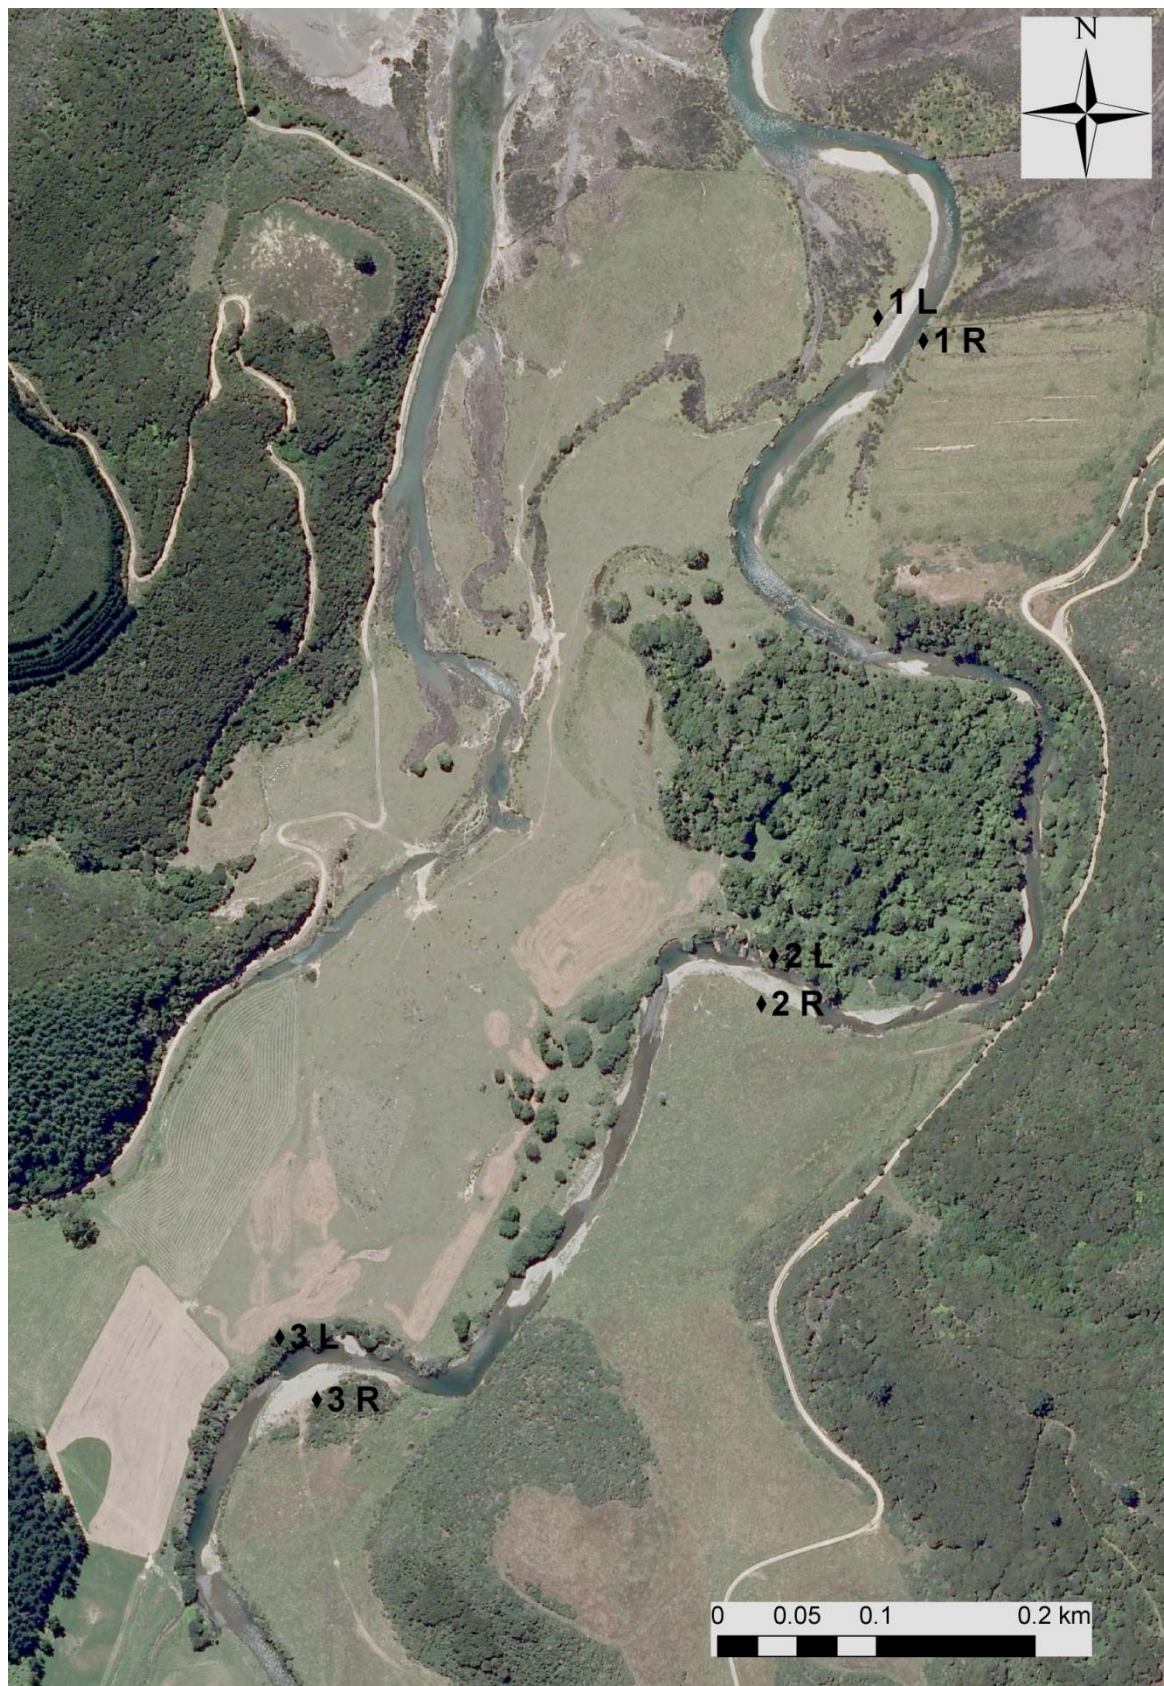
Figure 1 Overview of lower reaches of Whangamoa River showing location of forest remnant within meander loop of the river and the location of river cross sections. Underlying image was taken in 2009.

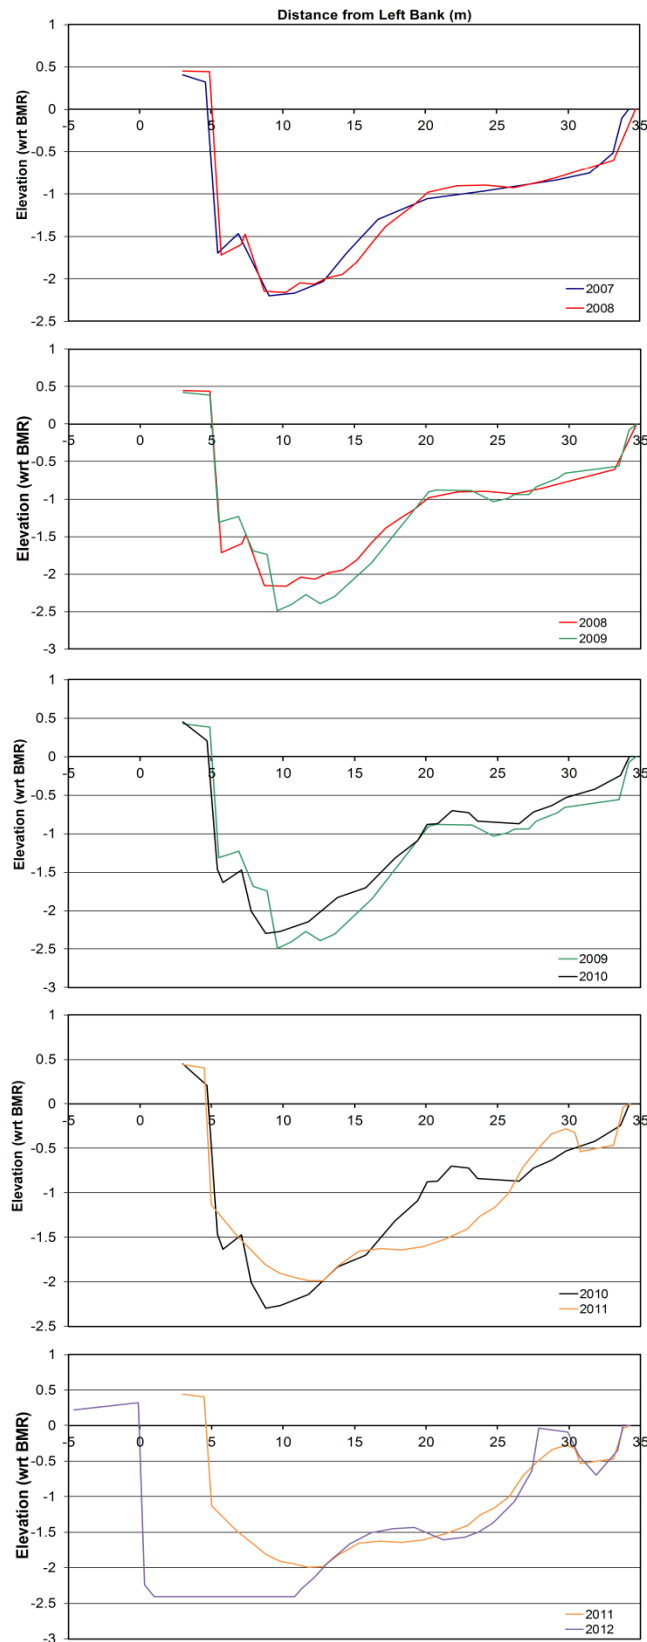
Figure 2 Comparison of annual plots of river-cross-section shape at Kokorua forest remnant, 2007–2012 (Cross Section 2).

- 2007–08: very little change
- 2008–09: slight deepening of the channel in the centre of the river
- 2009–10: slight aggradation in the channel and the beach of the true right bank, slight deepening at the base of the true left bank
- 2010–11: slight aggradation in the channel and degradation of the river margin of the gravel beach on the true right
- 2011–12: the left bank retreated by c. 5 m and the channel deepened by at least 1.5–2 m.

In summary, only small changes to cross-section shape occurred from 2007 to 2011, with the major change occurring between the 2011 and 2012 surveys when there was massive bank erosion and channel deepening on the true left. This may have been associated with high flows during the December 2011 and subsequent storms, although there is no flow record for the Whangamoa and the storm did not appear to be as large in the Whangamoa area as in the lower Wakapuaka. A local resident suggests much of the erosion occurred in a series of floods in December and January (B Healy, pers. comm., October 2013).

These observations are supported by mean bed level (MBL) calculations that show between 2007 and 2011 MBL varied by ± 6.5 cm (essentially within measurement error) but between 2011 and 2012 fell by at least 25 cm (MBL cannot be accurately calculated for 2012 because the deep wetted channel was not entirely surveyed). There does not appear to be any evidence of a build-up of gravel on the beach on the inside of the bend (true right) putting stress on the outside (true left) of the bend.

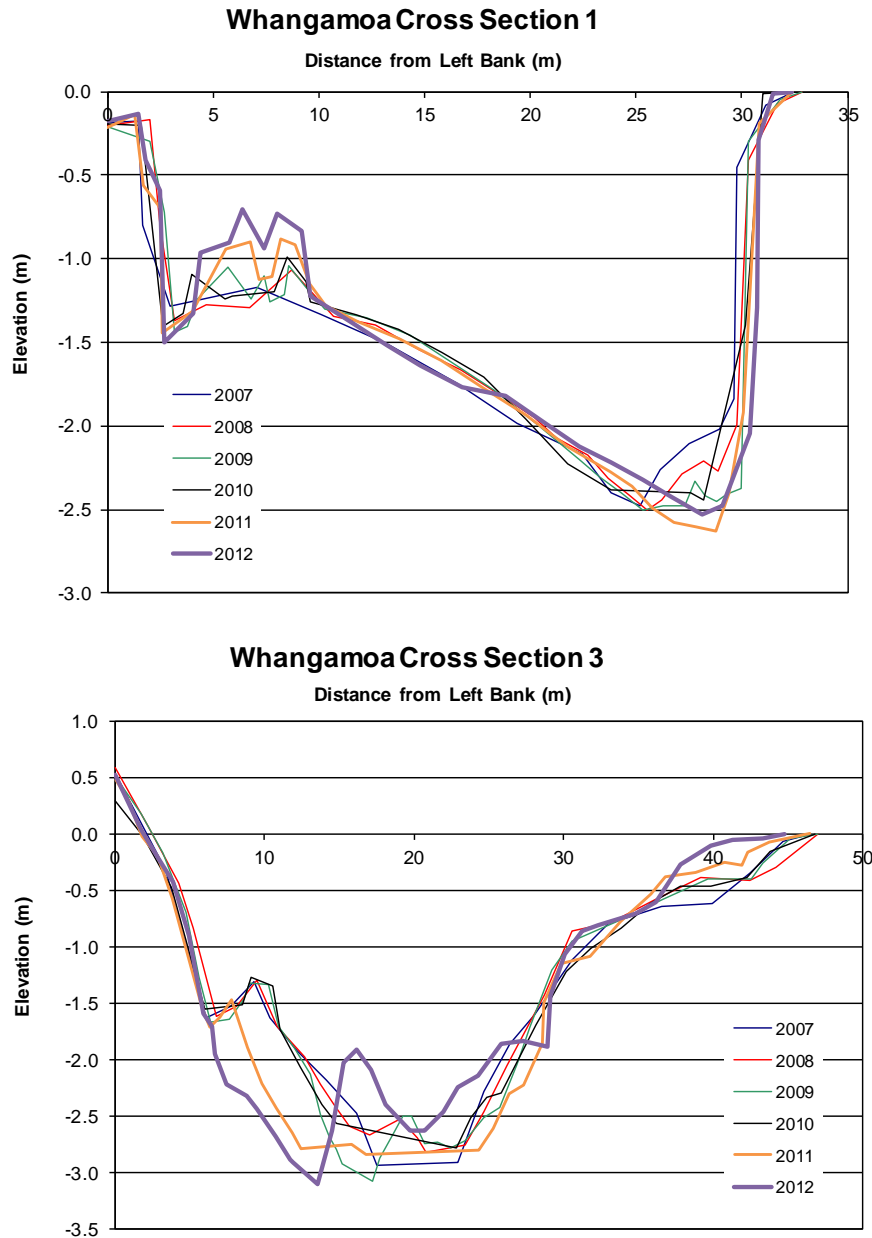
The adjacent cross sections are situated a long way (>450 m) upstream and downstream of Cross Section 2 and are not especially helpful in understanding the changes that have occurred there. Cross Section 3 is on a meander bend similar to Cross Section 2, while Cross Section 1 is on a relatively straight reach of river. There has been little change at either of these cross sections between 2007 and 2012 (Figure 3). At these sites the banks have remained stable and there have been only minor fluctuations in MBL (± 2.3 cm at Cross Section 1, ± 12.3 cm at Cross Section 3). There is a tendency for slight erosion and channel deepening at the base of the true left bank at Cross Section 3, but not as severe as at Cross Section 2.

Figure 3 Changes in river-cross-section shape at upstream (Cross Section 3) and downstream cross sections, 2007–2012.

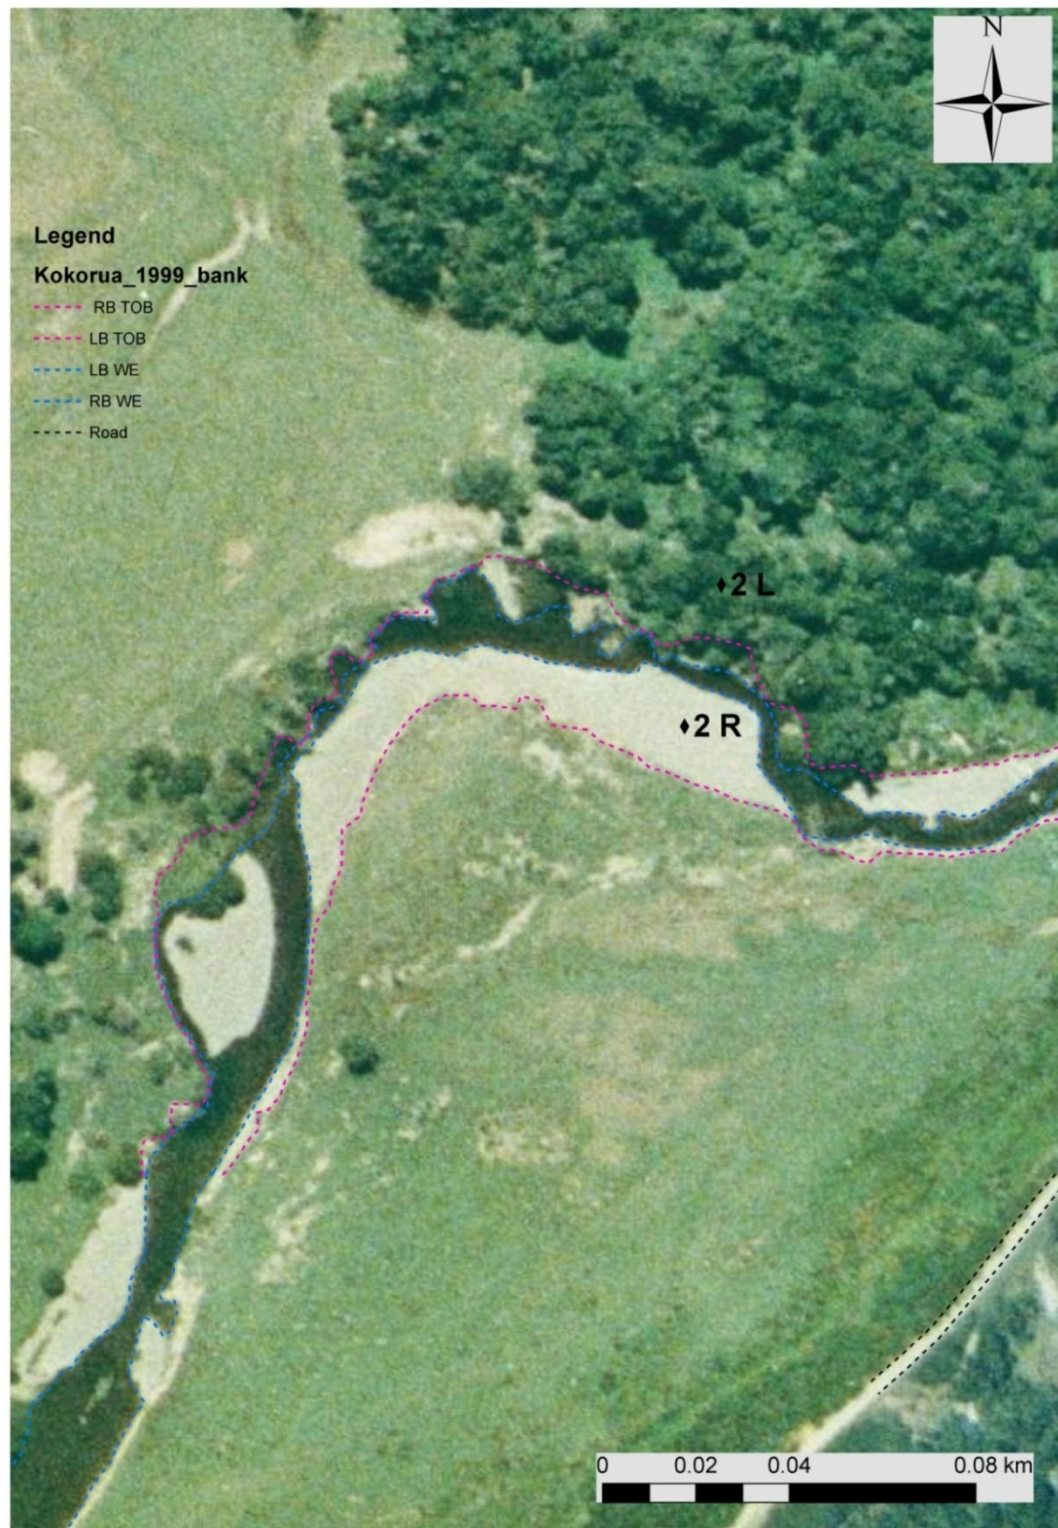
Figure 4 Mapping of channel planform in 1999 (RB = right bank, LB = left bank, TOB = top of bank, WE = water edge).

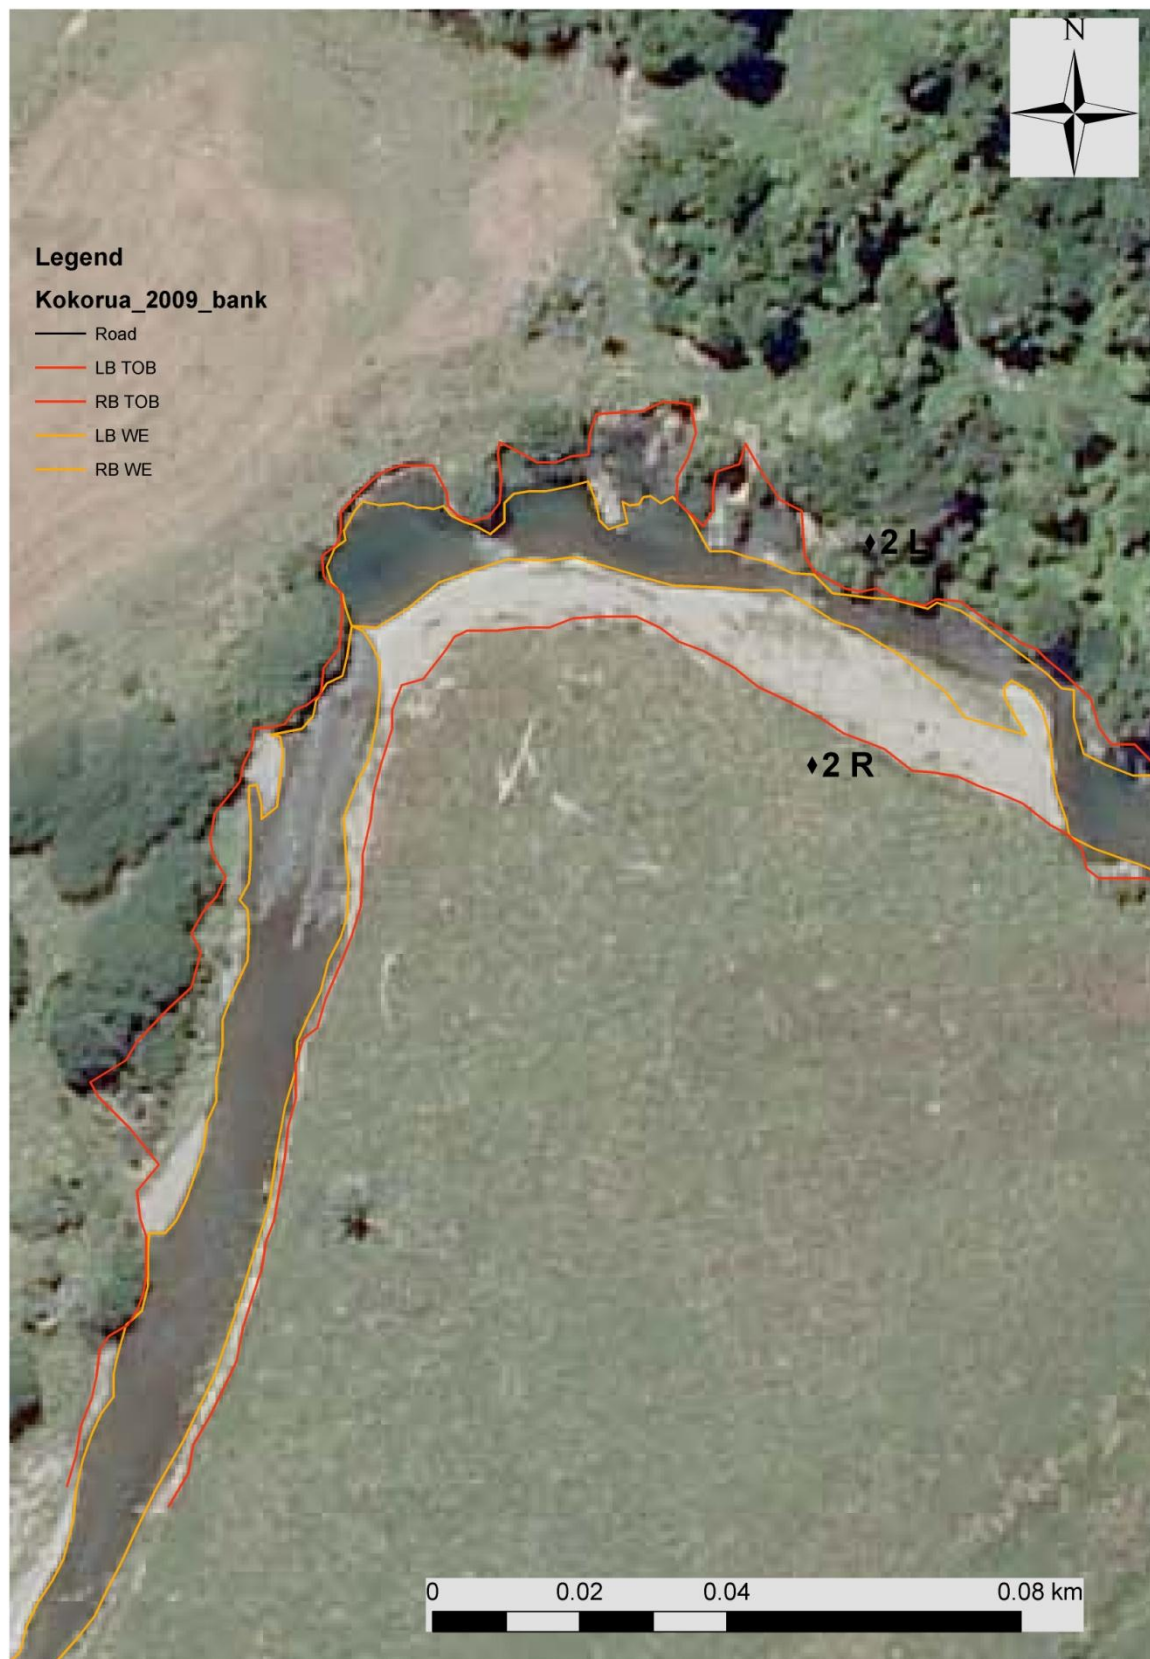
Figure 5 Mapping of channel planform in 2009.

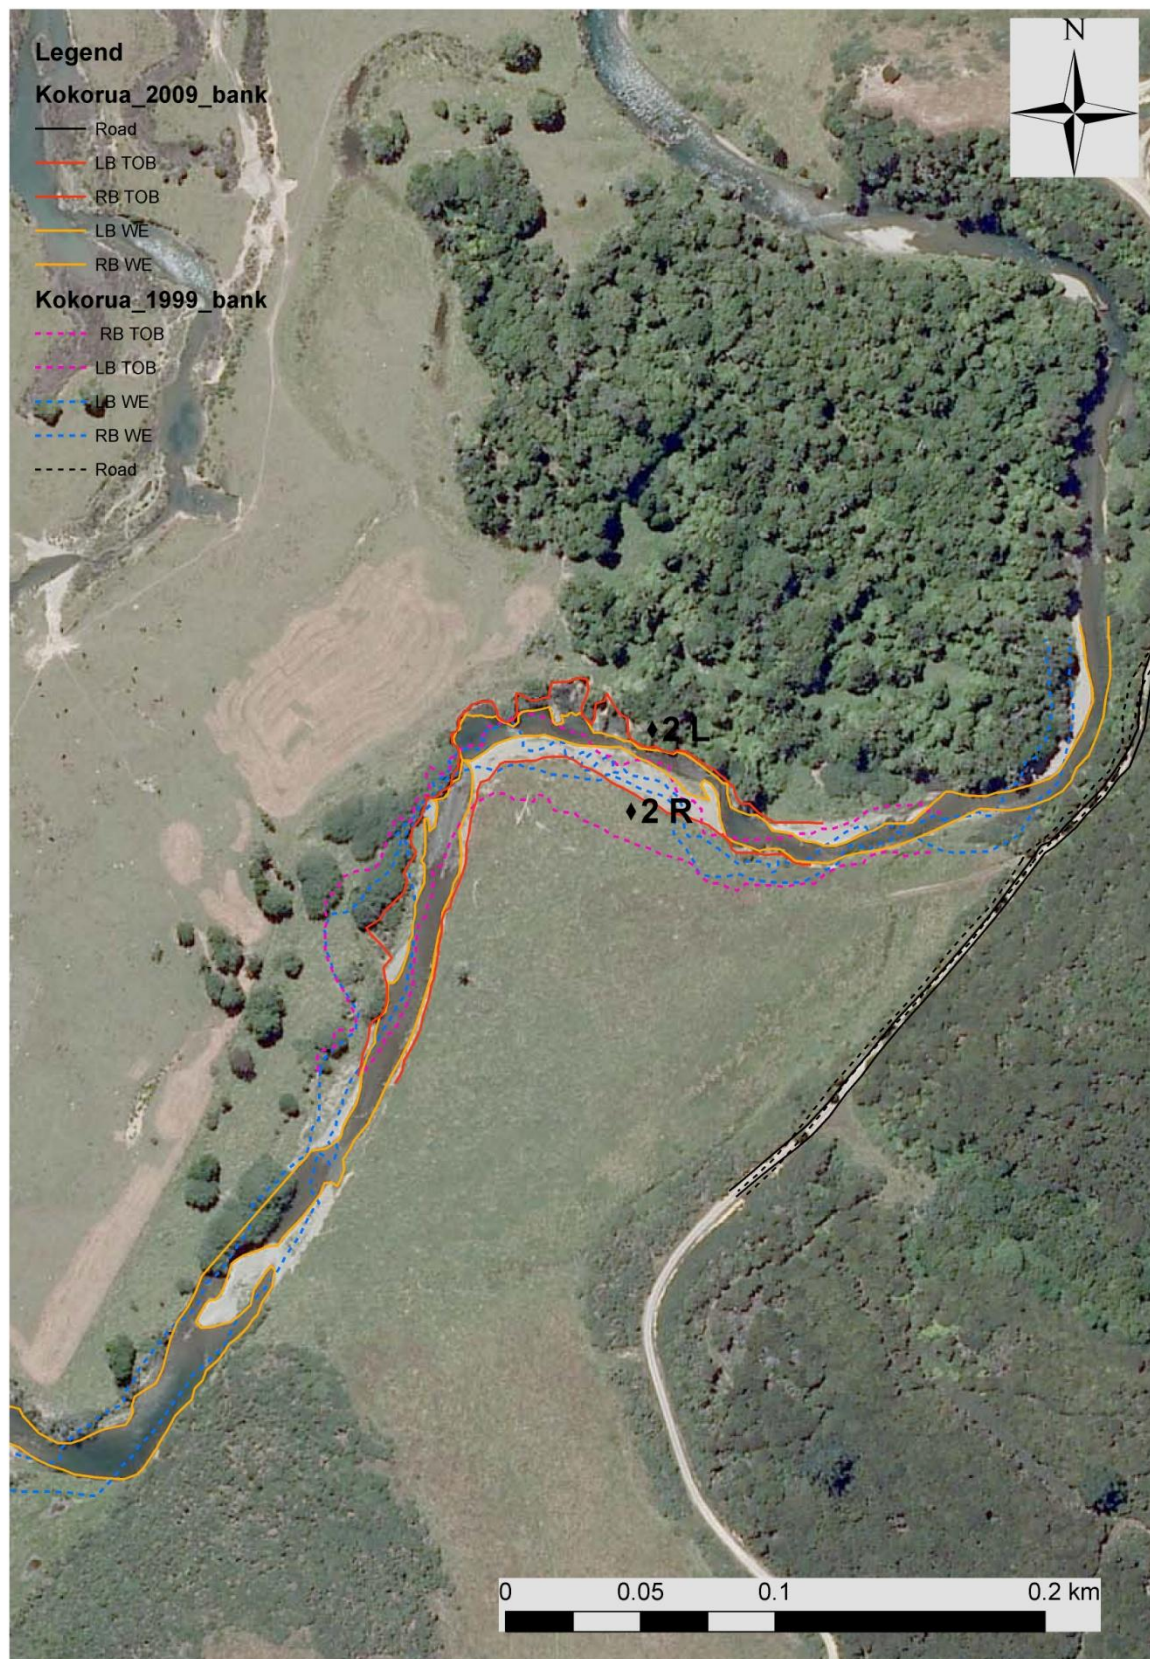
suggests substantial changes over the 10-year period. Part of the difference may be due to registration error, which can be up to 10 m on parts of the images; however, note the road adjacent to the site is well registered suggesting the differences are not likely to be due to registration error.

Figure 6 Comparison of channel planform in 1999 and 2009.

The mapping suggests that the straight reach of channel upstream of the bend on which Cross Section 2 is located has realigned eastwards (in the order of 10 m) causing the downstream bend in the channel to become tighter, putting more stress on the true left bank, causing the bank to erode and the channel to deepen. This has effectively resulted in the channel bend migrating and is part of the natural evolution of a meandering channel characterised by downstream migration of meander bends, which is associated with erosion on the outside of bends and deposition of point bars on the inside of bends (Figure 7). It is occurring at this point in the Whangamoa River because the sinuosity of the channel (ratio of channel length to down-valley length) between Cross Sections 1 and 3 is greater than anywhere else in the channel – it has a value of 1.6 compared with typical values of 1.1 to 1.2 between other cross sections.

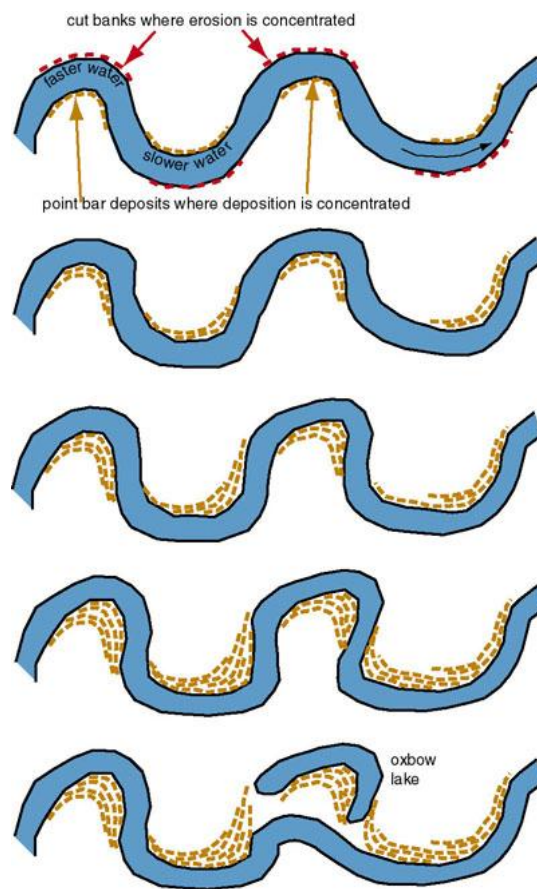
Figure 7 Diagrammatic illustration of the process of meander migration.

This apparent realignment of a straight reach of channel appears real since the channel mapping coincides upstream and downstream on the 1999 and 2009 mapping. It is not clear what has caused this channel realignment nor can the timing be established. It is possible the channel realignment may have occurred before the cross-section surveys began. It has occurred in an area with fairly dense willow cover, which may have caused deposition on the true-left berms. It does appear to confirm that the bank erosion is not a response to aggradation of the gravel beach on the inside of the bend – this is more likely to have been a consequence of sediment supplied by bank erosion from the upstream channel being deposited on the inside of the meander bend as a point bar. The channel is likely to continue to migrate and erode the left bank in the absence of significant bank protection or realignment of the channel.
