Review of Nelson City Council's river-cross-section network for managing gravel extraction

Envirolink grant 1214-NLCC64

September 2012

Landcare Research Contract Report:

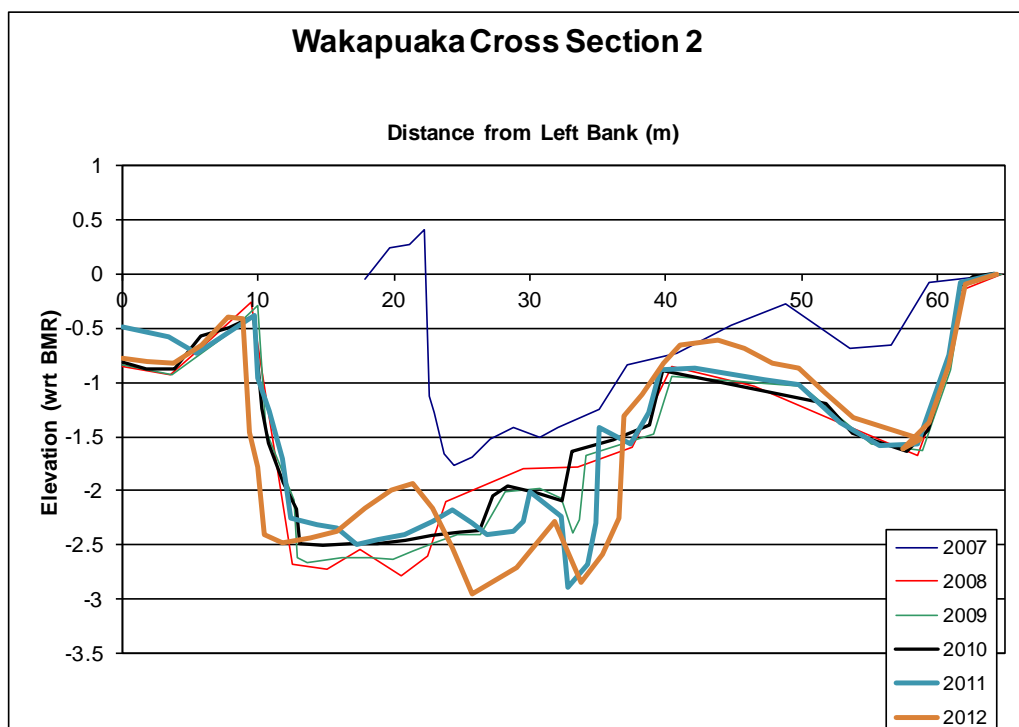
- Wakapuaka Cross Section 2. A completely different surveying set-up was used in 2007 compared with all later data. The 2007 data may be usable but the distances would need to be corrected.

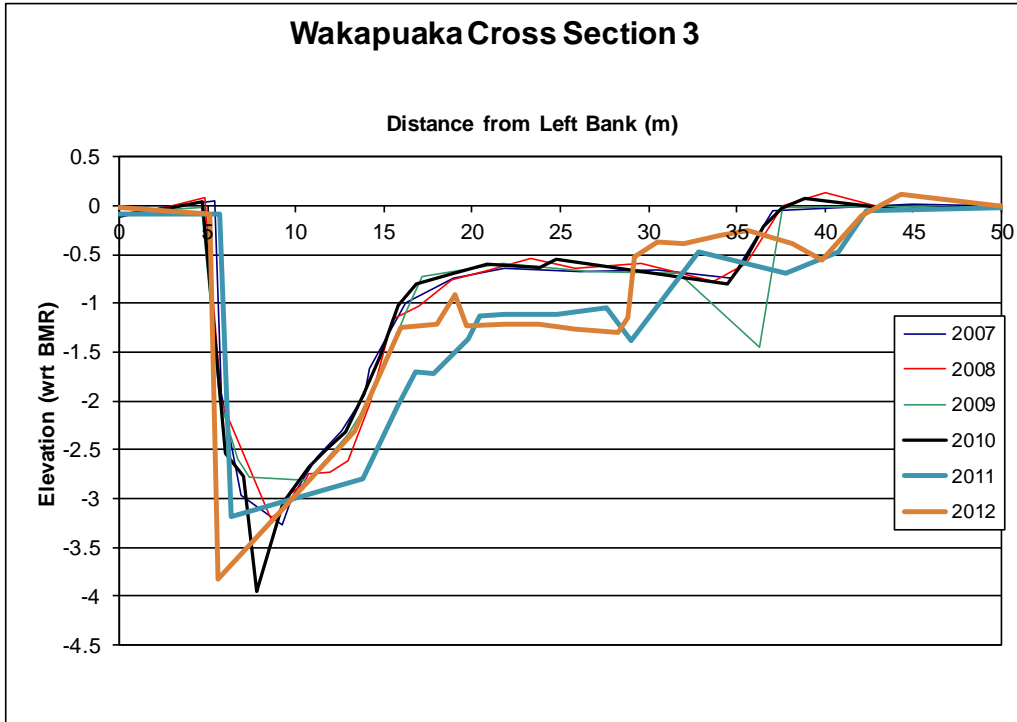
- Wakapuaka Cross Section 3. The surveyed distance along this cross section is much greater in 2011 and 2012 (c. 55 m) than earlier surveys (c. 49 m). The data state the true left bank had eroded and a new true-left benchmark was established. This suggests the 2011 and 2012 data should be plotted to the true right benchmark instead of extending the plot on the true right bank.

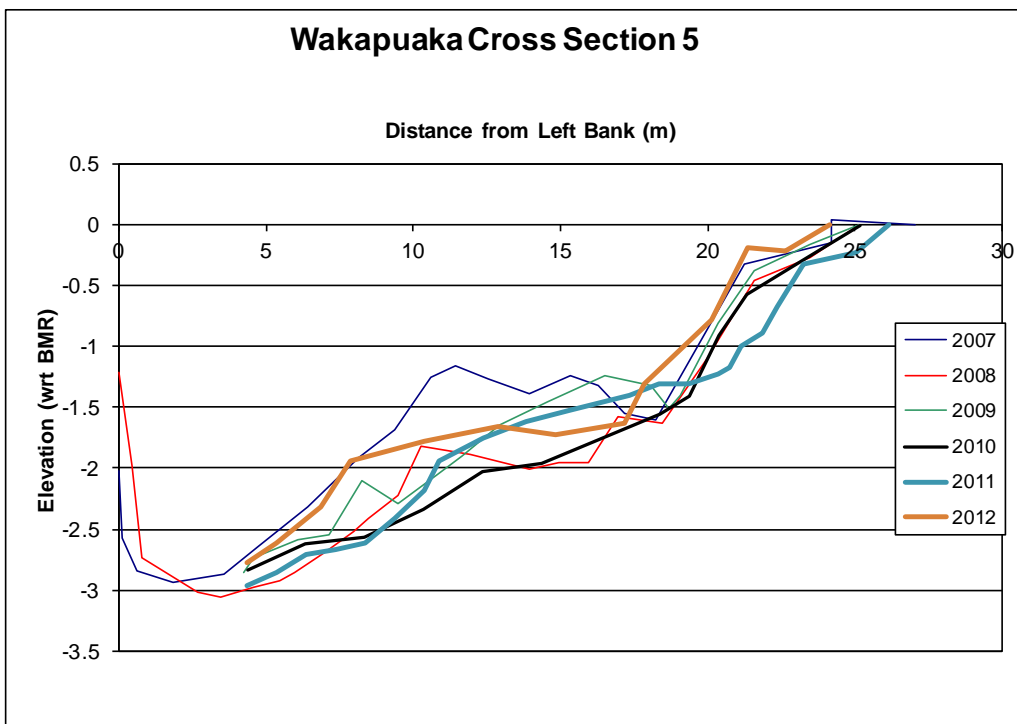
- Wakapuaka Cross Section 5 has not been surveyed full width since 2009 and cannot be used for calculating mean bed level or gravel volume. It should be relocated to somewhere it can be surveyed full width.

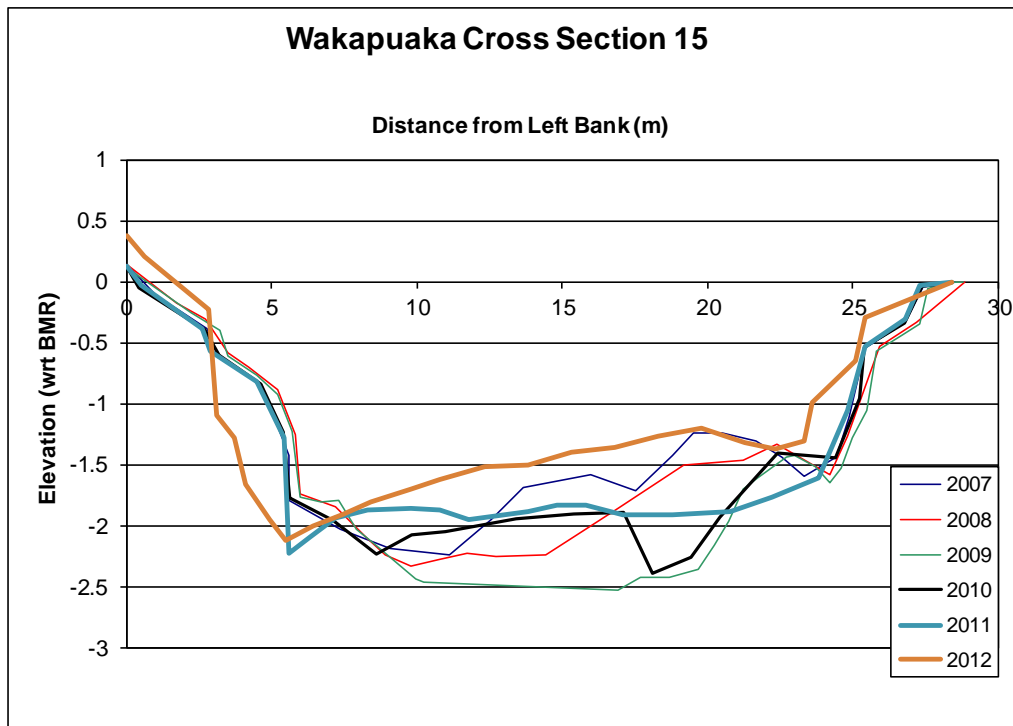
- Wakapuaka Cross Section 15. The survey data for 2009 looks odd compared with all other years and the straight line suggests the water was too deep to survey from 10 to 17 m.

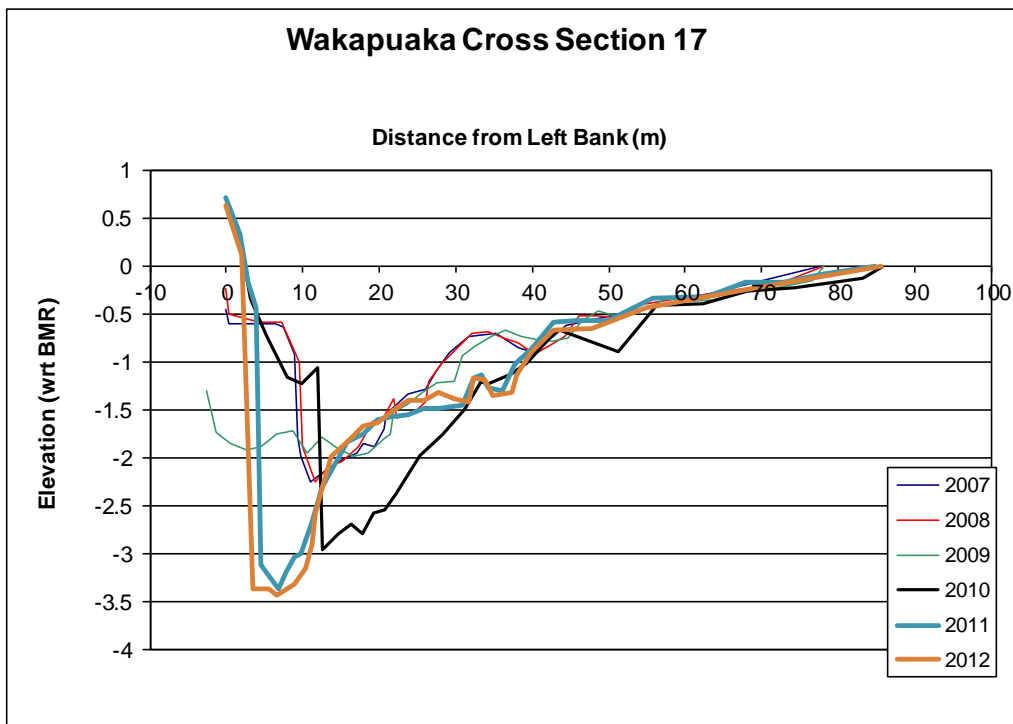
- Wakapuaka Cross Section 17. There was a major river avulsion here beginning in 2009 and there was considerable bank erosion on the true left bank. All data should be plotted relative to the true-right benchmark and their suitability for analysis considered.

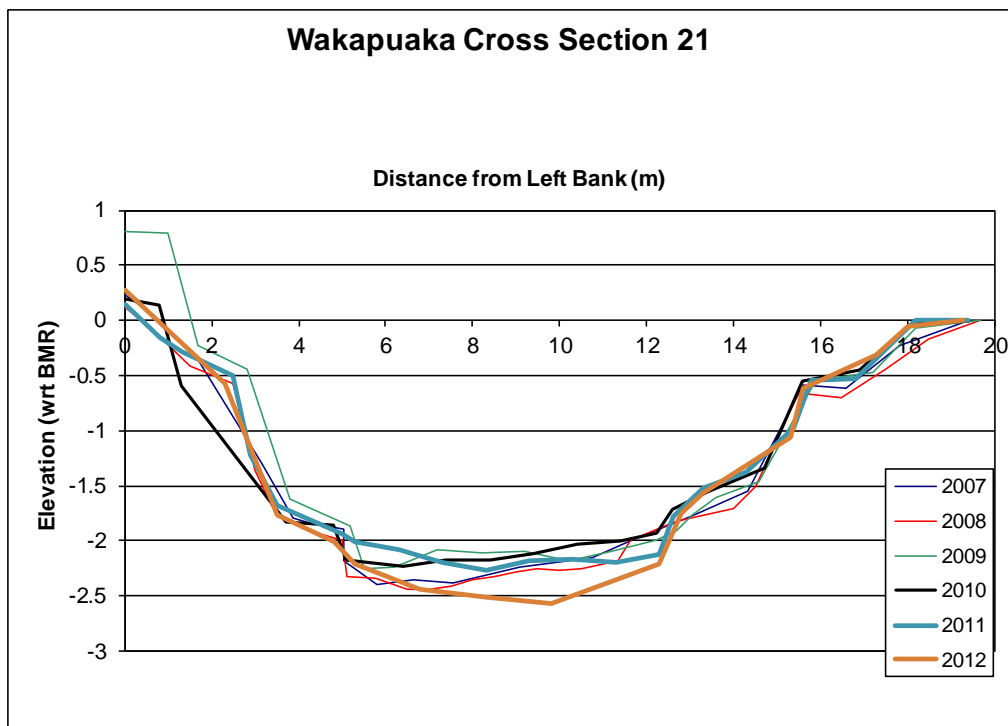
- Wakapuaka Cross Section 21. The plot of the 2009 data looks odd with a much higher left-bank origin than in all other surveys. It is not clear if it was surveyed to an existing benchmark.

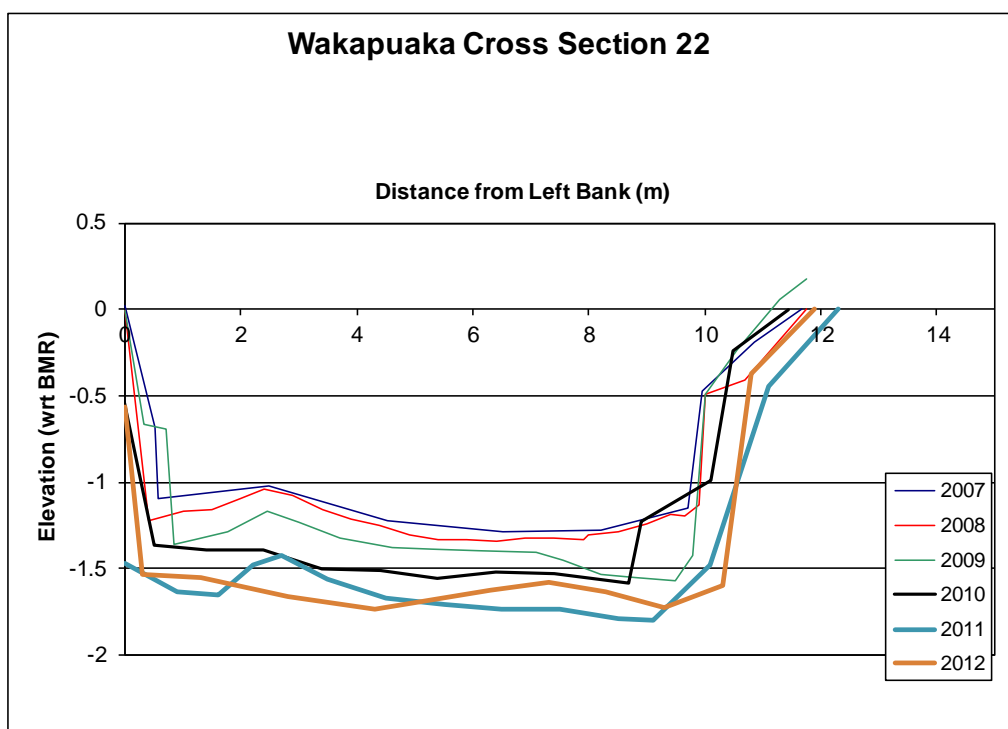
- Wakapuaka Cross Section 22. This cross section has always been surveyed to the existing staff gauge on the true left bank. All plots should converge on the same elevation on the true left bank. This section looks very stable but the plot suggests considerable change of bed level (by 0.5 m).

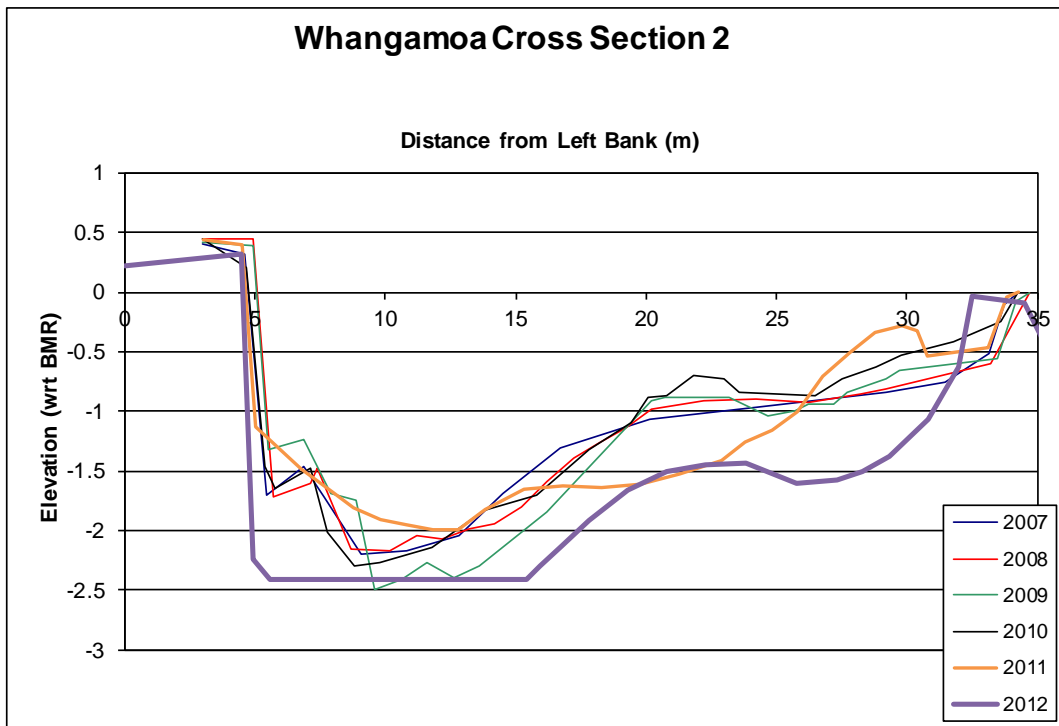
- Whangamoia Cross Section 2. There has been massive bank erosion on the true left bank yet the cross-section plot does not show this. Part of the section is now too deep to survey (between 6 and 15 m) and it may be necessary to relocate the section.
