# Opportunities to Address Water Quality Issues in Lakes Wiritoa and Pauri

June 2013  
Report No. 2013/EXT/1327  
ISBN 978-1-927250-30-3

Report No: HAM2013-053  
Project: ELF13226

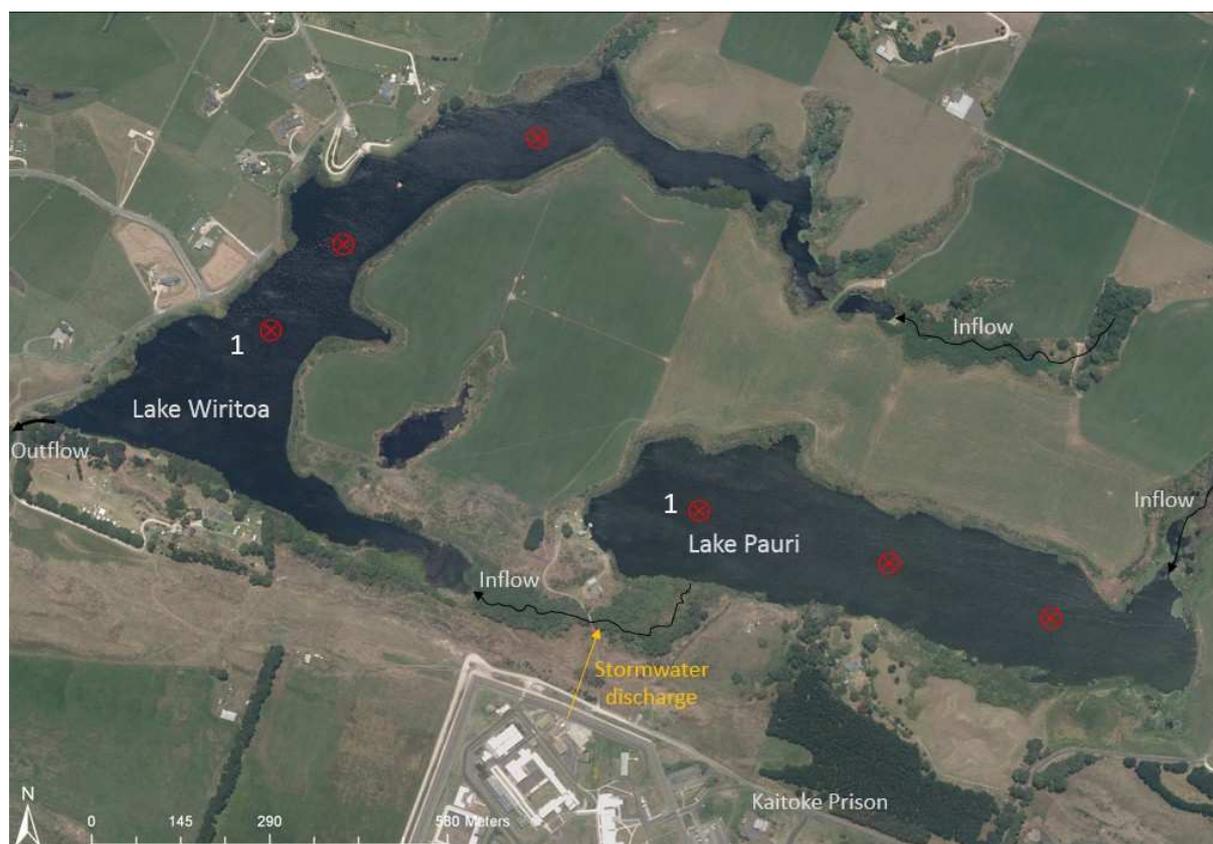
**Figure 1: Lakes Wiritoa and Pauri showing the inflows, outflows and the short stream linking the two lakes.** Stormwater from the Kaitoke Prison discharges into the linking stream between the lakes. Red markers are profiling sites used in 2013. Aerial photo provided by Horizons..

Lake Pauri connects with Lake Wiritoa to the west via a short stream (Figure 1). Under normal conditions, water flows from Lake Pauri into the south-eastern end of Lake Wiritoa, which discharges into the outlet stream from the south-western end of the lake. During a site visit on 5<sup>th</sup> February 2013, the flow was in the opposite direction due to obstruction of the outlet stream from Lake Wiritoa by a slip / bank collapse (Figure 5). Lake Wiritoa also has a small inflow from the smaller north-eastern catchment.

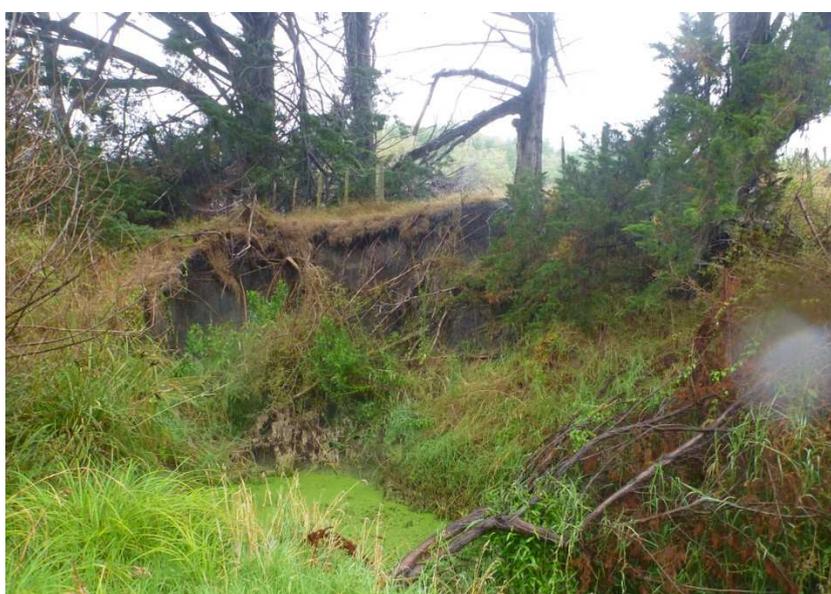
**Figure 5: Collapse of the stream bank partially blocked the outflow from Lake Wiritoa.** The sub-soil is black iron sand with a thin layer of soil on top. The blocked stream is covered with duck weed (*Lemna disperma*). (Photo: Max Gibbs 5/02 2013).

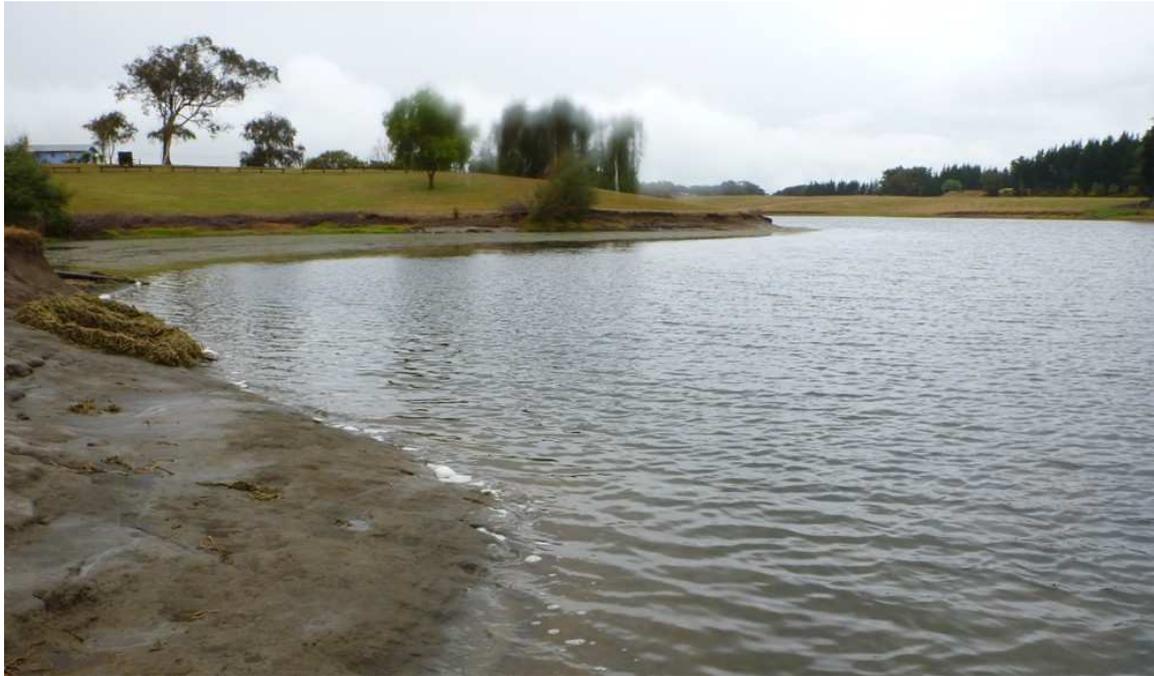
**Figure 6: Lake Dudding at low water level exposing the hard impermeable clay layer that underlies the lake.** (Photo: Max Gibbs 5/02 2013).

These lakes are on highly permeable iron sands which implies that they are likely to be on clay lense geological formations similar to those at Lake Dudding (Figure 6). Because of the permeable sandy soil in the catchment, there will be rapid infiltration of rainfall, along with stock effluent and seepage from domestic septic tanks, which will leach nutrients into the surface groundwater aquifer where they can seep into the lakes. Because the outflow from these lakes is small at best and nil during the summer, the theoretical residence time of water entering these lakes will be very long. Consequently, nutrients in the inflows will accumulate in the lake to augment the internal load.

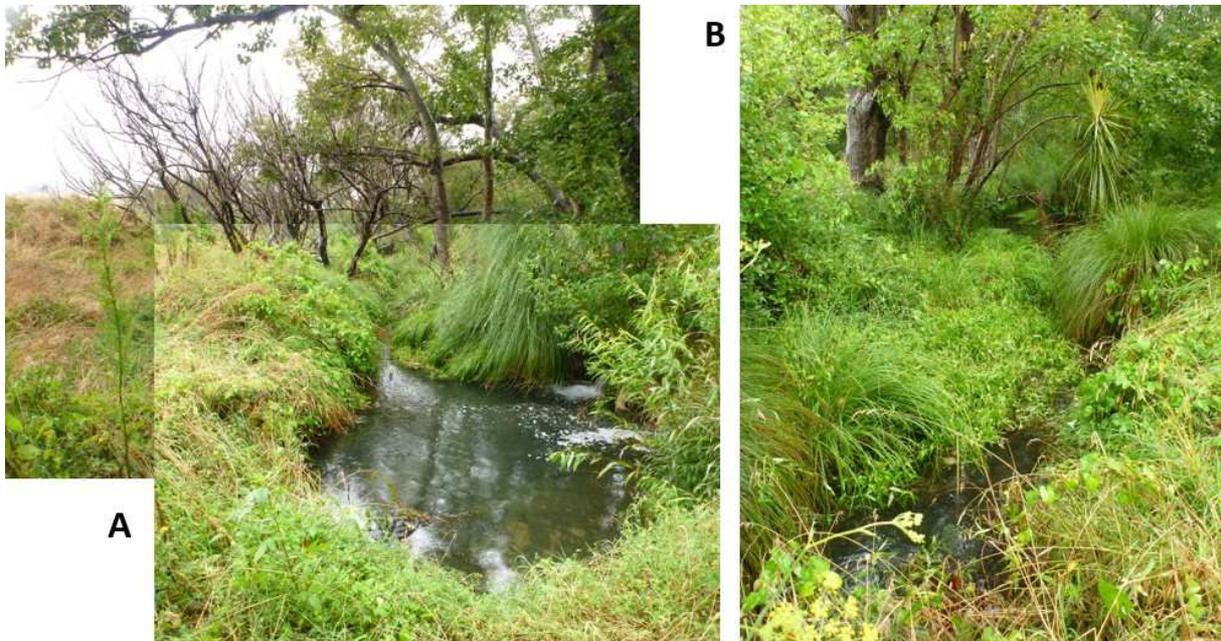
**Figure 7: Stormwater drains (2) discharging into the connecting stream between the two lakes from the crossing.** A) View east towards Lake Pauri, B) View west towards Lake Wiritoa. The connecting stream was heavily overgrown. (Photos Max Gibbs 5/02/2013).

Stormwater from the Kaitoke Prison complex on the southern side of Lake Pauri discharges directly into the stream channel between the two lakes via two pipes (Figure 7). Samples taken of the stormwater discharge on 4 February 2013 showed that they were enriched with nutrients (Table 3).

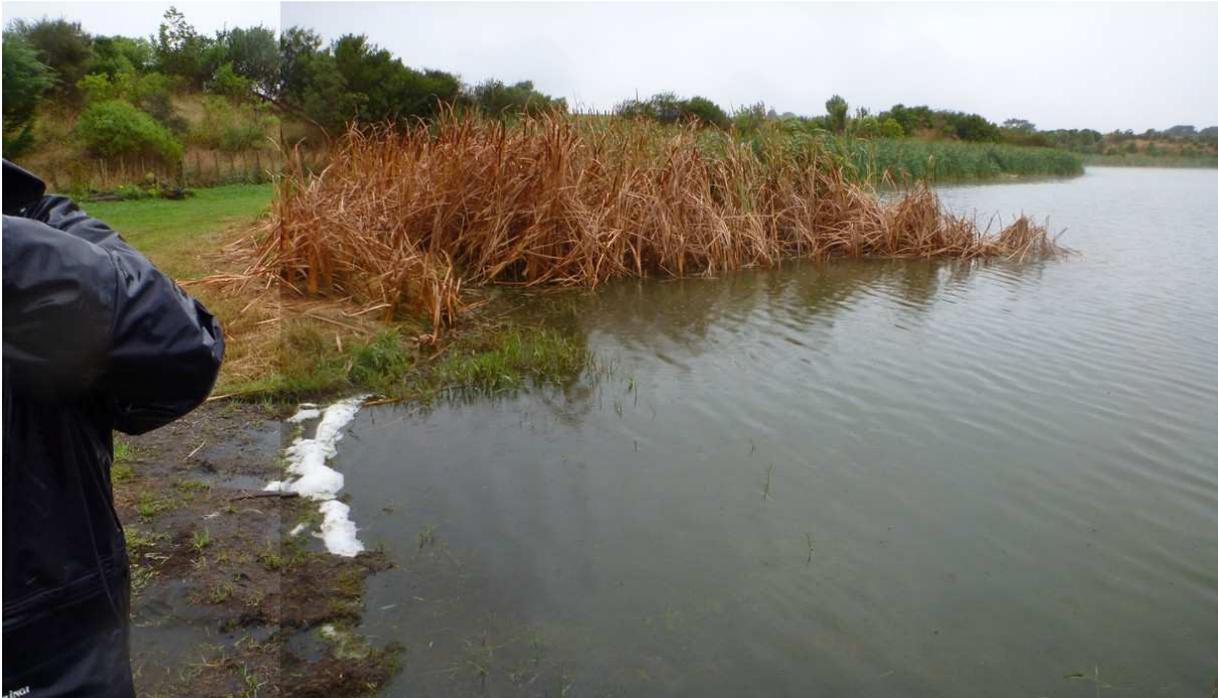
**Figure 12: Spay damage to the raupo on the lake margin in Lake Pauri (5/02/2013).** The green dense leaf mass of growing plants surrounds most of the lake. (Photo: Max Gibbs 5/02 2013).

The lake edge plants were dominated by raupo but there was evidence that spraying had been used in Lake Pauri to keep some lake-shore areas clear for lake access (Figure 12).

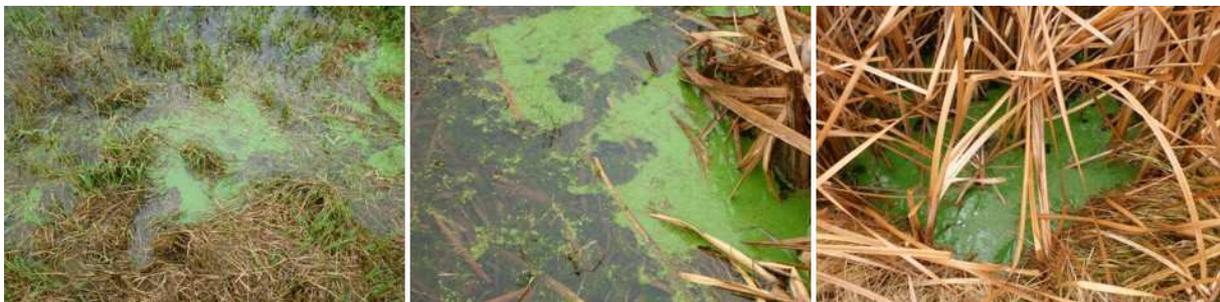
**Figure 13: Cyanobacteria (*Microcystis* sp.) proliferations in the edge waters of Lake Pauri (5/02/2013).** (Photos: Max Gibbs 5/02 2013).

During the inspection of the lakes on 5 February 2013, patches of *Microcystis* spp. were found in the grass and dead raupo along the edge of Lake Pauri (Figure 13), and a few, more-dispersed cells were found at the boat ramp in Lake Wiritoa.

The  $\text{NH}_3$  is also thought to inhibit the nitrification process that converts  $\text{NH}_4\text{-N}$  to  $\text{NO}_3\text{-N}$ , thereby shutting down the denitrification process, preventing the loss of N. These biologically driven actions mean that there is a source of both inorganic N and P in the water beneath the cyanobacteria bloom allowing it to continue to grow. This process is likely to be a contributing factor in the growth of *Microcystis* sp. when there is no apparent inorganic nitrogen source. In Lake Paui, the *Microcystis* was growing in the edge waters and the shallow water between the dead raupo stems (Figure 13).

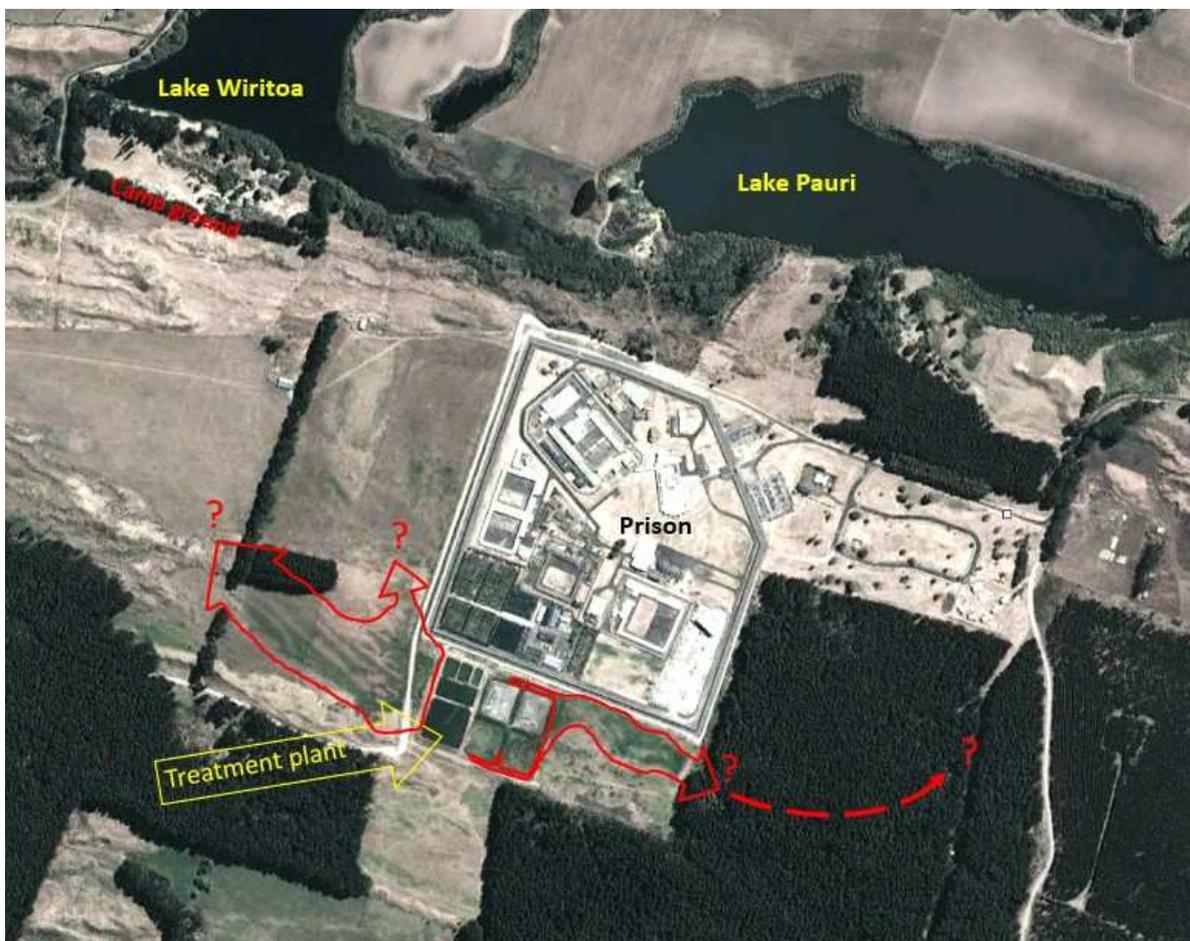
**Figure 23: Kaitoke (Wanganui) Prison showing the positions of the prison and the wastewater treatment plant relative to Lakes Wiritoa and Pauri.** The image [Google Earth] was flown on 11 March 2013 during a drought. Green areas (excluding dark green pine forest) are interpreted as receiving water. Areas enclosed in red polygons may indicate surface discharge of treated wastewater. Arrow heads on the red polygons indicate potential direction of flow. The broken red line indicates a possible flow path to a gulley leading into Lake Pauri.
