Investigation of Remediation of Acid-Mine-Impacted Waters at Cannel Creek

Landcare Research Contract Report: LC0506/169
CRL Report: 06-41101

PREPARED FOR:
West Coast Regional Council

DATE: July 2006

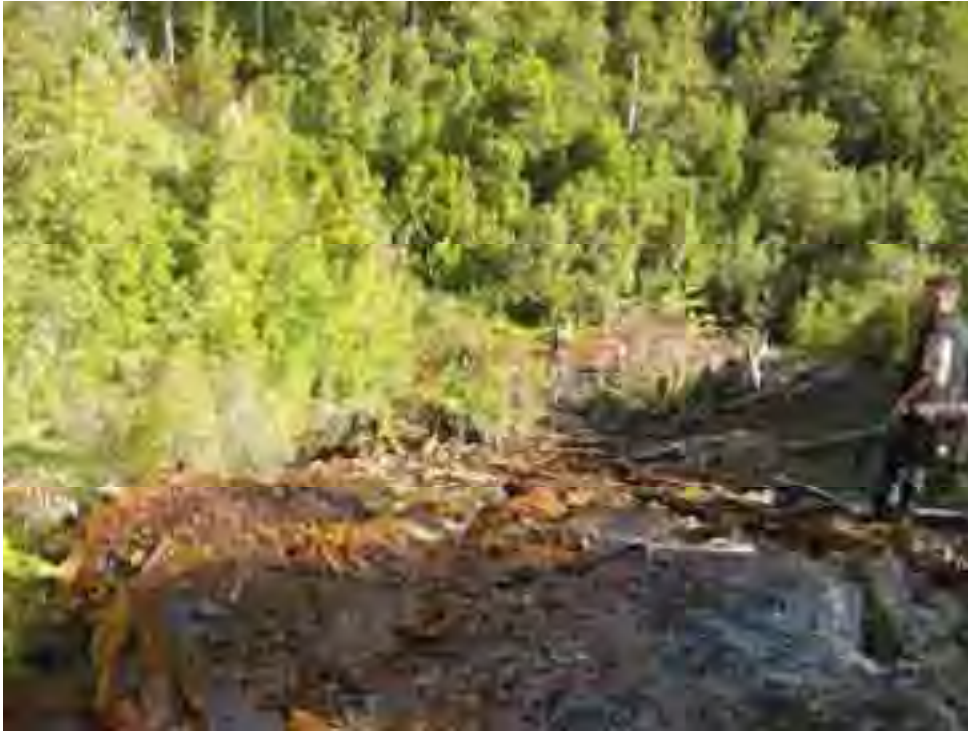
Fig. 2 Acid mine drainage at Bellvue Mine on the West Coast of New Zealand

Cannel Creek has its head near Strongman Mine and joins with Griffin Creek to discharge into the Tasman Sea north of Rapahoe (Fig. 1). It receives discharge from several disused mine adits. Poor water quality, namely lowered pH and high conductivity, occurs downstream of these adits, and indicates an impact arising from acid mine drainage (AMD). The majority of the AMD discharging into Cannel Creek appears to arise from the adit of Bellvue Mine (Fig. 2), as pH in Cannel Creek drops from c. 7 upstream to c. 3 downstream of the mine adit. Previous water quality sampling shows that the AMD has a low pH (2.6) and high conductivity (1500 $\mu\text{s}/\text{cm}$). Flow from the adit is approximately 1 L/s.
