Investigation of Remediation of Acid-Mine-Impacted Waters at Cannel Creek

Landcare Research Contract Report: LC0506/169
CRL Report: 06-41101

PREPARED FOR:
West Coast Regional Council

DATE: July 2006

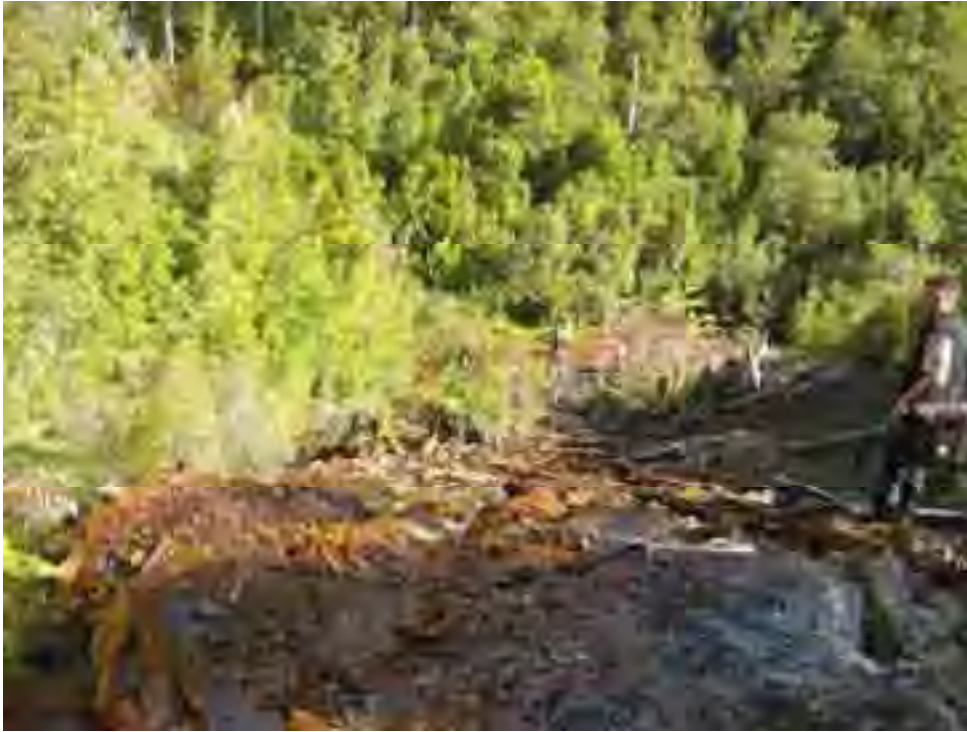
Fig. 2 Acid mine drainage at Bellvue Mine on the West Coast of New Zealand
