Assessment of threat of the aquatic weed elodea at Piriaka, Whanganui River

NIWA Client Report: HAM2008-035 March 2008

# Assessment of potential threat of aquatic weed (elodea) at Piriaka, Whanganui River

## Horizons Regional Council

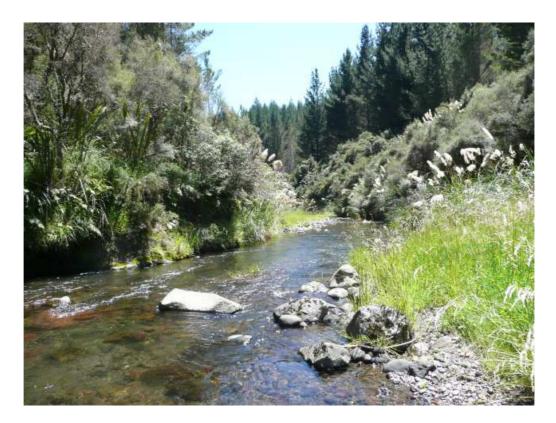
The headwaters of the Whanganui River had no submerged plant growths (Fig. 2) but both Lakes Otamangakau and Te Whaiau are dominated by lagarosiphon and elodea and periodically discharge into the Whanganui River headwaters (Fig. 3). Rocky

substrate and high velocities appeared to be prohibitive for aquatic plant establishment.

**Figure 2:** The Whanganui River near Lake Te Whaiau had no submerged plant growths.

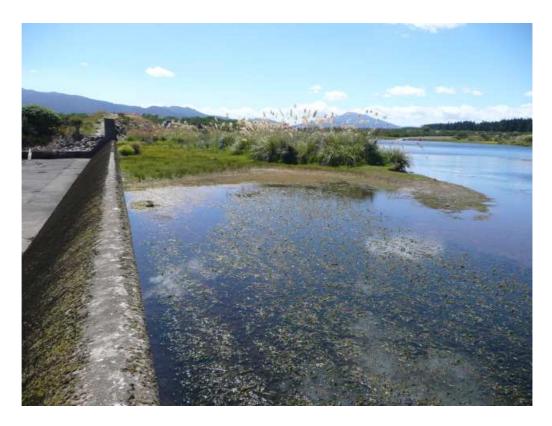
**Figure 3:** Lake Te Whaiau showing the weir which overflows periodically to the Whanganui River nearby and therefore must be a source of elodea and lagarosiphon propagules.

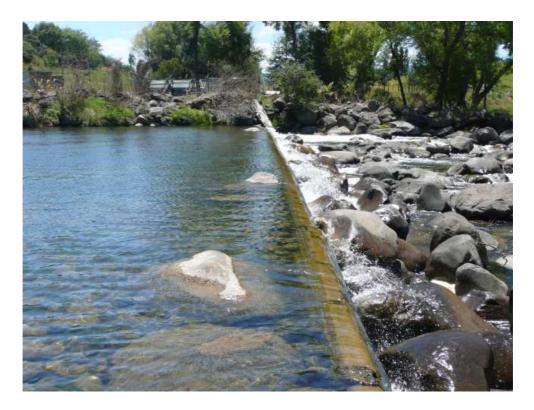
At Piriaka there is a series of three weirs (Fig. 4) on the Whanganui River that create a small impoundment (about 500 m long by 40 m wide) for the intake to the Piriaka power station. At times of high flow much water overflows the weirs and the left bank of the impoundment is not scoured as flows remain low being determined by the water take through the small (1.2 MW) power station. On the left bank elodea grew intermittently over a length of 461 m (measured by laser) in clumps, the largest being 7 m wide (Figs. 5 and 6) but they were mostly about 2 - 3 m wide. Elodea grew on soft sediment in low flow areas to a depth of 2.2 m and with a maximum height of 0.8 m. The floor of the channel was armoured rock (Fig. 7) with little opportunity for elodea growth, but with the odd plant finding a "foot hold" close to the left bank only (Fig. 8). Above the impoundment, the Whanganui River was of similar width and had suitable fine substrate for plant growth but no submerged plants were present (Fig. 9). Below the weirs there was no suitable substrate for plant growth with the river channel being lined mainly with large boulders and subject to high flows.

**Figure 4:** A weir on the Whanganui River at Piriaka.

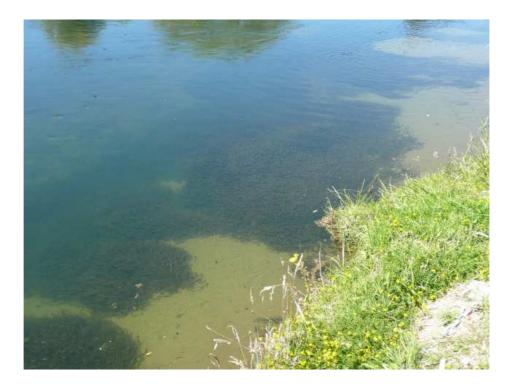
**Figure 5:** The largest patch of elodea at Piriaka, 7 m wide, growing to 0.8 m tall in up to 2.2 m water depth on soft silt.

At Piriaka it is possible elodea could spread further by expansion of existing clumps. Once clumps are established they act as sediment traps and the more sediment the larger the area of suitable substrate for plant growth. This pattern of colonisation is known in hydro-canals such as in the Rangitaiki Canal (Wells and Taumoepeau 1997). Removal of the weed cover in the Rangitaiki Canal there was necessary periodically to allow erosion of sediment from the central parts of the canal. Re-establishment of weed beds was then slow without significant areas of suitable substrate.

Elodea, control would not be difficult. Options include: hand weeding / cutting by SCUBA diver, herbicide using diquat application with subsurface injection, suction dredging, or shading.

Suction dredging: A diver operated suction dredge could remove the weed, its roots and large amounts of sediment. If the sediment is removed there would be limited opportunity for elodea re-colonisation. It takes about 1 hour to remove  $10 \text{ m}^2$  of weed bed with a suction dredge, so there is an estimated 60 hours of suction dredging to remove it the bulk of the weed, provided the flows are not too difficult to work in.

Elodea eradication could be achieved with repeat suction dredging and hand-weeding until all fragments were removed. It could require several years with possibly 2 suction dredging efforts and 12 hand removal attempts by divers skilled in the procedure. With NIWA guidance, DoC eradicated a site of lagarosiphon in Lake Waikaremoana, and numerous sites of lagarosipon in Lake Wanaka have been removed in this way with less effort (Clayton 1996).

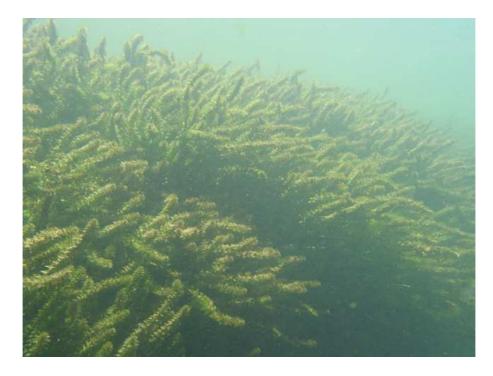
**Figure 6:** The largest patch of elodea at Piriaka, photographed underwater from the deep side.

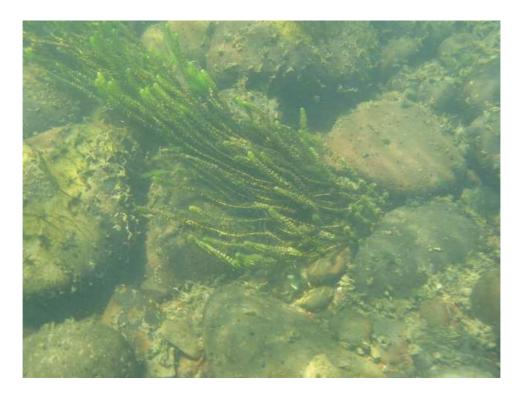
**Figure 8:** Elodea gaining a "foot hold" on the armoured rock floor of the canal close to the left bank.

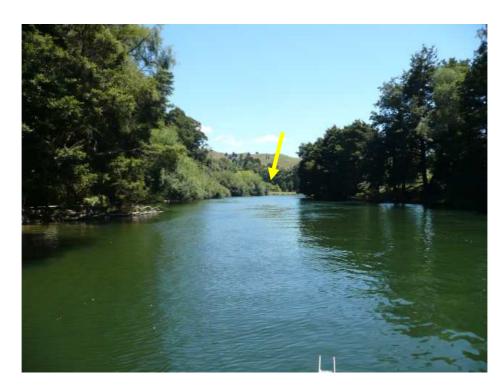
**Figure 9:** The Whanganui River at Piriaka just upstream of the impoundment had no submersed aquatic plants, despite suitable substrate being present. The yellow arrow indicates where elodea growths started.

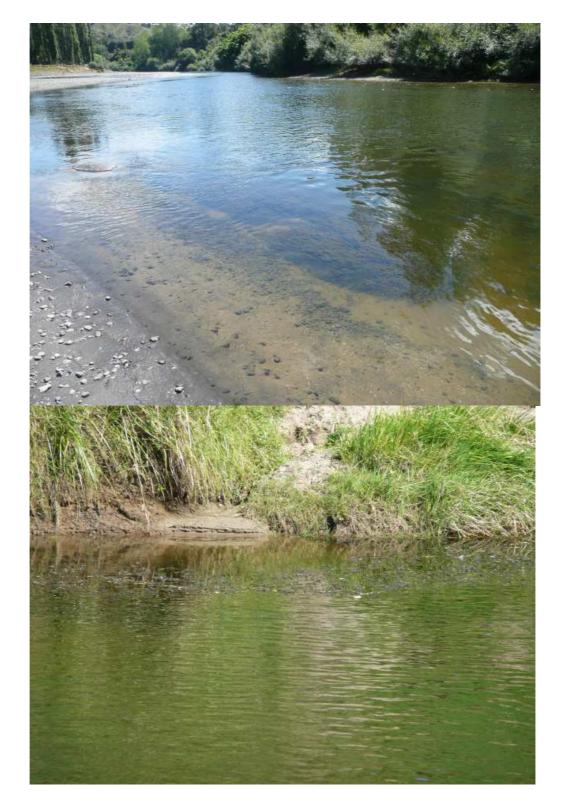
Elodea was located at Cheery Grove, Taumarunui, about 10 km downstream, but it was growing in the Ongarue River and not in the Whanganui River. The Ongarue River had elodea growing about 30 km upstream near the township of Ongarue (Fig. 10). The Ongarue River is another source of elodea to the Whanganui River.

**Figure 10:** TOP Elodea in the Ongarue River confluence; the Whanganui River is in the background beyond the gravel bar; BOTTOM elodea growing in the Ongarue River near the township of Ongarue about 30 km upstream.

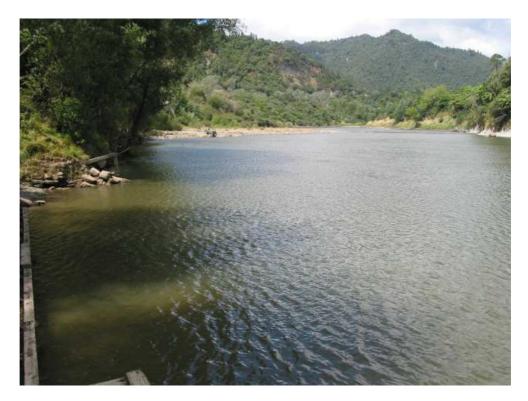
From Whakahora to Pipiriki (Fig. 11) the river had no submerged aquatic plants. Nor were any found from Pipiriki to Whanganui. The river bed had gravels or was rocky and in combination with high flows and large variations in water levels was unfavourable for submerged plant growth. Within about 10 km of Wanganui the river widens (Fig. 12) and flows become more favourable for submerged plant growth but the water was turbid and low light becomes the likely excluding factor. At the time of the survey (after a long spell of little or no rain) the water had poor transparency with a 0.3 m Secchi Disc (distance a white disc is visible in water), which restricts plant growth to a shallow photic zone (probably <1 m). However water level fluctuations would exceed the range of the photic zone leaving no area with a suitable light climate for submerged plant growth.

**Figure 11:** The Whanganui River at Pipiriki is a wider section of the river but had no submerged plants. The river was turbid and the river bed armoured with rocks.

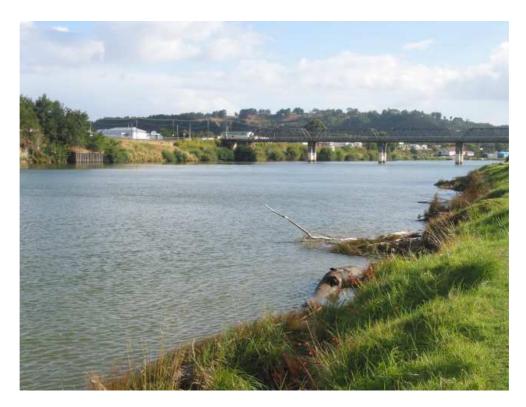
**Figure 12:** The Whanganui River at Wanganui had no submerged plants and is likely too turbid for them to grow given there are frequent water level fluctuations greater than the depth of the photic zone (c. <1m).
