# Lake Stream Sediment Management

## Envirolink Report 2304-WCRC205

Professor Ian Fuller

June 2023

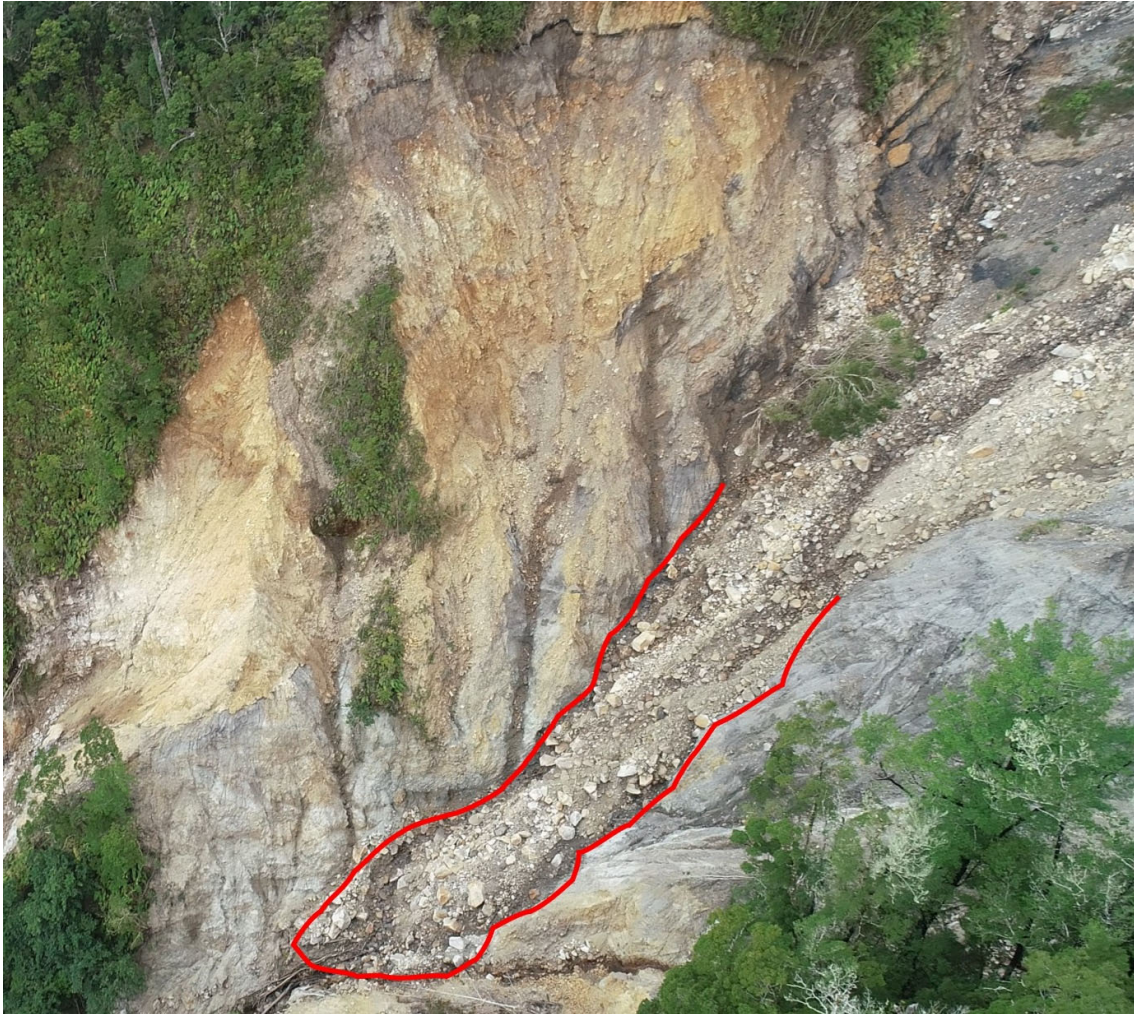
**Figure 8.** Debris supplied into the channel network from landsliding in the upper Lake Stream catchment (lobe of sediment in channel highlighted). Wetting and mobilisation of the material sitting in the bed of the channel is likely to be in the form of a debris flow or debris flood, given the steep nature of the channel bed at this point in the catchment and the apparent range of grain sizes in this material. The nature of sediment supplied to the Lake Stream channel from slope failure appears to include a range of crushed rock from the Kongahu Fault Zone, as well as boulders of more coherent sandstones from the Coal Measures. WCRC, supplied, dated 18 February 2021.

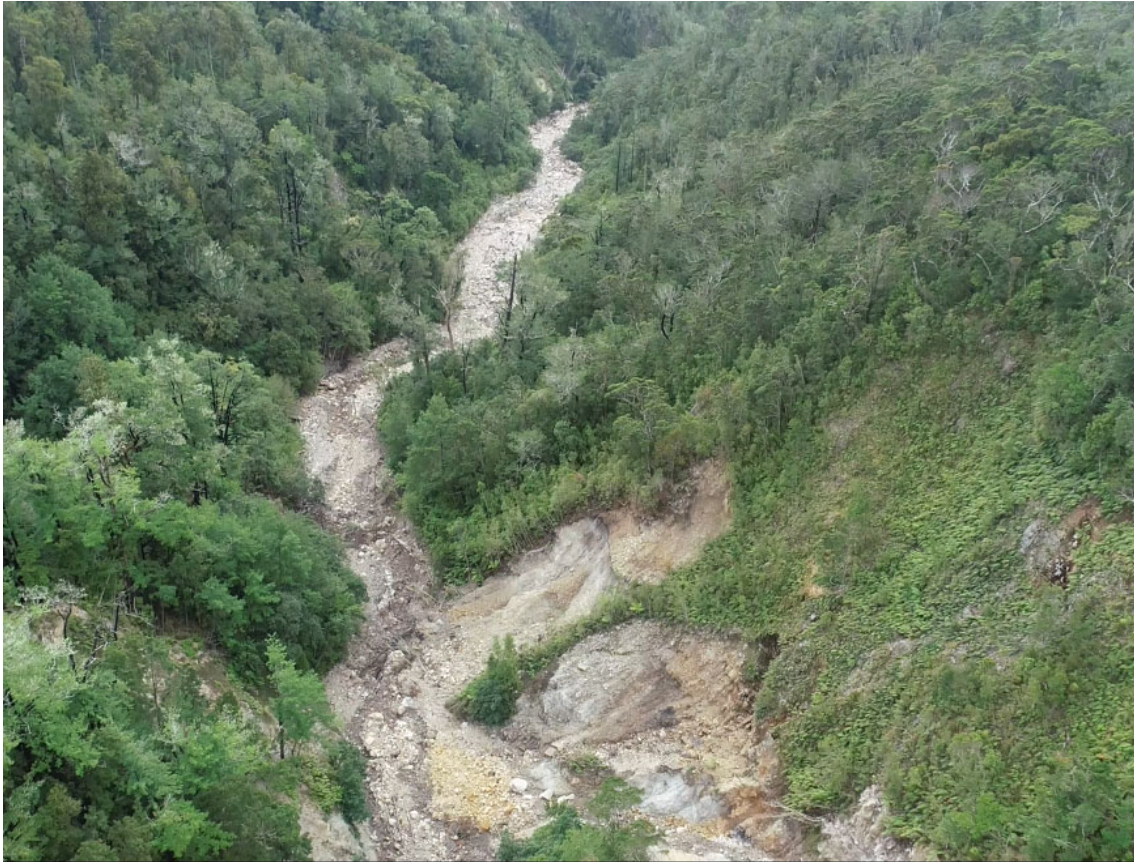
**Figure 9.** Debris routed along the narrow, confined upper Lake Stream from the headwater source landslide (WCRC, supplied), dated 18 February 2021.

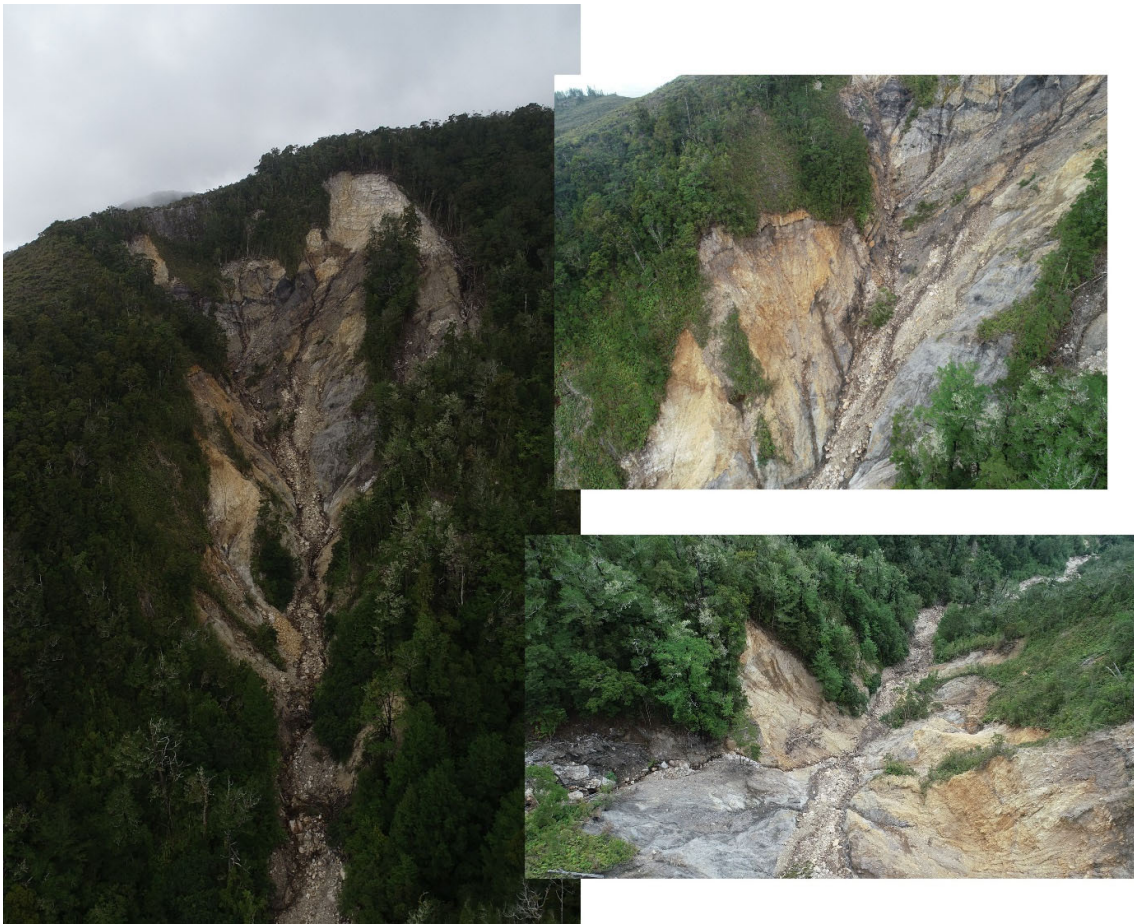
**Figure 10.** Photos of upper Lake Stream landslide (WCRC, supplied), dated 18 February 2021.

The catalyst for this report is the ongoing impact on Lake Stream of sediment sourced from a landslide in the upper catchment on steep slopes (cf. Figure 2, Figure 10). This landslide was thought to have been initiated during Cyclone Lusi, March 2014. A sequence of Google Earth images of Lake Stream provides some context for this event (Figure 11). This sequence reveals some erosion in the catchment present in 2003 (earliest available Google Earth imagery), but more substantial slope failure and sediment delivery after 2014.

The landslide should be monitored to understand sediment delivery into the channel system. I recommend a full assessment of slope stability in the upper catchment, since it is formed on apparently crushed and erodible terrain. There is a risk of a far larger slope failure than has to date been witnessed, which has the potential to threaten life, property, and infrastructure on Lake Stream Fan should it occur and trigger a major mass flow event in the catchment. To this end it would be advisable to engage landslide experts who have the capability to run Rapid Mass Movement Simulation (RAMMS).

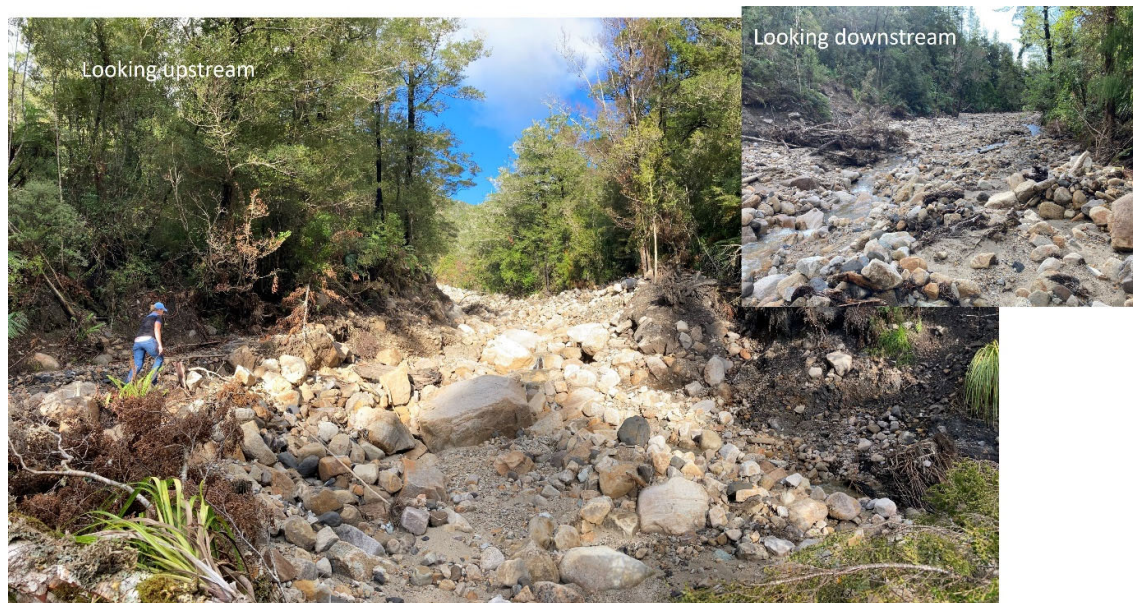
**Figure 12.** Upper Lake Stream, indicating coarse sediment accumulation in the steep channel bed in a narrow, confined valley. Note the wide range of grain sizes from boulder to sand and relatively chaotic arrangement of material in the valley floor, indicating minimal reworking by fluvial processes, and typical of mass flow deposits. 11 May 2022 (ICF).

Photos taken in the upper Lake Stream catchment in a site visit in May 2022 reveal the extent of impacts sediment delivery from the landslide upstream has had on the upper channel (Figures 12-17). Debris flow deposits have filled the valley floor and Lake Stream is reworking this material. Within the upper valley there appear to be alternating zones of incision and accumulation. Stream incision of the loose debris transfers material a short distance until it is deposited. Alternating reaches of incision and deposition reflect pulsed sediment transfer along the channel system. In this way the stream reworks the 'overload' of the debris flow deposits in its channel bed.

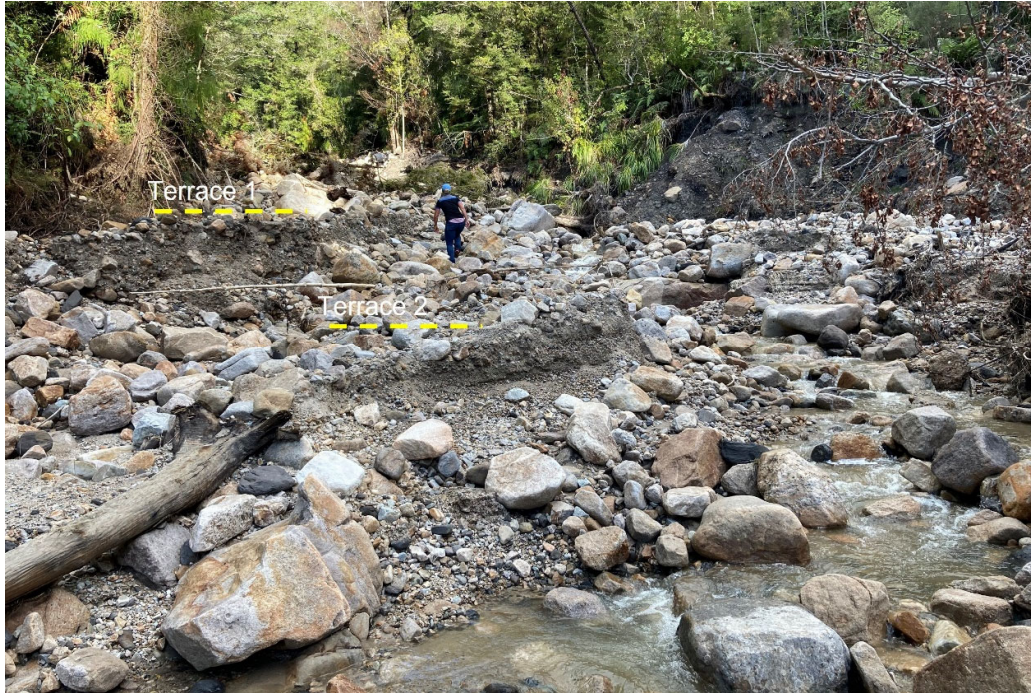
**Figure 13.** Upper Lake Stream, immediately downstream from Figure 12 indicating incision of the channel bed with terrace surfaces present (labelled). Note the large range of grain sizes in the channel (boulder to sand) and a bouldery lag developing in the wetted channel, as distinct from sandy matrix observed in cut faces of the terraces. 11 May 2022 (ICF).

Lake Stream channel incises and reworks the substantial debris flow deposits in its bed (Figures 13 & 14). It is highly likely that future slope failures in the upper catchment will continue to deliver equivalent volumes of sediment to Lake Stream.

Lake Stream is actively incising and reworking debris flow deposits along its upper reach. Future debris flows are also likely to be routed along the channel and be reworked. Monitoring of morphological adjustments of the upper channel as it responds to these processes and reworks these deposits would provide a valuable means of assessing sediment volumes being generated from the upper catchment and ultimately being delivered to the fan. A morphological budgeting approach utilising helicopter- or drone-mounted LiDAR would probably be the most cost-effective way of capturing the surface morphology of the upper Lake Stream channel. Repeat surveys at an annual or significant event frequency would allow generation of difference models from which volumetric changes can be derived and morphological adjustments assessed.

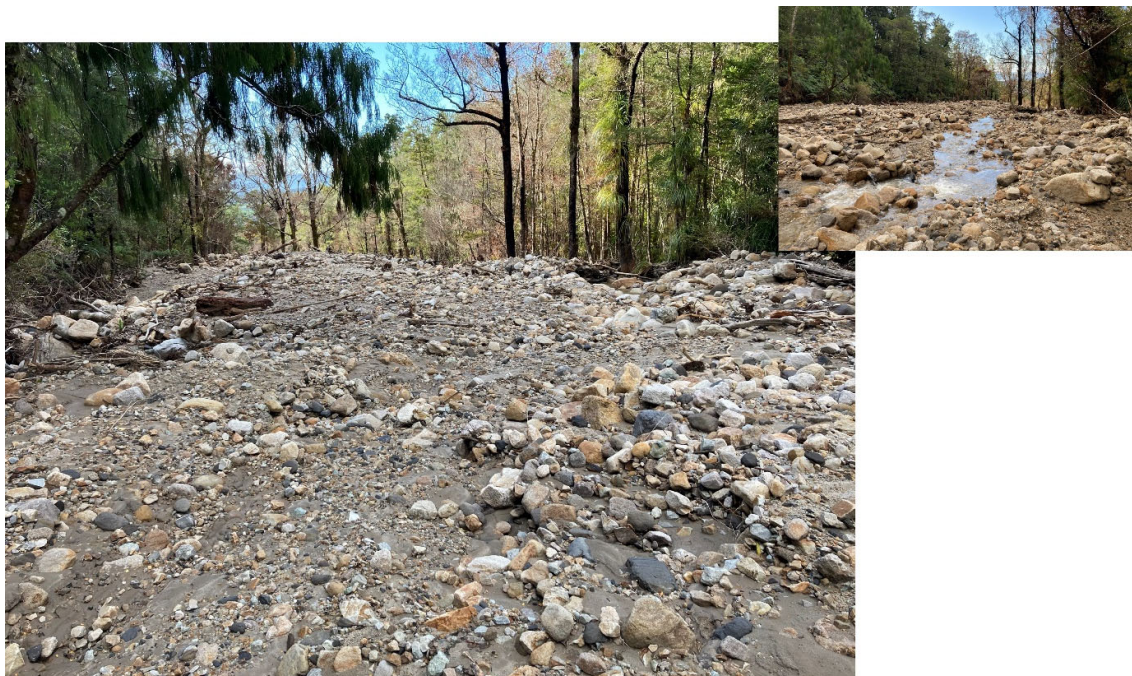
**Figure 14.** Upper Lake Stream, local accumulation zone downstream from local incision zone (Figure 13). This site shows more evidence of fluvial reworking of these (smaller) sediments, which are less chaotically arranged, with a smoother surface. Fewer boulders are evident here and they have likely been buried by stream deposition of this material. 11 May 2022 (ICF).

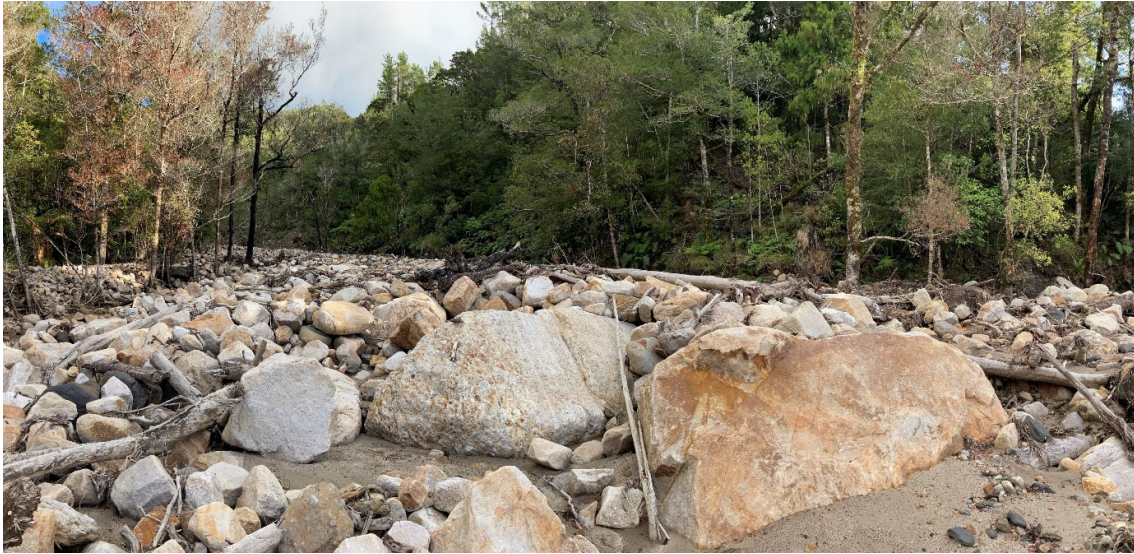
**Figure 15.** Upper Lake Stream, coarse, bouldery lobe downstream from Figure 14, note significant accumulation of sand downstream of large boulders. 11 May 2022 (ICF).

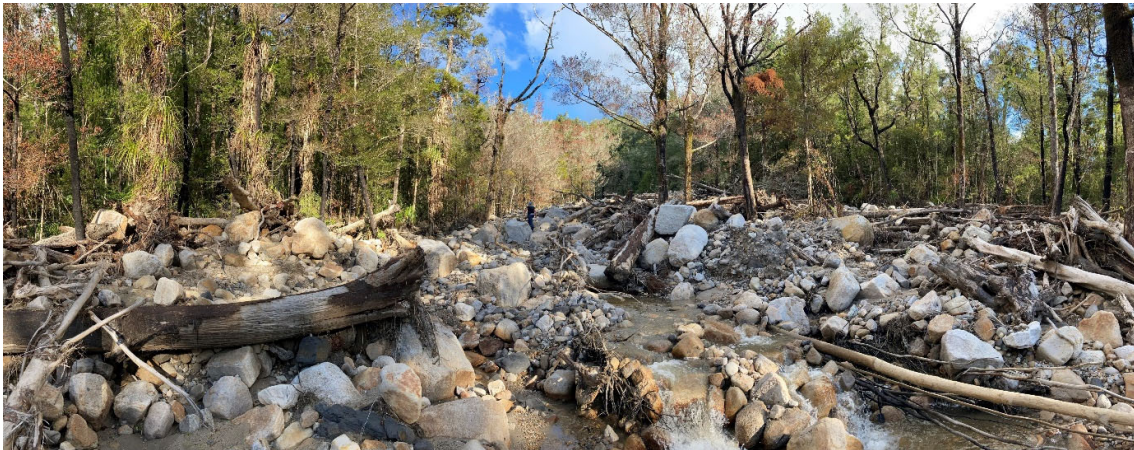
**Figure 16.** Upper Lake Stream, incision of lower debris flow deposits, note valley widening and chaotic arrangement of deposit indicative of mass flow deposition. Significant wood has been recruited. 11 May 2022 (ICF).

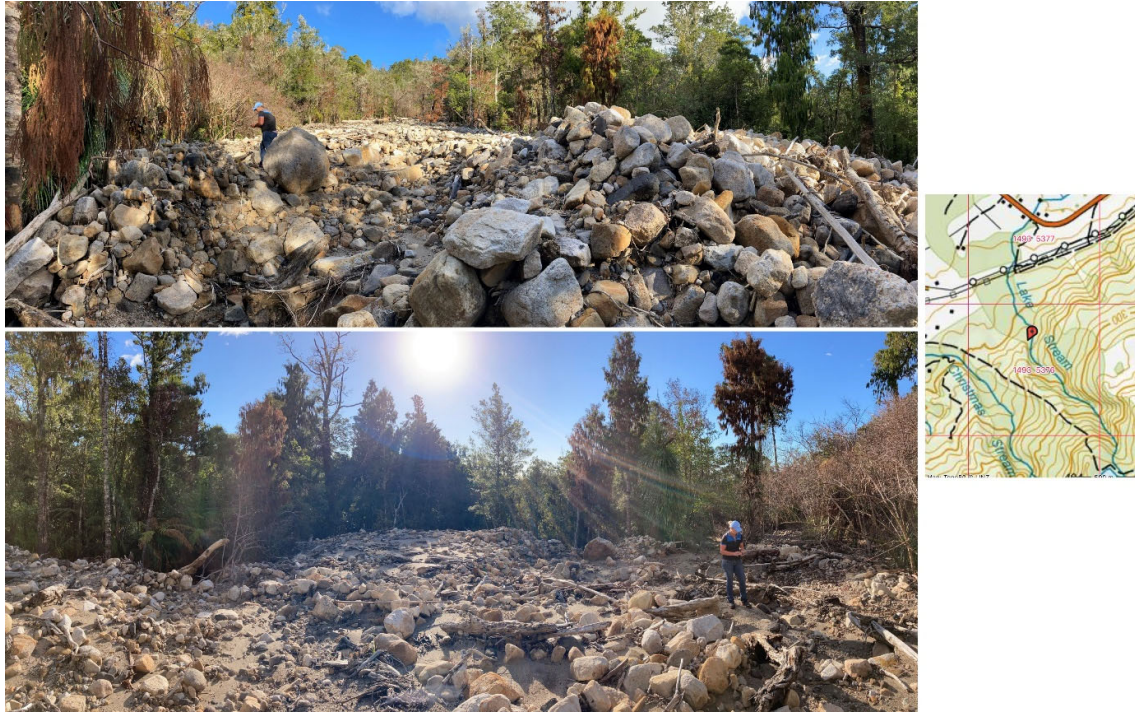
**Figure 17.** Upper Lake Stream, limit of debris flow deposits observed, looking upstream from the lobe crest (top) and downstream towards this limit (bottom). Approximate location given by red waymarker on topo map insert. Lake Stream now flows to the true-left (western) margin of this deposit and is not visible in these photos, which are taken mid-lobe. The re-routing of Lake Stream towards the west is described in the text. 11 May 2022 (ICF).

The debris flow lobe (Figure 17) has plugged the former Lake Stream channel (Figure 18). The blockage of this eastern channel has resulted in reoccupation of former channel courses and / or cutting of a new course to the west. Across the alluvial fan, downstream of the debris flow lobe, along the new (western) course of Lake Stream, there is evidence of gravelly splays over the fan surface and subsequent downcutting (Figures 19 & 20). Farther from the channel sediment splays are more sandy in nature (Figure 21). Prior to apparent abandonment of the eastern route of Lake Stream the stream was competent to transport boulders where the gradient remained steep across the fan (Figure 22), but flattening of the gradient towards the distal margin reduced flow competence (Figure 23). Figures 22 and 23 also show far less flow compared with the western Lake Stream channel (Figure 24).

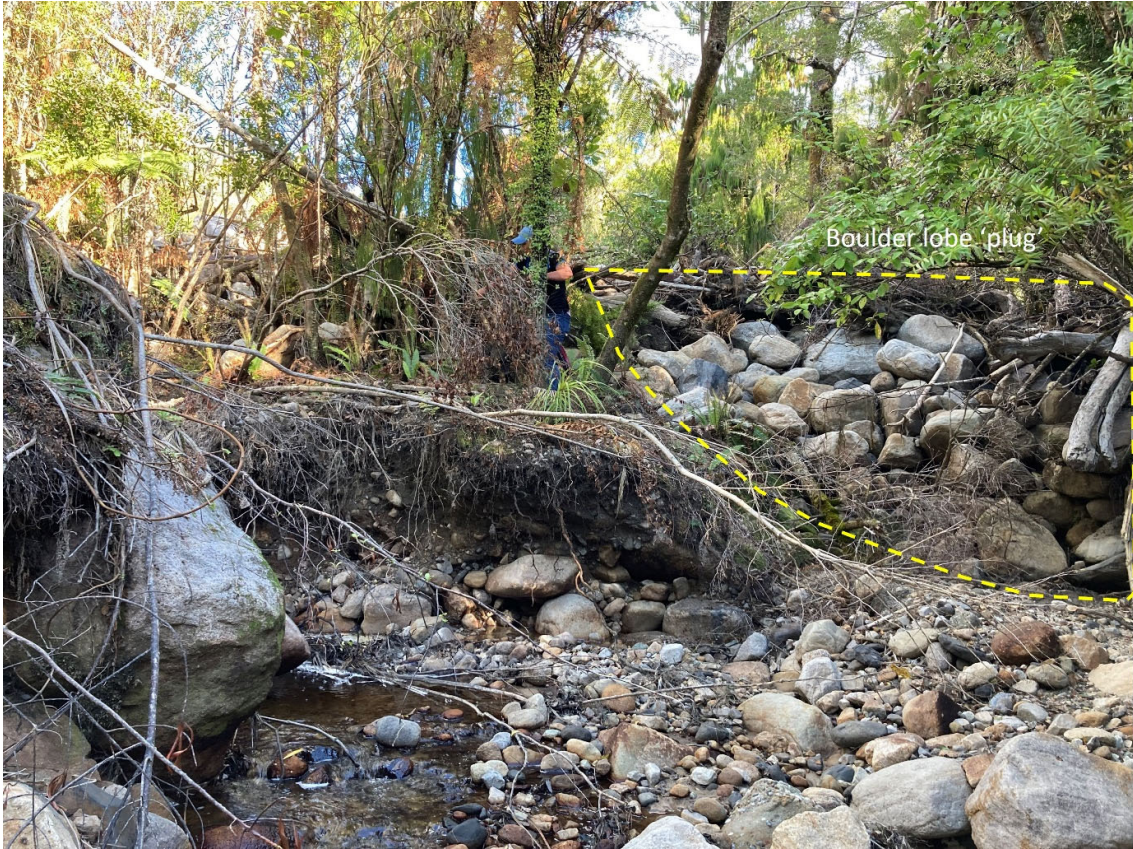
**Figure 18.** Lake Stream channel plugged by debris flow lobe.

4. The former (eastern) Lake Stream channel remains blocked by a significant debris flow lobe. Attempts to re-open this stream course risk remobilising significant quantities of sediment (including boulders) down the eastern course of Lake Stream.

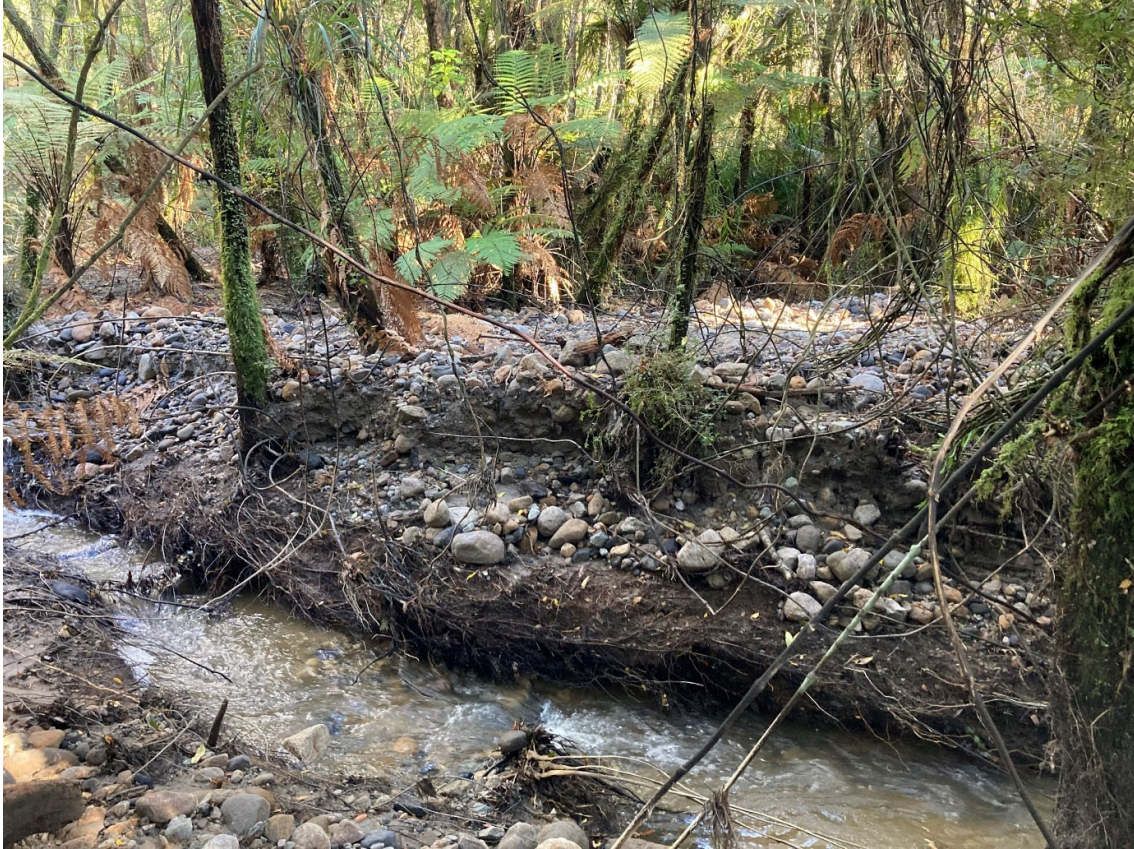
**Figure 19.** Lake Stream distributary channel downcutting, following deposition of gravelly splays across the fan surface.

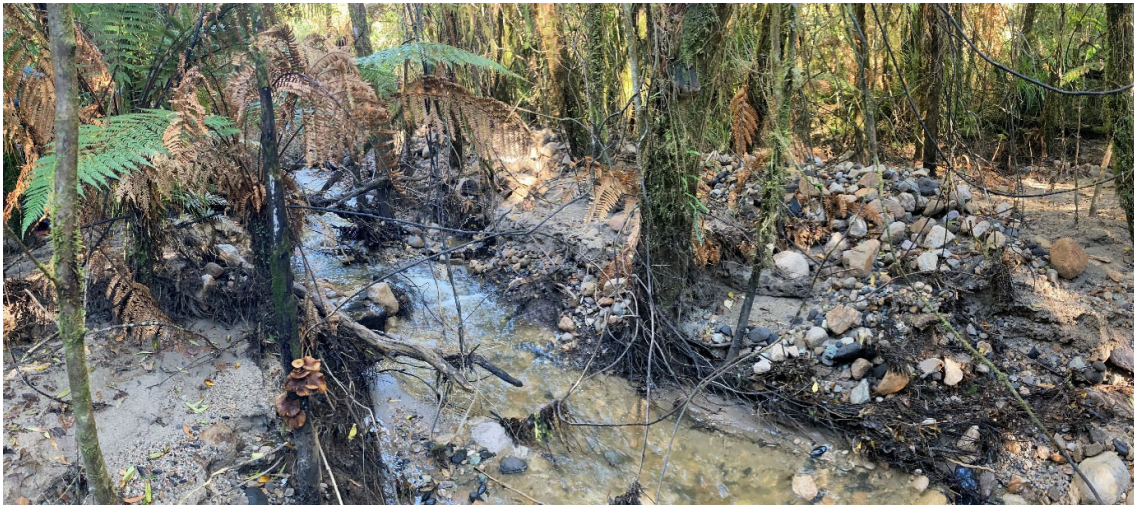
**Figure 20.** Splays of coarse gravel and sand across the fan surface, subsequently incised by the stream.

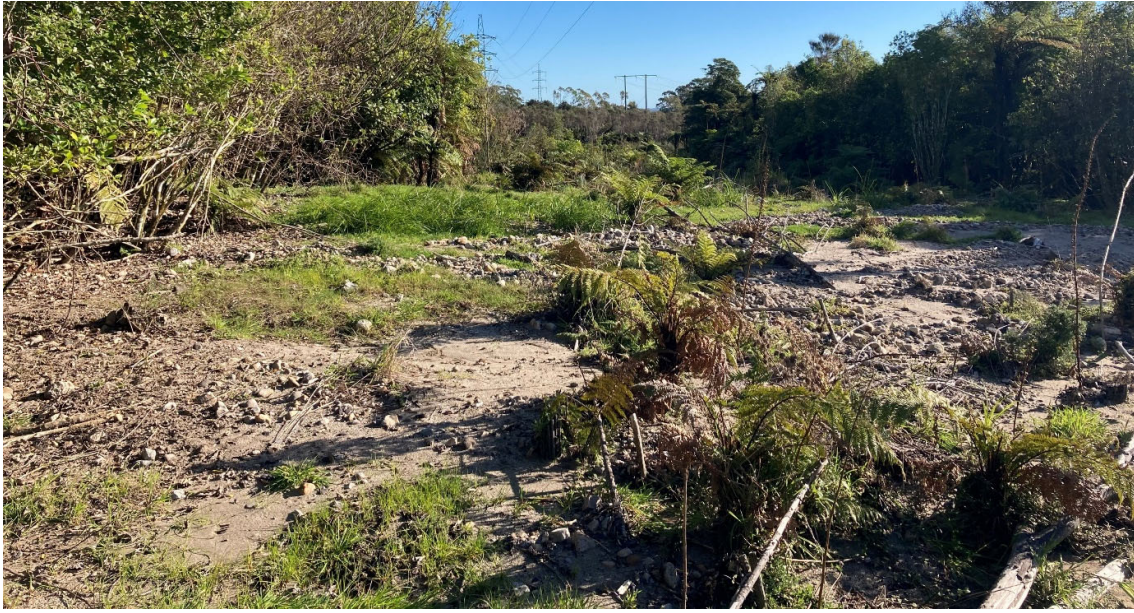
**Figure 21.** Splays of sediment beyond Lake Stream channel across the fan surface

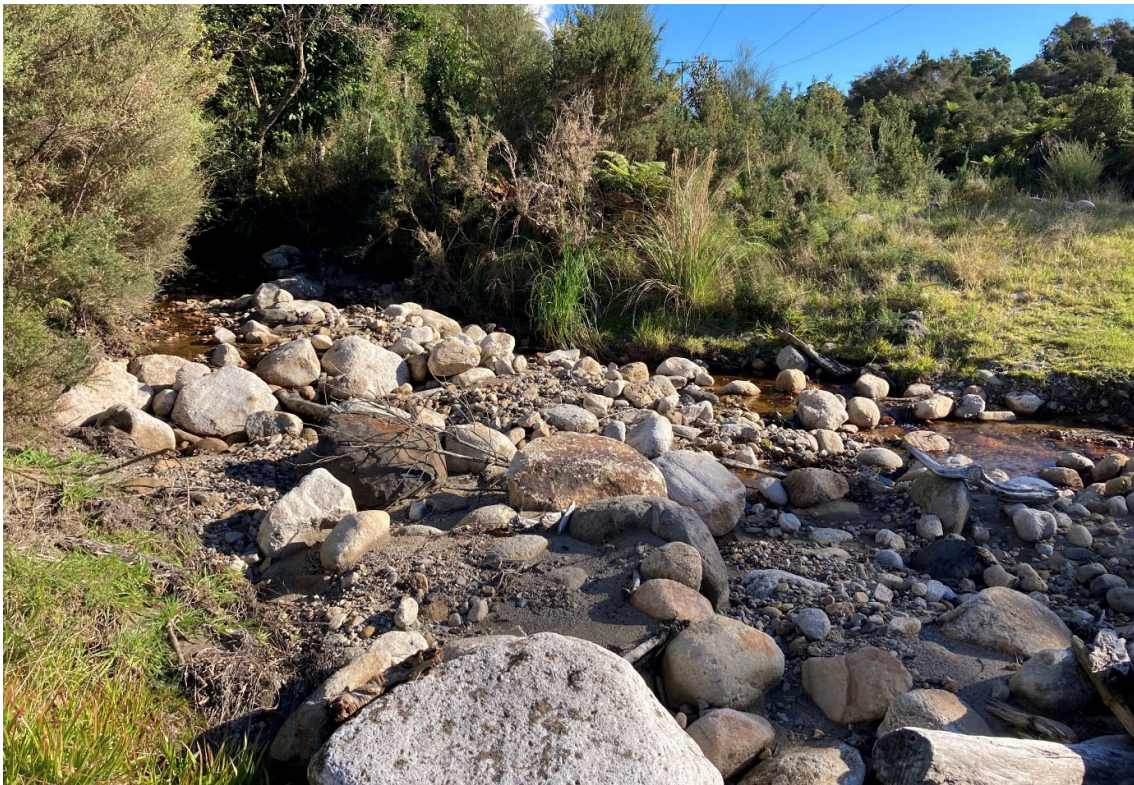
**Figure 22.** Coarse sediment (boulders) within stream bed of (former) Lake Stream channel, steep gradient of channel bed still evident

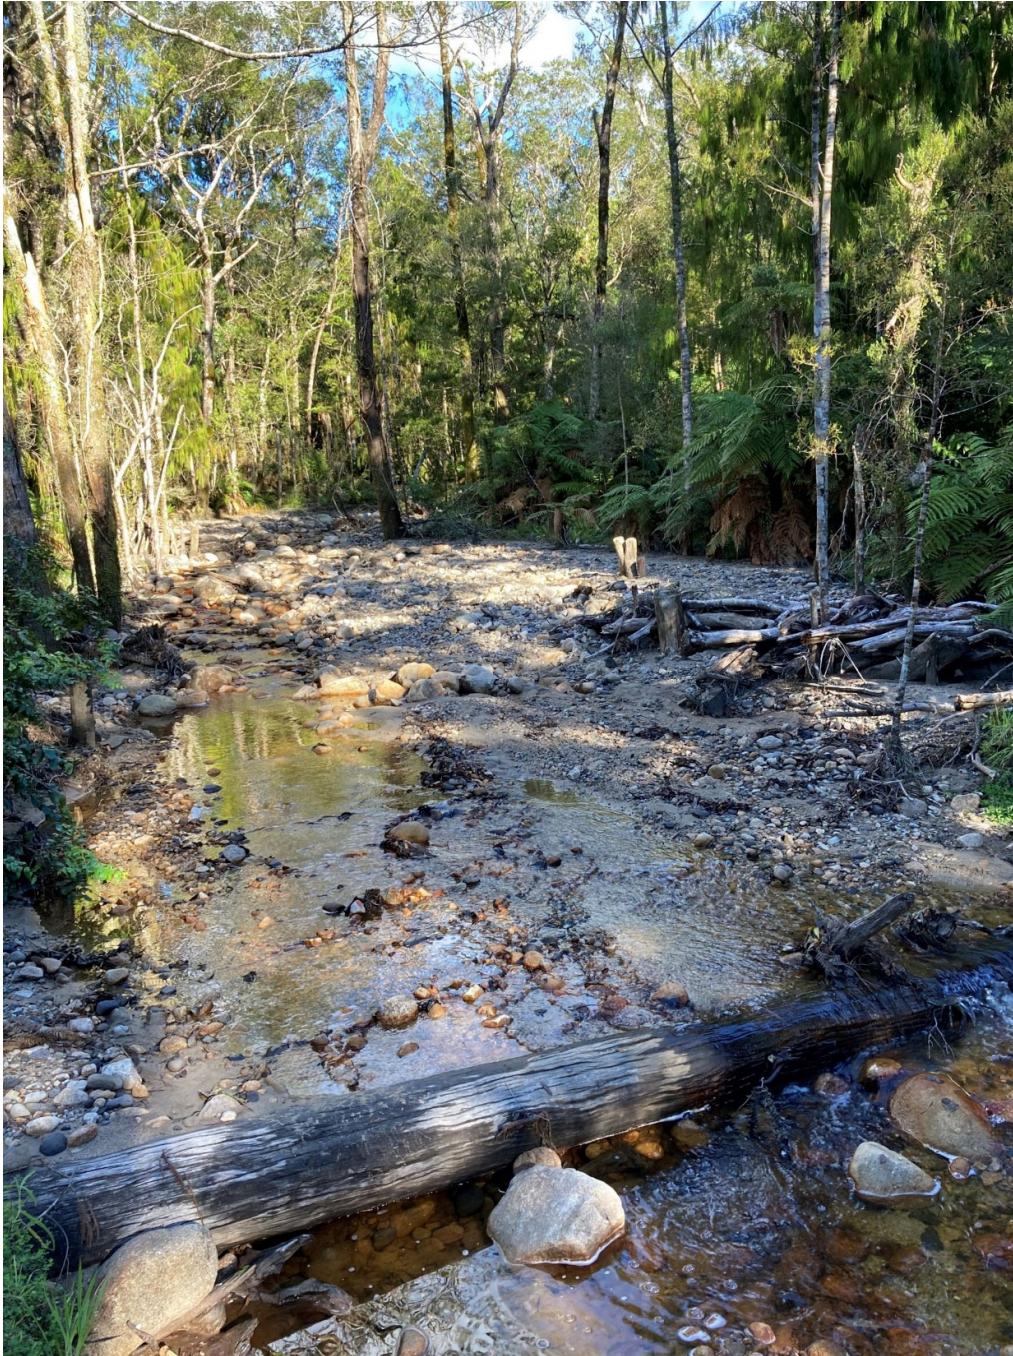
**Figure 23.** (Former) Lake Stream channel towards margin of alluvial fan, stream gradient begins to flatten compared with steeper section upstream (Figure 22), the channel is far less bouldery, but appears to be moving large quantities of sand and gravel.

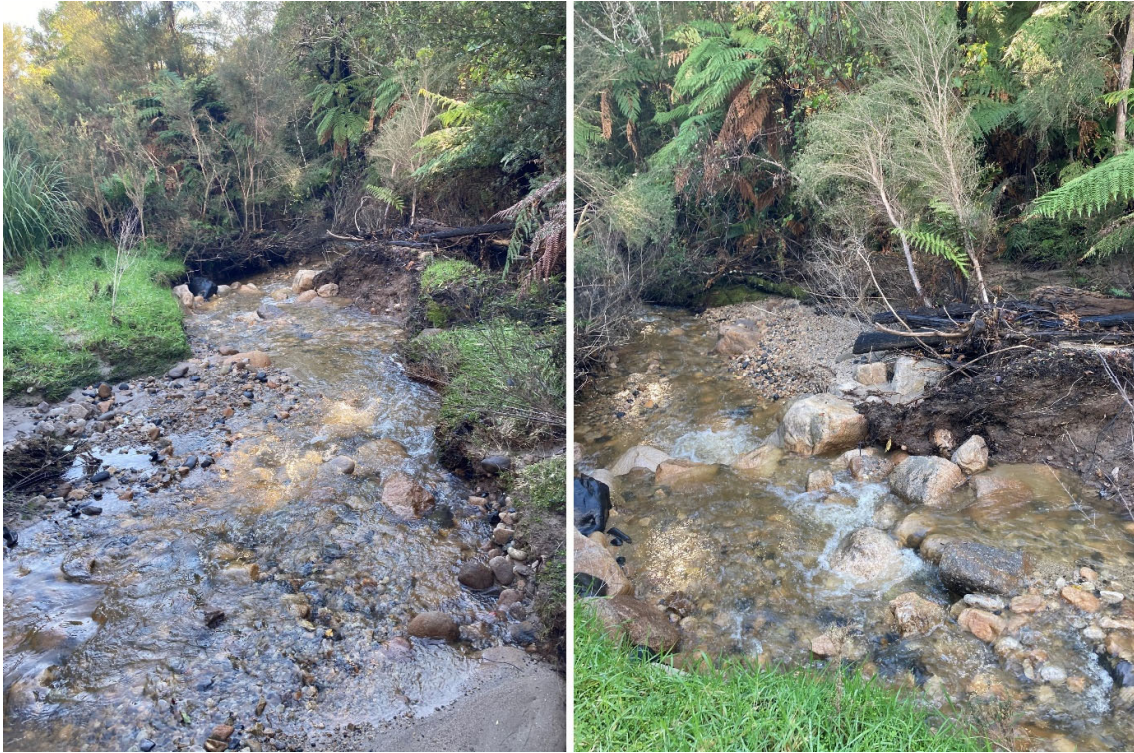
**Figure 24.** Current Lake Stream channel, sited further west (cf. Figure 25), most of the flow appears to be routed down this western distributary channel across the fan (Figure 25, cf. Figures 19-20, with the debris flow deposit plugging the previous primary channel, cf. Figure 18).

Monitoring of the section of Lake Stream where it flows across the Lake Stream Fan is problematic due to dense vegetation cover. However, sufficient ground-strikes should be feasible using a helicopter-mounted LiDAR (drone equipment may not be sufficiently powerful?). I recommend a one-off high resolution survey of the Lake Stream Fan to capture surface topography and assess any changes since acquisition of regional LiDAR (acquired between May 2020 and February 2022). Thereafter, repeat surveys along the active channel distributaries should suffice to assess morphological adjustments and sediment transfers (as per monitoring of the upper channel – at least annual or significant event frequency).

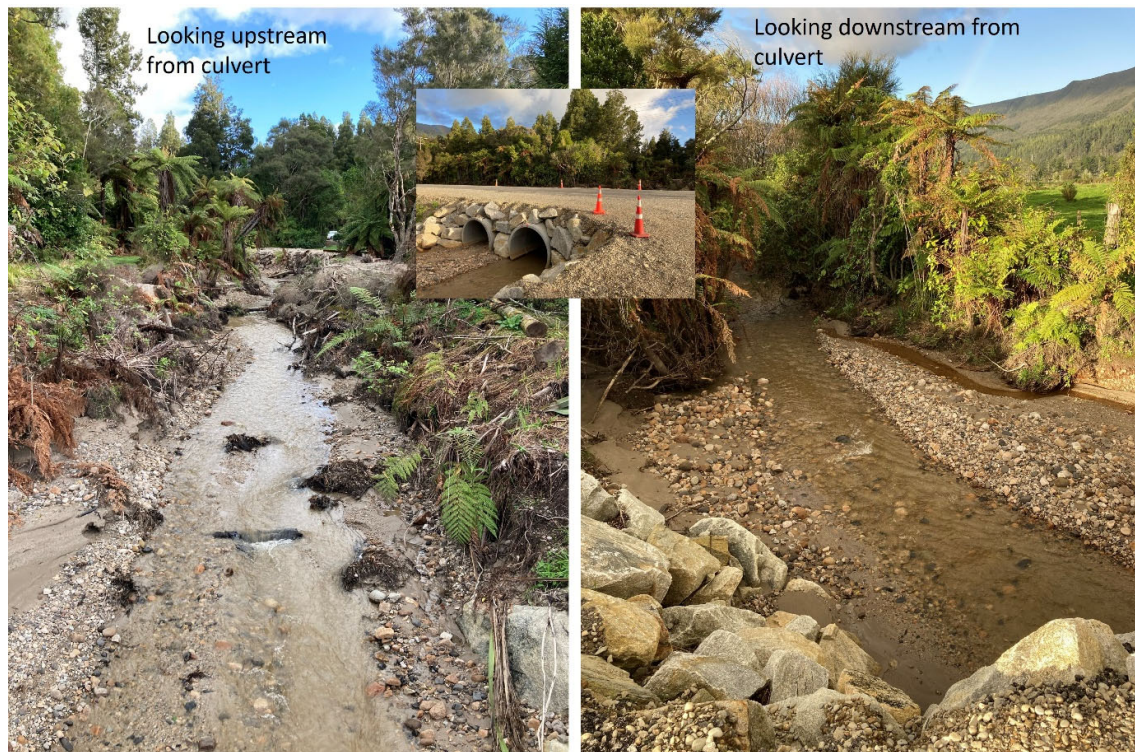
In the lower Lake Stream catchment as a consequence of flow diversion across the fan, the channel that runs alongside Crows Nest Road has become the primary channel for Lake Stream. This diversion required clearance and upgrade of a culvert underneath SH 67 (Figure 26). The Crows Nest channel now appears to transport most of the Lake Stream sediment in the lower portion of the catchment and significant sediment deposition has occurred in the vicinity of and downstream from Crows Nest Road (Figures 27-30).

**Figure 26.** Lower Lake Stream channel (Crows Nest channel) in the vicinity of SH 67. Inset shows SH 67 culvert. 11 May 2022 (ICF).

The lower Lake Stream (and Crows Nest channel) should be monitored following each storm event to assess rates of sediment accumulation and potential for blockage of the SH 67 culvert because this sediment is most mobile. Since these surveys would be at an event scale and across open terrain, there is probably no need to deploy LiDAR at such a frequency. Surface morphologies can be generated using Structure from Motion photogrammetry, with photography acquired using a drone platform. However, I would also recommend that LiDAR monitoring in the upper and middle catchments be extended into the lower catchment to provide a 'whole of catchment' understanding of sediment conveyance in the system.

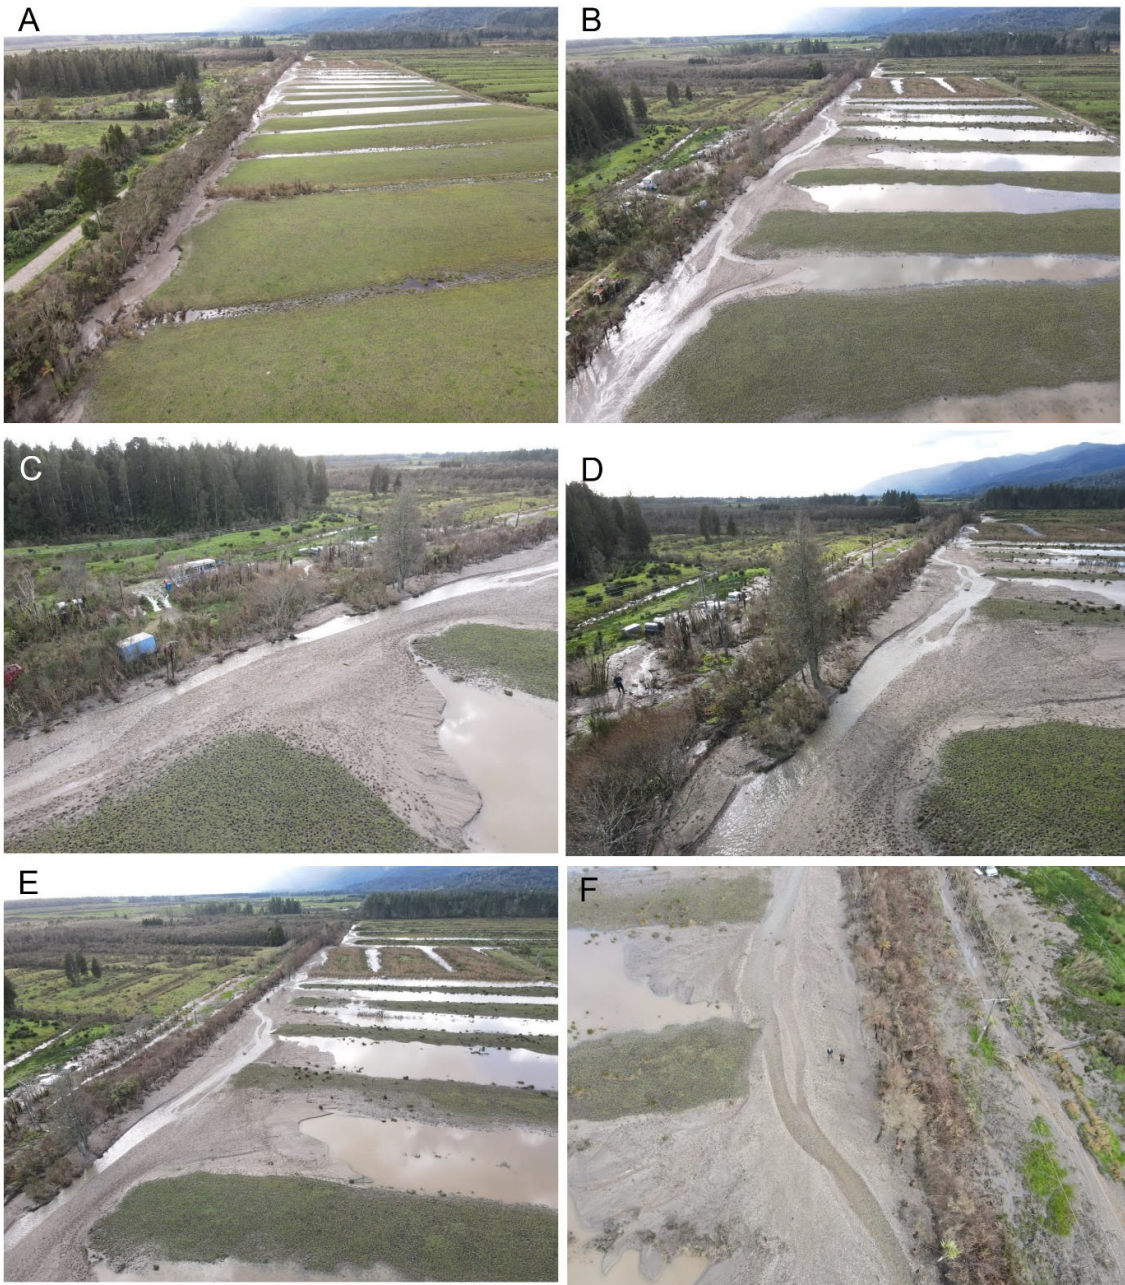
**Figure 27.** Sediment deposition in the Crows Nest channel alongside Crows Nest Road. (A) looking along the channel, (B) sediment splays into humped and hollowed paddocks, (C) channel vicinity of blocked culvert, which routed the current channel to the east (D), where it has deposited significant splays of sediment into humped and hollowed paddocks (C,D). (F) shows the contrasting channel dimensions between the former channel (narrow, straight, to the right of the photo, and the new channel, wide, sinuous, to the middle-left of the photo. Note the former channel does not have the capacity to transport the sediment and discharge now being routed along this course. WCRC supplied (photos obtained July 2022).

As a consequence of erosion and conveyance of large volumes of sediment in the upper catchment and across the Lake Stream Fan, sediment loads in the lower Lake Stream have increased. Furthermore, avulsion to the west is now delivering significant sediment loads to the Crows Nest channel. The Crows Nest channel has responded by enlarging and depositing significant sediment quantities in the hollows of adjacent humped and hollowed paddocks. The former Crows Nest channel no longer has the capacity to transfer water and sediment supplied to it and a new channel has formed immediately to the east (Figure 27).
