# Testing the Effectiveness of Fish Passage Solutions

Horizons Report 2015/EXT1418

Client Report No. HAM2014-117  
Project ELF15204

# Testing the effectiveness of fish passage solutions

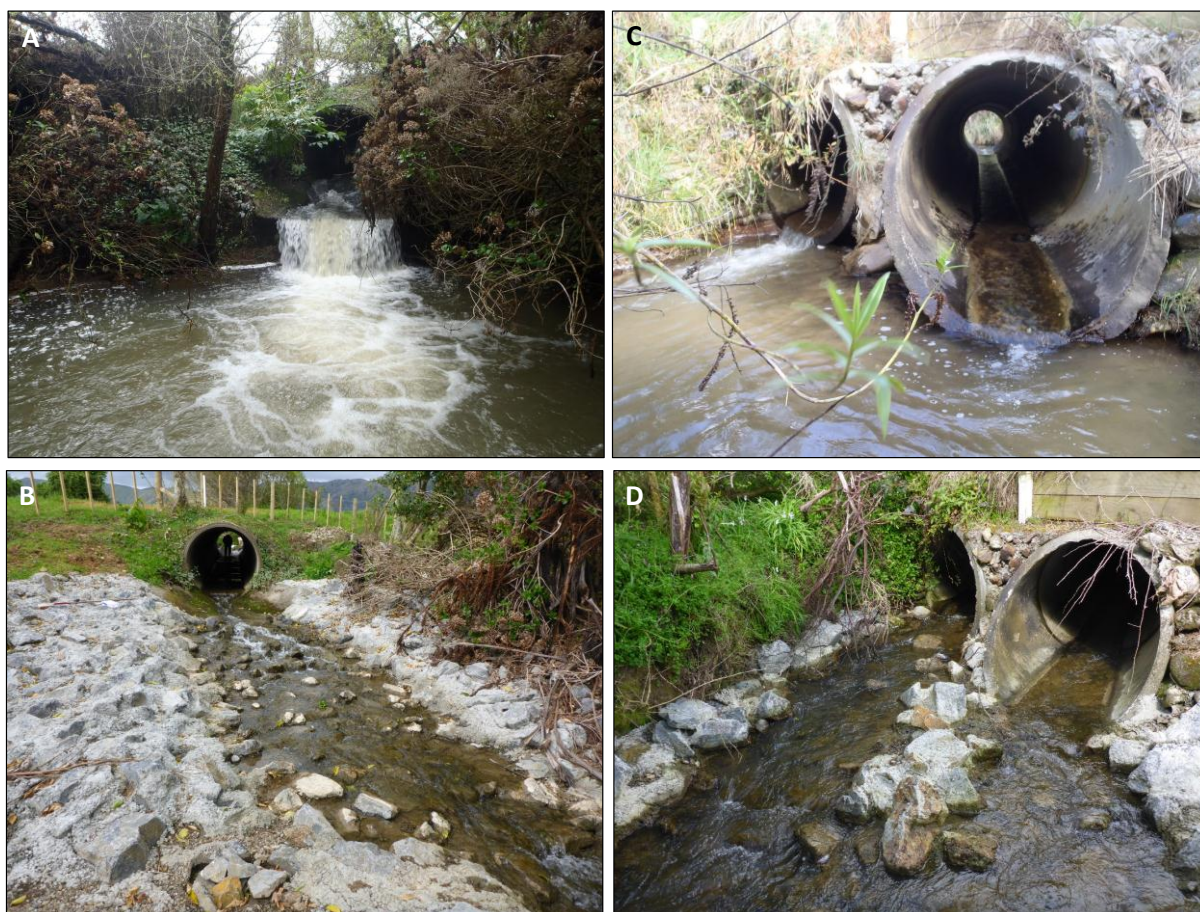
**Figure 2-1: Rock-ramps created to enhance passage of both swimming and climbing fish species in Kara Stream, Manawatu.** A, Upper Kingston Road culvert before remediation. B, Upper Kingston Road culvert after remediation. C, Lower Kingston Road double culvert before remediation. D, Lower Kingston Road double culvert after remediation.

For streams prone to floods and erosion, such as many waterways in the Manawatu, back-filling the weir or culvert outlet with rock and cement to create a rock-ramp can effectively promote passage of both swimming and climbing fish species. This technique is advantageous for flashy dynamic streams as the solution is long lasting and retains a natural look against the surrounding landscape. Presently, rock-ramps have been retrofitted to perched culverts at two sites in Kara Stream (Figure 2-1), and these fishways are planned to be installed at several other sites in the Manawatu Region.

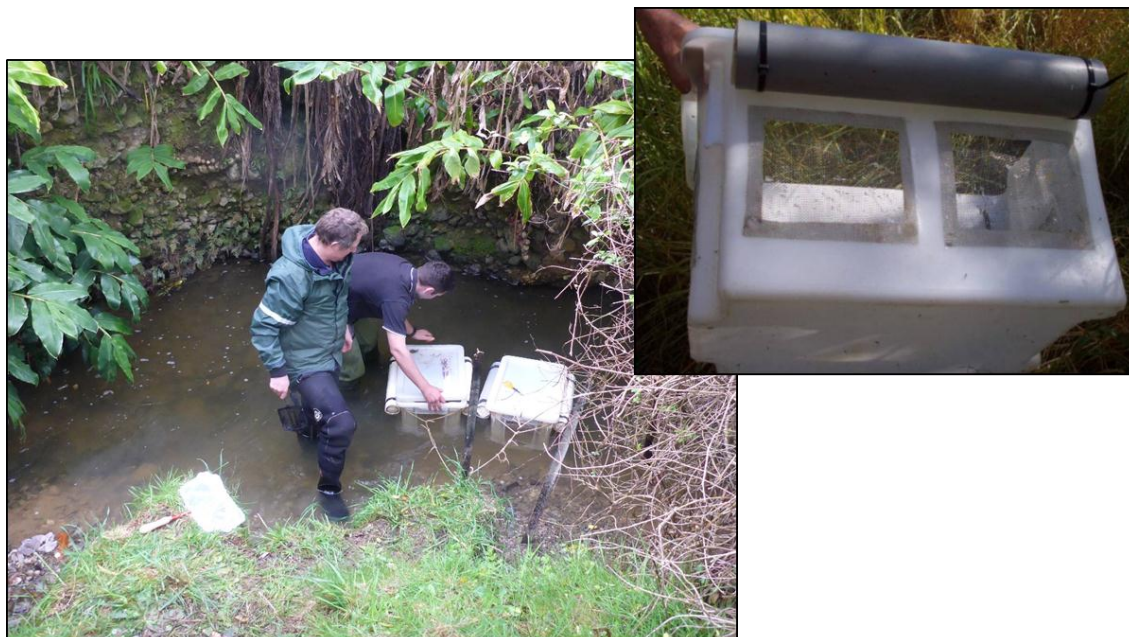
**Figure 5-1:** Live-bins deployed in Kara Stream to maintain inanga for fish passage trials. Inset shows close up of live-bin.

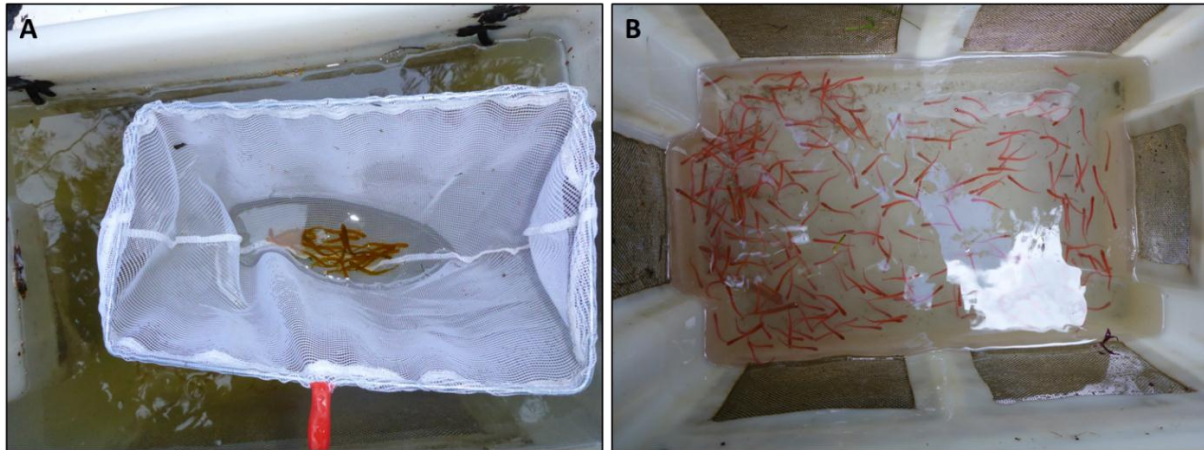
**Figure 5-2: Fish coloured orange with Bismarck Brown (A) and pink with Rhodamine B (B).**

- Add 10 g of Rhodamine B<sup>1</sup> (0.2 g/L) or 2.5 g Bismarck Brown<sup>2</sup> (0.05g/L). Wear gloves when handling both dyes. Refer to the MSDS for each compound to ensure safe practices are adhered to. Rhodamine B colours fish pink, and Bismarck brown colours fish orange (Figure 5-2).

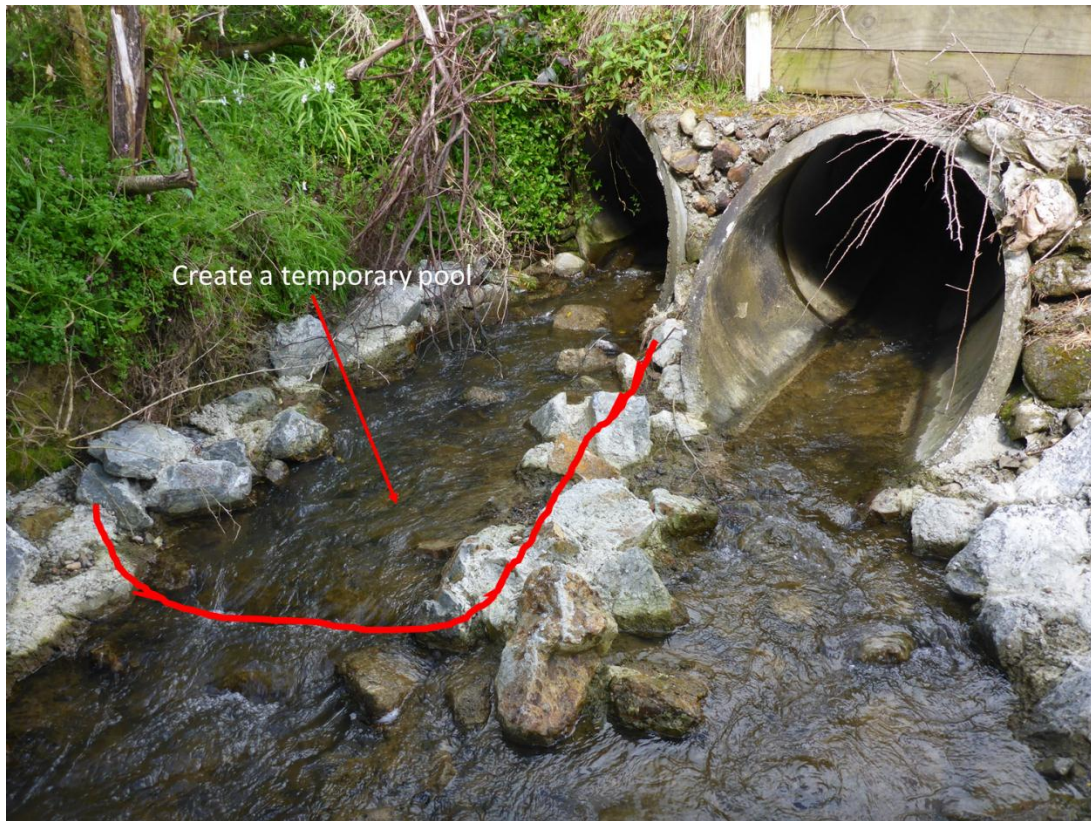
**Figure 5-3: Recommended area to create a temporary pool to facilitate testing inanga passage through the baffled culvert in Kara Stream at Lower Kingston Road.** Utilise sandbags and/or rocks to form the pool boundary.

Alternatively, or additionally, passage through the true right culvert with the spat ropes and baffles could be tested independently. Here, a temporary pool would need to be created in the rock-ramp below the culvert outlet (Figure 5-3). Sandbags and/or rock (lined with mesh) can be used to form the pool boundaries. However, the pool should be kept shallow (20 – 40 cm) to prevent significant increases in the water level within the culvert. If deemed necessary, place one or two large boulders in the pool to ensure low velocity refuge areas are present. This approach will determine the effectiveness of the spat ropes and baffles in promoting inanga passage through the culvert, but will provide less information on how effective the whole system is in promoting inanga passage.

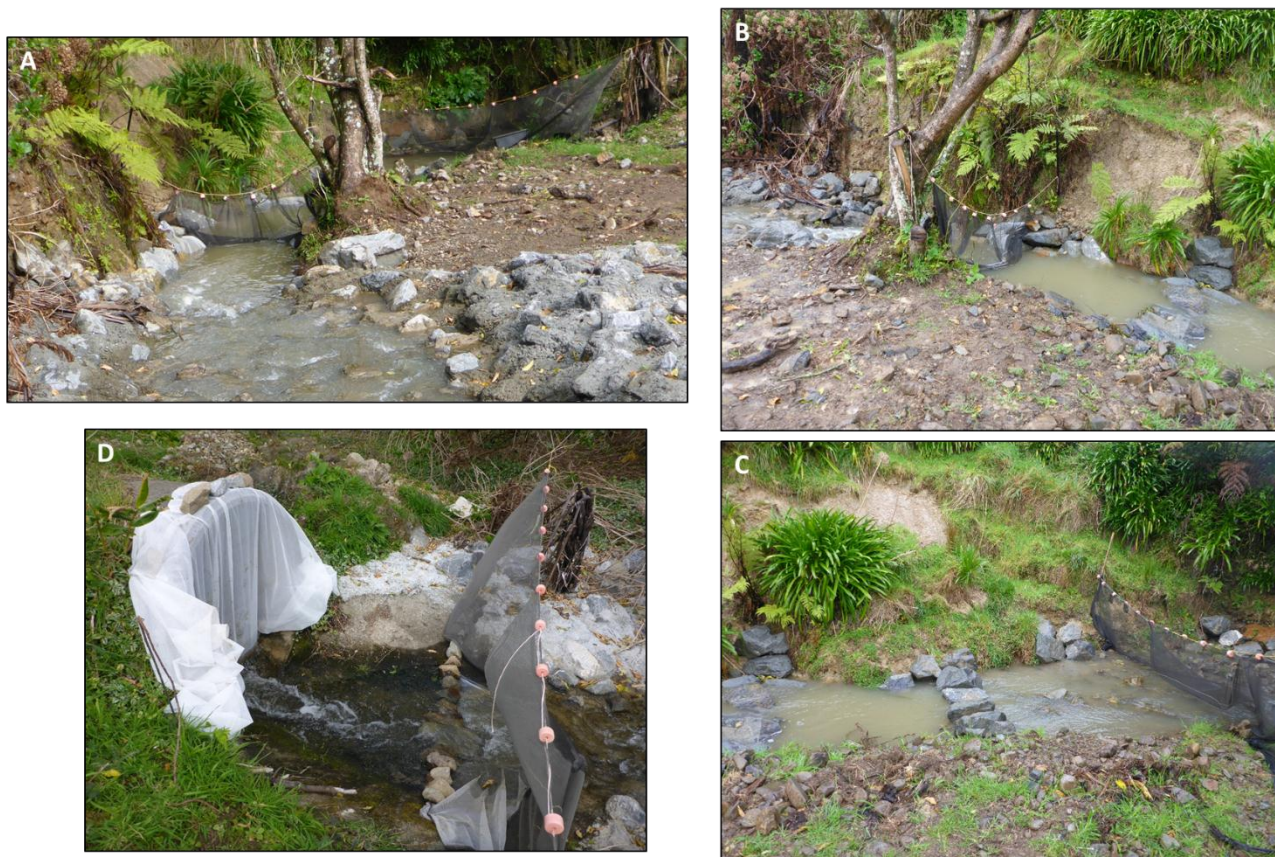
**Figure 5-4: Downstream barricades installed in Kara Stream during the inanga passage trial.** A - C Barrier nets deployed during the rock-ramp trial. D, Barrier nets deployed for testing inanga passage through the culvert independently of the rock-ramp.

Install a barricade at the bottom of the test site to prevent fish escaping downstream or stream fish moving upstream. A seine net or whitebait mesh form suitable barriers (Figure 5-4). It is important to dig the bottom of the mesh into the substrate and cover with boulders to try and create a secure barrier. If possible, the top of the mesh can be secured to trees on the stream banks (Figure 5-4B), otherwise waratahs or stakes will need to be utilised (Figure 5-4C). Installing a second net downstream as a back-up is also advisable (Figure 5-4). The barrier should be installed below the pool at the base of the rock-ramps to provide fish with a low velocity area to rest before ascent. Note: each retrofit rock-ramp should have rock weirs installed downstream to create a pool at the base of the ramp (Figure 5-4B & C) to dissipate energy and prevent erosion.

After 24 hours, no inanga had successfully passed the in-stream structure, and no inanga were found inside the culvert itself (Figure 6-4). Close to half of the inanga released were recaptured on the rock-ramp, in the pool below the rock-ramp, or below the first barrier net in the pools created by the rock weirs before the secondary stop net (Figure 6-4; see Figure 5-4B & C for stop net positioning).

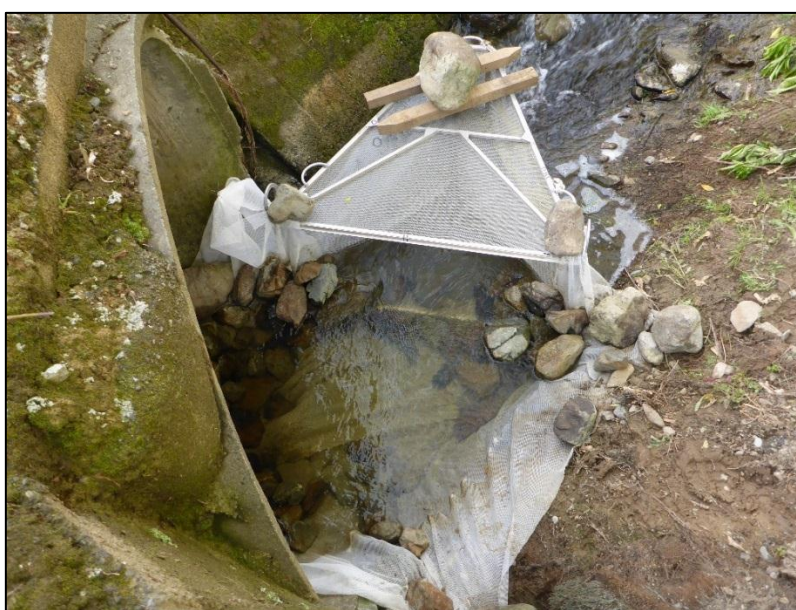
**Figure 5-5: Whitebait trap installed at the culvert inlet in Kara Stream.**

At the top end of the test site, a whitebait trap and barrier net also needs to be installed (Figure 5-5). Ensure the trap is weighted down to avoid any movement with increases in water flow.

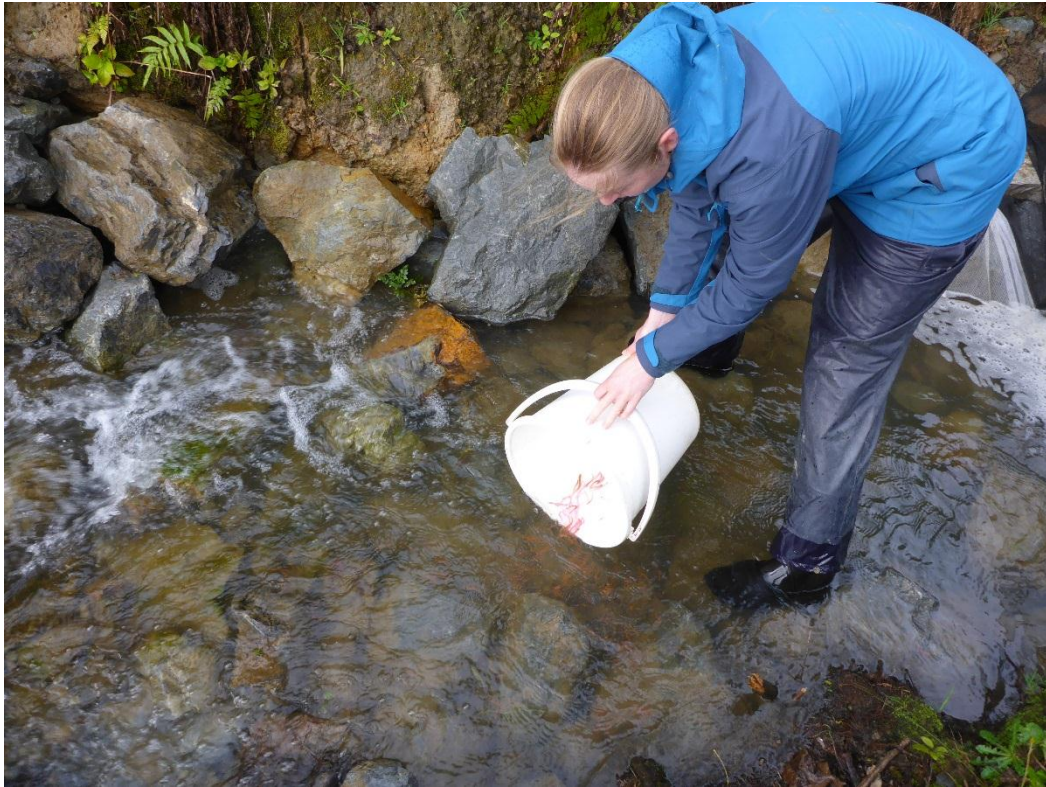
**Figure 5-6: Releasing marked inanga below the rock-ramp in Kara Stream, at Upper Kingston Road.**

- Prior to releasing the marked fish, electric-fish the test reach to remove any resident fish that could confound trial results. Utilise multi-pass fishing until no fish are captured.
- Release the marked fish at either the base of the rock-ramp or culvert (Figure 5-6).

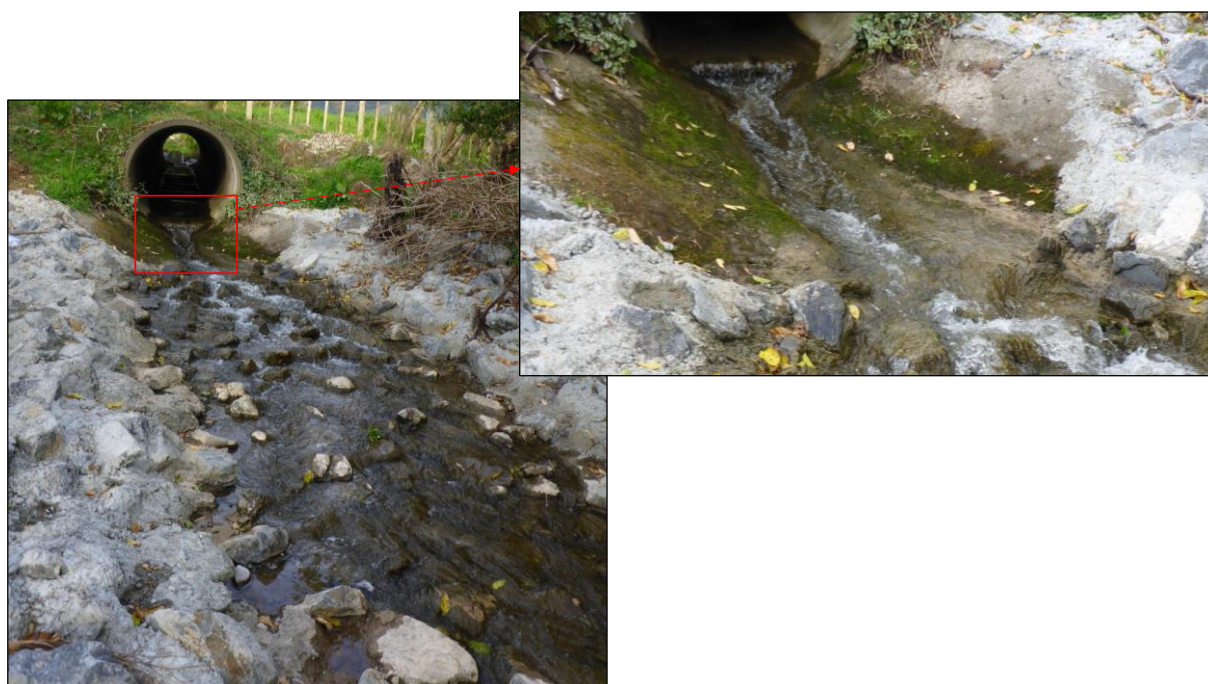
**Figure 6-1:** Remediated culvert on Kara Stream, Upper Kingston Road. Inset shows the unmodified culvert apron.

During the remediation works, it was deemed unfeasible to build the rock-ramp on top of the existing culvert apron (Figure 6-1). As such, one aim during the mark and recapture trials was to determine if the apron presented a bottleneck for fish passage and therefore also required retrofitting (Figure 6-3). In addition, there was no documented field tests of the plastic baffles (0.18 m in height) installed at 1.24 m intervals along the length of the culvert barrel (Figure 6-2). Therefore, to ensure each component of the in-stream structure was effective at promoting inanga passage, the culvert was assessed independently from the rock-ramp. To achieve these aims, three mark and recapture trials with juvenile inanga were carried out between 15 and 19 September 2014:

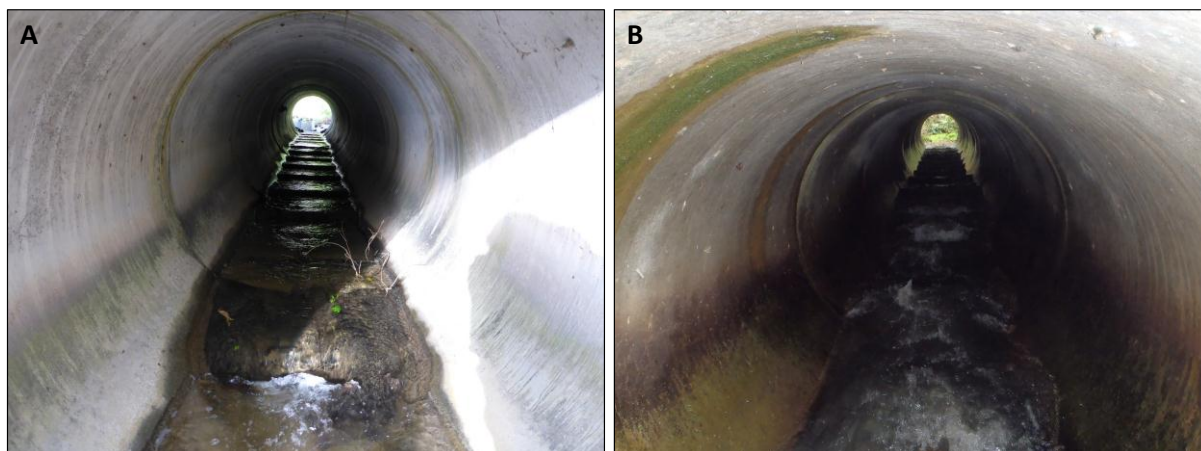
**Figure 6-2: Culvert under Upper Kingston Road.** A, at low flow. B, at high flow.

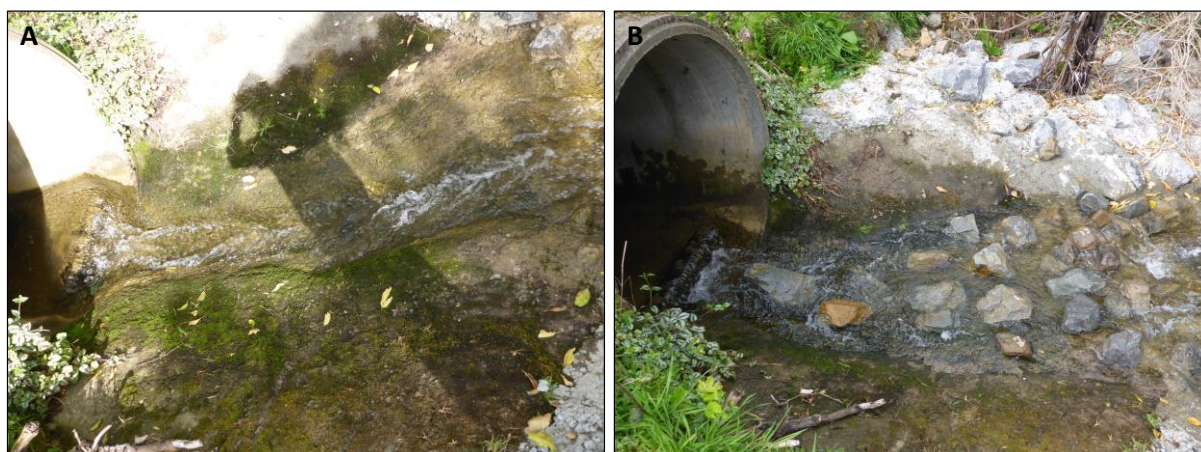
**Figure 6-3: Culvert apron at Upper Kingston Road.** A, unmodified. B, modified using boulders as baffling elements.

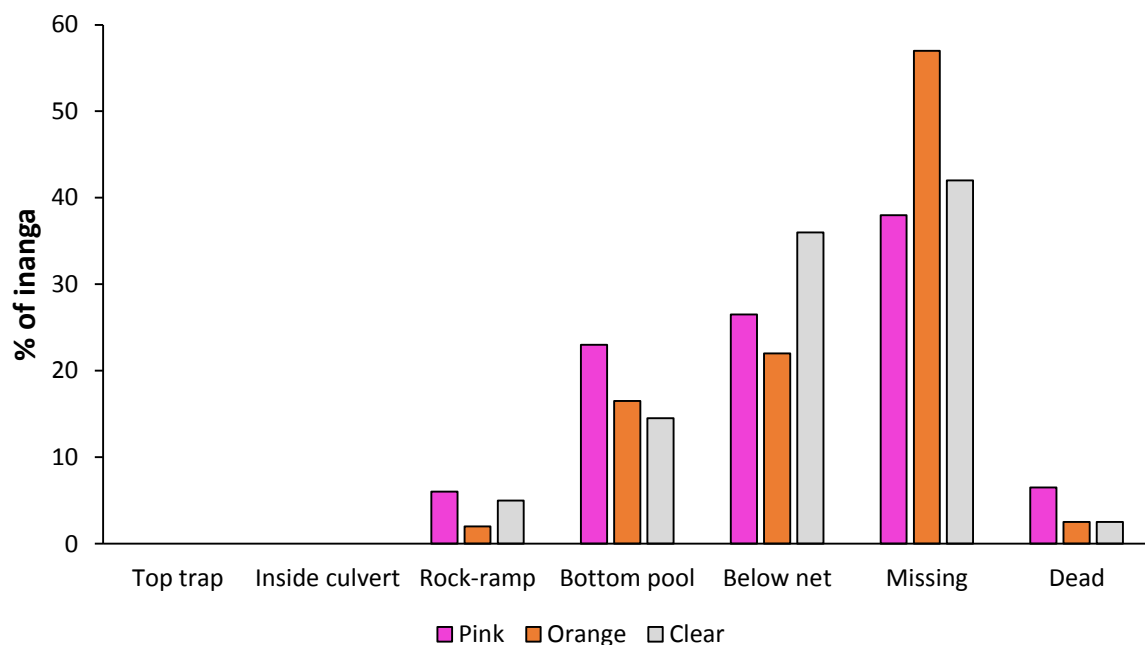
**Figure 6-4: Percentage of inanga successfully passing the rock-ramp and culvert, recaptured in different sections of the structure, and fish either unaccounted for or found dead after 24 hours.** 'Bottom pool' represents inanga in the pool at the base of the rock-ramp. 'Below net' represents inanga captured in the pools above the second barrier net.

At the conclusion of the trial the proportion of fish that were recaptured in each section of the in-stream structure, missing and dead fish were relatively similar between marked (pink and orange) and uncoloured replicates (Figure 6-4). This indicates that the marking procedure did not unduly influence behaviour or passage ability compared to inanga that were not subjected to the marking procedure.

However, around half of the test fish were missing with a small proportion found dead in the barrier net (Figure 6-4). As the trials were carried out at higher than base-flow conditions, it is likely that inanga were attempting to move downstream into quieter waters and were successful at passing the barrier nets. The small proportion of dead fish are most likely fish that succumbed to the cumulative stressors of capture, handling, and release into an area where they were vulnerable to damage or getting trapped by the barrier net when trying to move downstream.

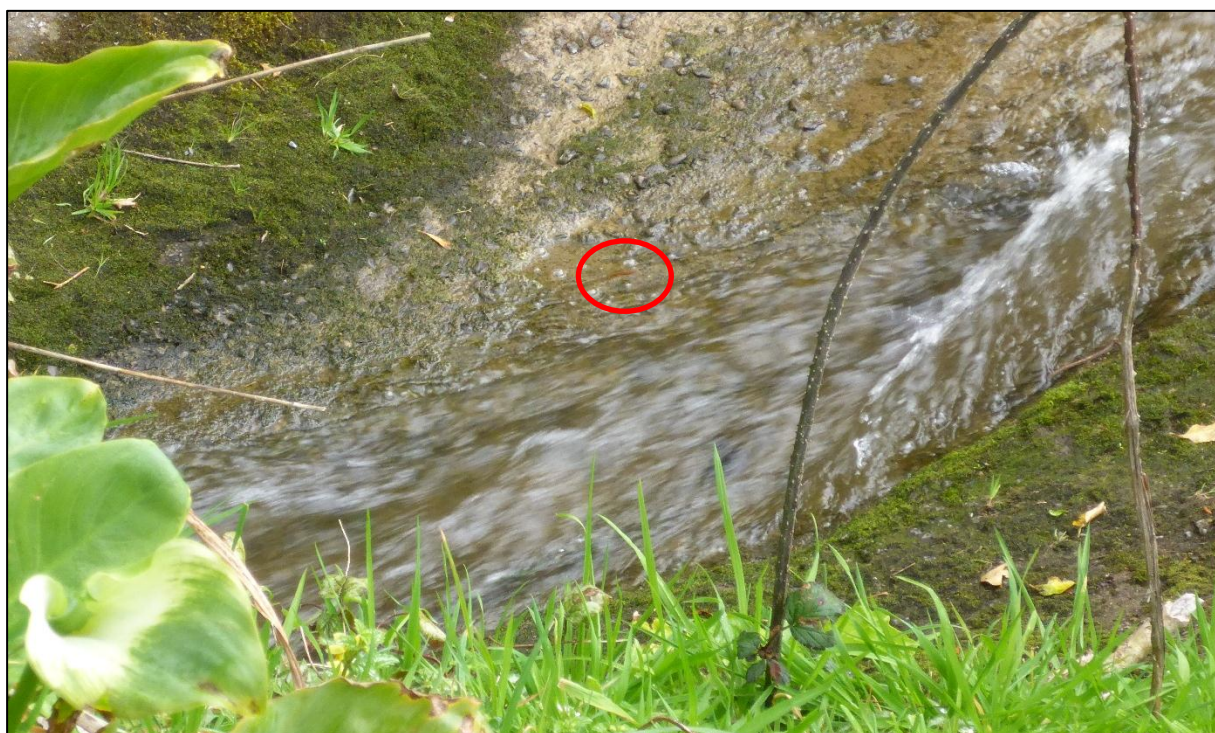
**Figure 6-5: Pink inanga resting on the culvert apron (red circle).**

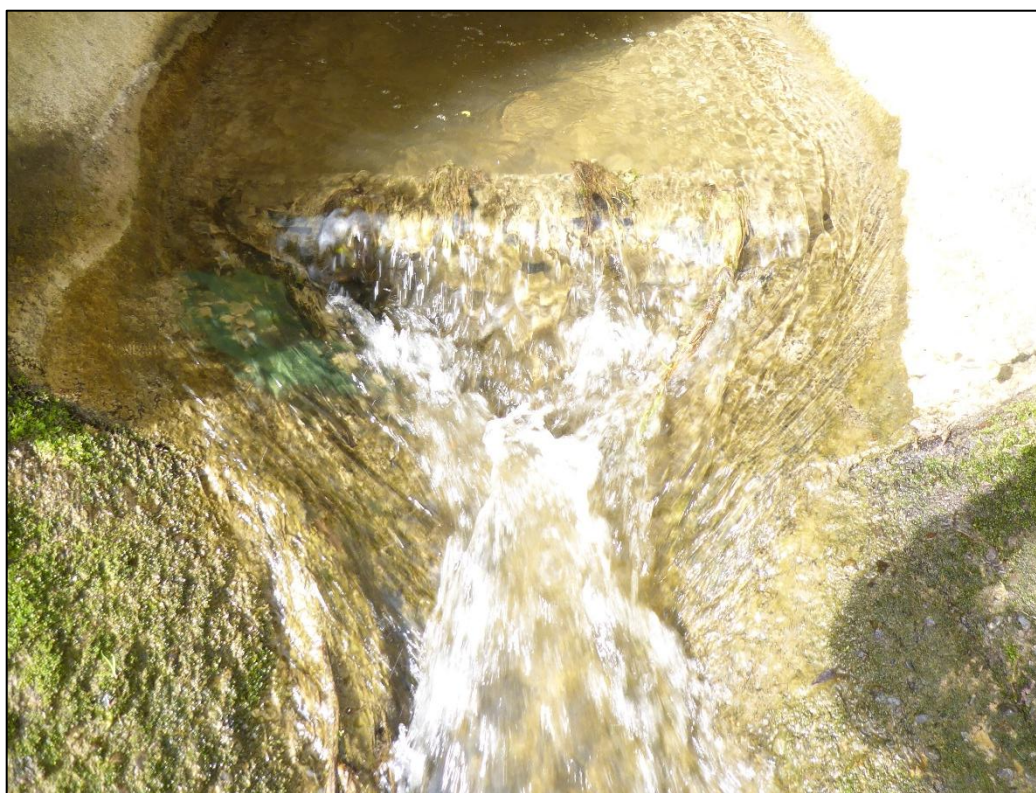
**Figure 6-6: Weir created by the baffle at the transition point between the culvert outlet and apron.**

A further impediment for inanga is likely caused by the transition between the culvert apron and the baffling inside the culvert barrel, where a weir is formed immediately at the culvert outlet (Figure 6-6). Should inanga successfully burst swim over the apron, there is no low velocity water or rest area prior to the requirement to burst swim over the weir. Therefore, the cumulative effect of water velocity over the apron and the weir at the culvert outlet are, in my opinion, the key factors presently preventing inanga passage past the culvert. It should be noted, however, that species capable of climbing, such as banded and shortjaw kokopu, (that are also found in Kara Stream) will not be prevented from passing over the apron and into the culvert as the wetted margin is sufficient for promoting passage of these species.

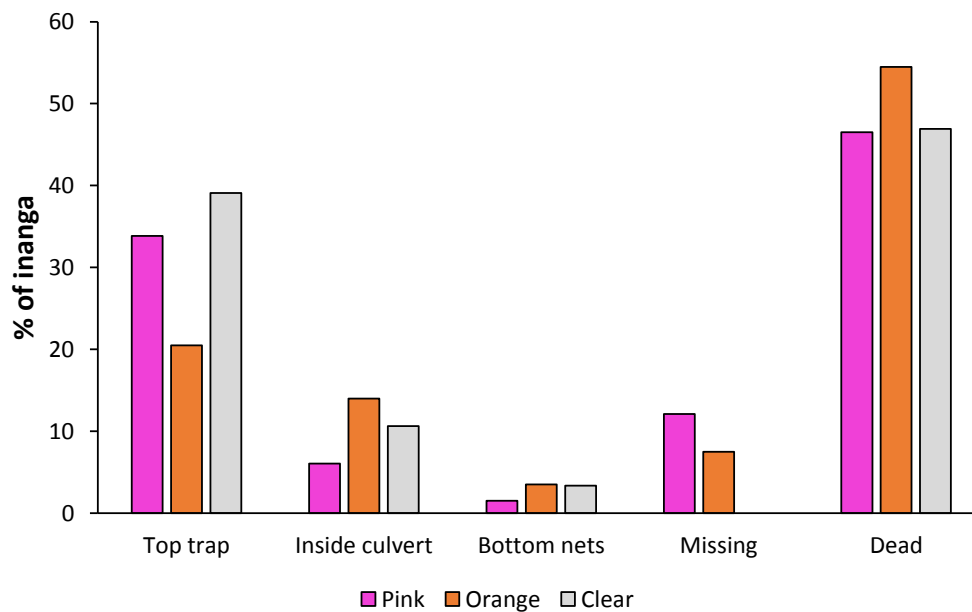
**Figure 6-7:** Percentage of inanga successfully passing the culvert, still migrating upstream inside the culvert, caught in the bottom barrier nets, and fish either unaccounted for or found dead after 20.5 hours.

In contrast to Trial 1, the majority of inanga from each replicate were recaptured (Figure 6-7). Here, the barrier nets were more effective due to the smaller wetted width of the stream and the more uniform shape of the culvert and apron. However, around half of the fish released were found dead against the barrier net (Figure 6-7). The high death rate is most likely a result of carrying out the trials under higher, sub-optimal flows. Although the baffling inside the culvert creates a pool between the weirs, the pool is shallow (c. 18 cm), and under the trial flows, the pool was turbulent with areas of fast water velocities. It is likely that many of the smaller weaker fish encountered, and were unable to swim against, the fast water velocities and ended up getting swept into the barrier net. Once pinned against the mesh, the fast water velocities would make it difficult if not impossible for small fish to free themselves (Figure 6-8).

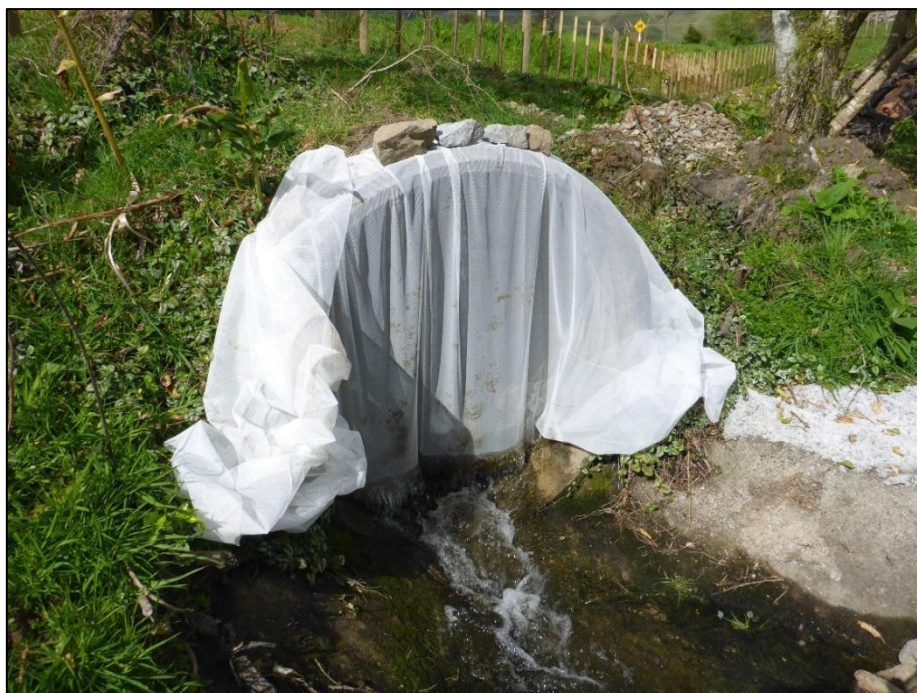
**Figure 6-8:** Barrier net set upstream of the baffle at the culvert outlet.

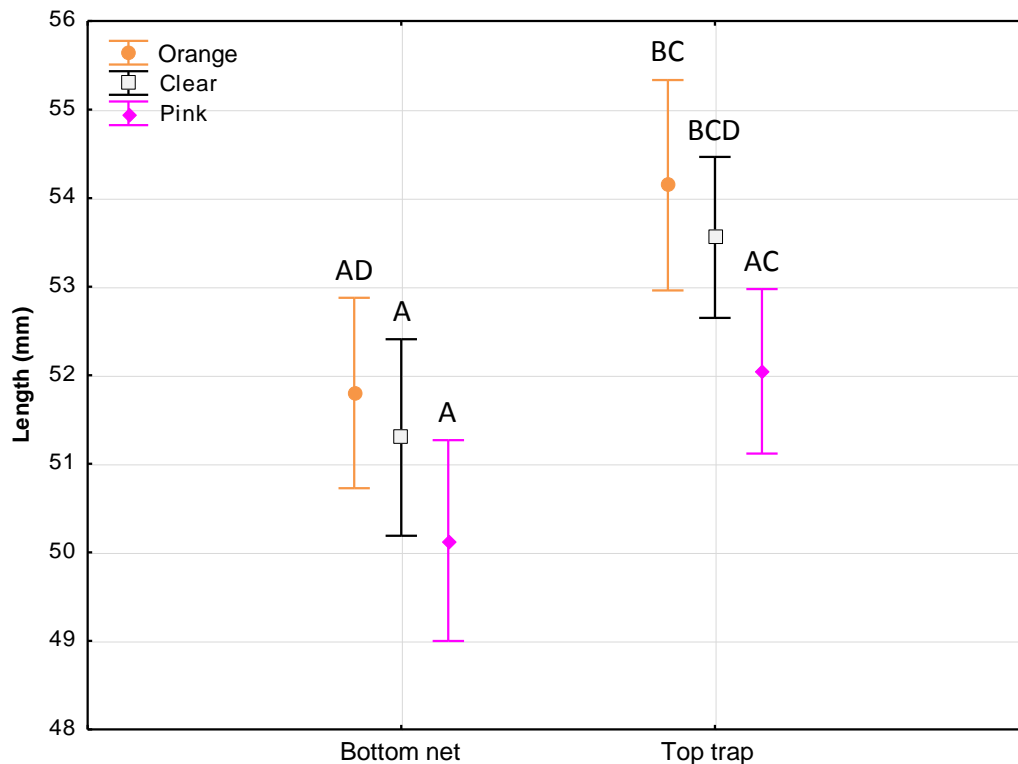
**Figure 6-9: Mean length (mm) of inanga successfully and unsuccessfully passing the culvert in 20.5 hours.** 'Bottom net' represents expired fish collected in the first barrier net at the culvert outlet. Error bars denote  $\pm 95\%$  confidence intervals. Different letters signify significant differences between means (Factorial ANOVA & Tukey HSD test,  $P < 0.05$ ).

An examination of fish size successfully passing the culvert compared to those dead in the barrier net supports this notion (Figure 6-9). For the orange and clear inanga, those successfully passing the culvert were significantly larger than those found dead in the barrier net ( $P < 0.05$ ; Figure 6-9). Collectively, the pink inanga were significantly smaller than those in the clear and orange replicates ( $P < 0.019$ ), and although the larger of the pink fish were more successful at passing the culvert, the smaller variation in fish size within the cohort meant the difference was not significant (Figure 6-9).

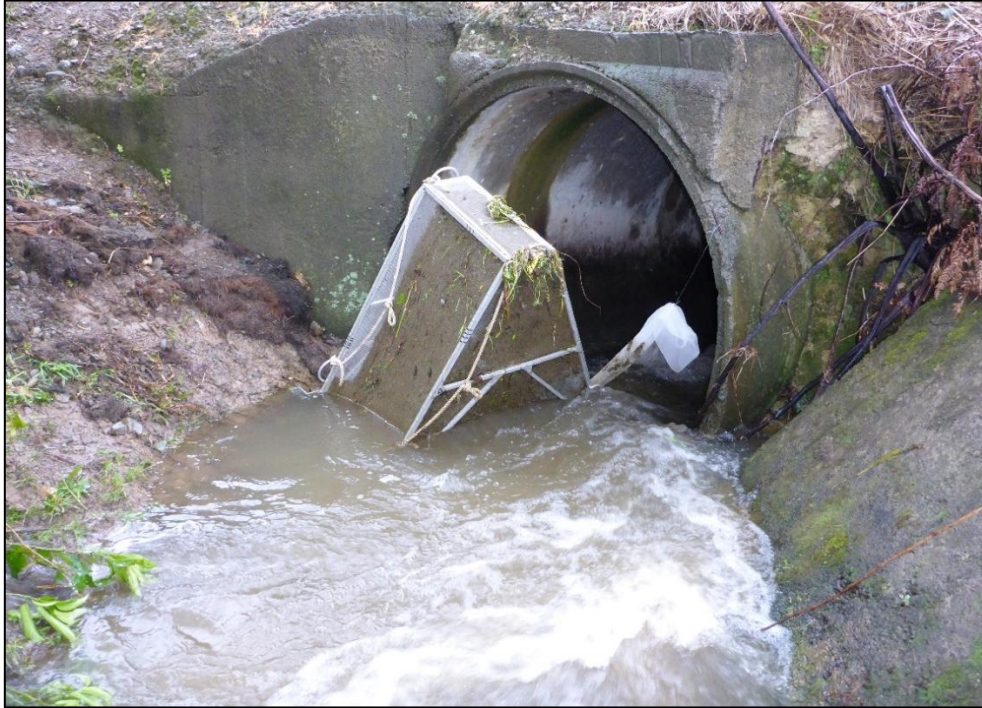
**Figure 6-10: Top trap during increasing flood waters at the conclusion of Trial 3.**

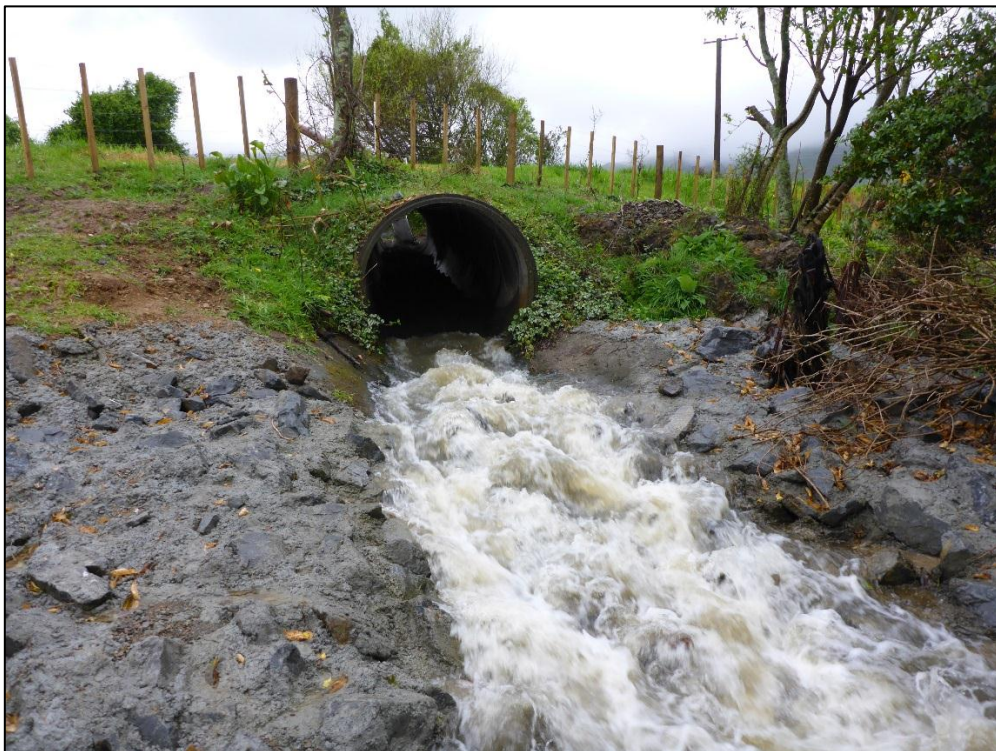
**Figure 6-11: Flow through the culvert and over the rock-ramp at the conclusion of Trial 3.**

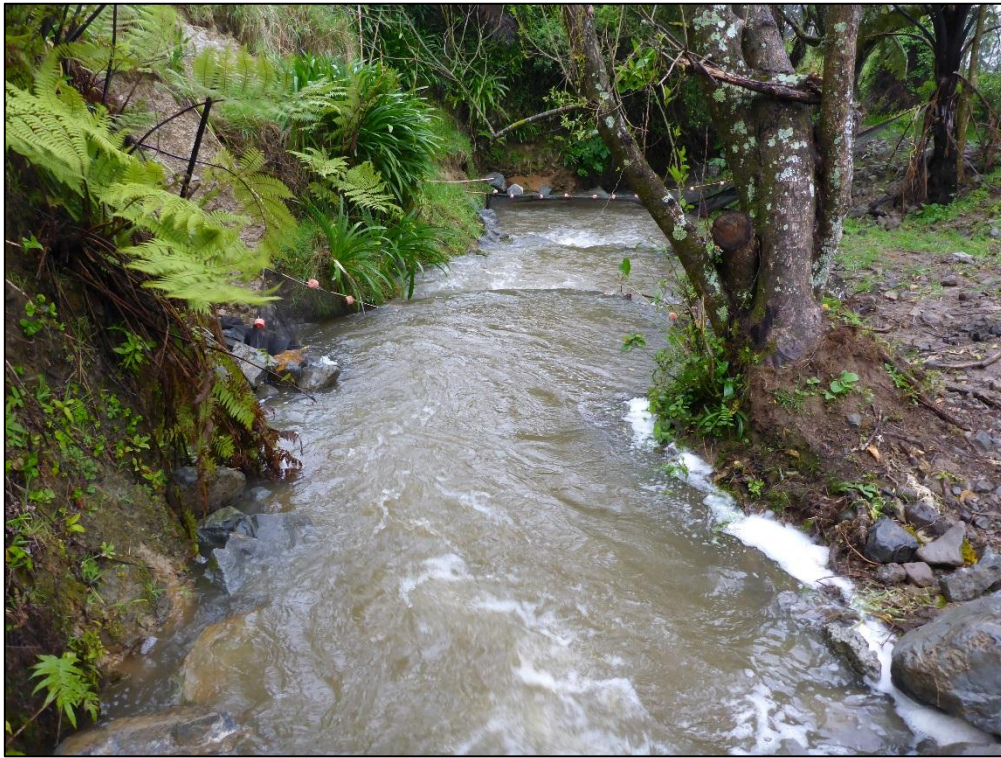
**Figure 6-12: Bottom barricades at the conclusion of Trial 3.**

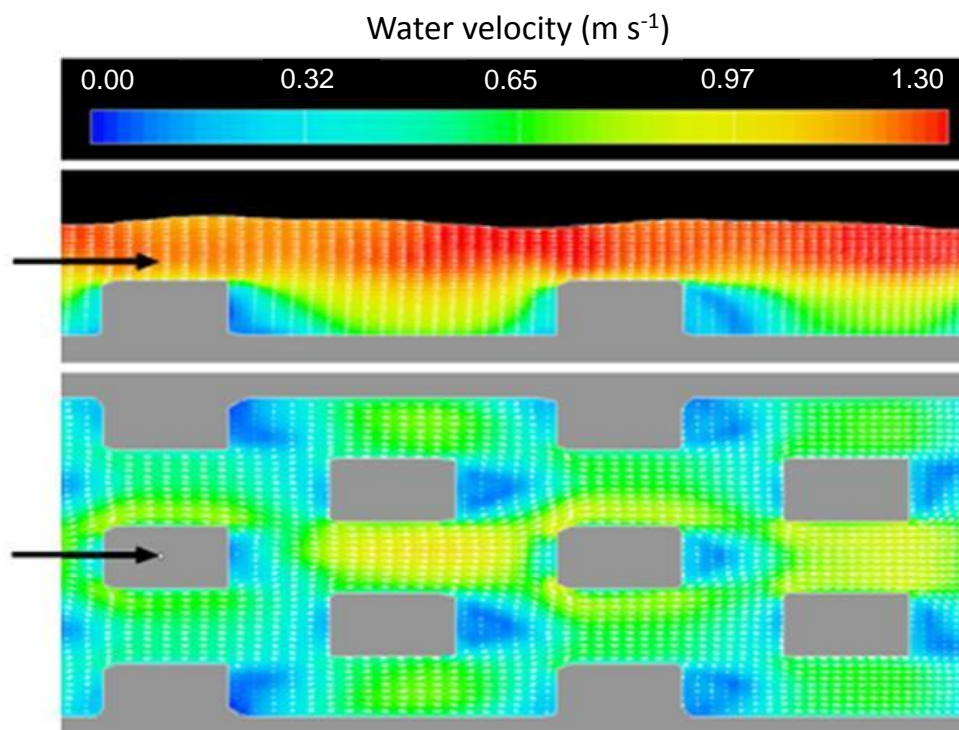
**Figure 6-13: Side view (top section of diagram) and plan view (bottom section of diagram) of modelled water velocities in a culvert fitted with alternating rows of rectangular spoiler blocks (0.25 m length, 0.12 m width and 0.12 m height), spaced 0.20 m apart at a flow of  $0.11 \text{ m}^3 \text{ s}^{-1}$ . Arrows indicate the direction of flow. Culvert diameter = 1.35. The coloured band at the top of the figure gives the water velocity range (red =  $1.30 \text{ m s}^{-1}$ , blue =  $0 \text{ m s}^{-1}$ ).**

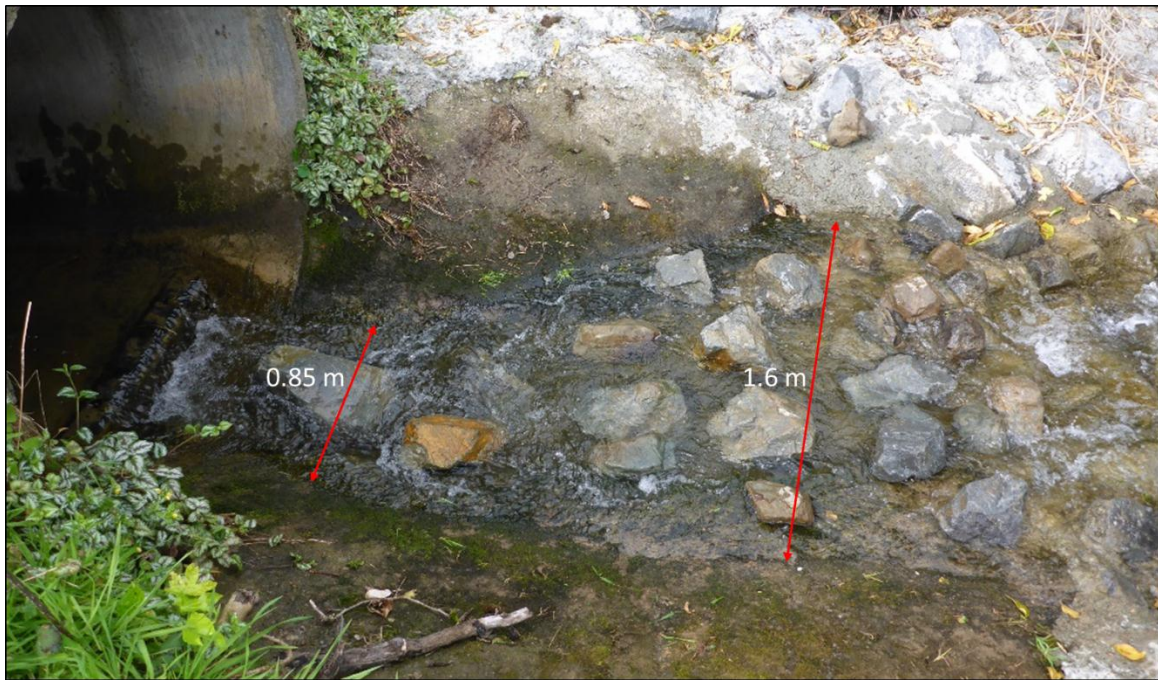
**Figure 6-14: Wetted widths measured across the culvert apron after installing boulder baffles.** Flow was approximately  $0.015 \text{ m}^3 \text{ s}^{-1}$ .

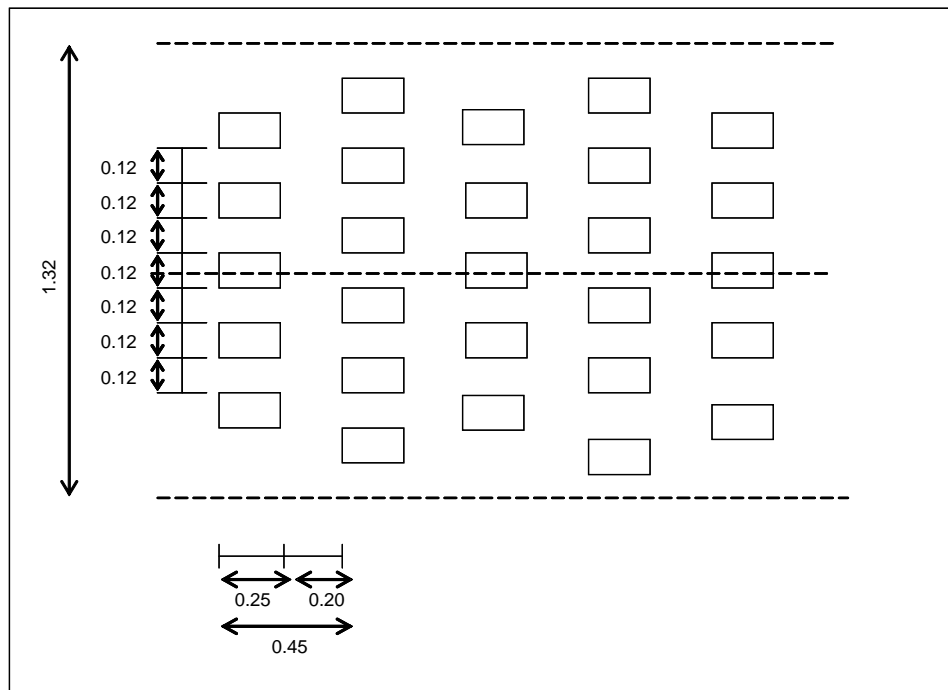
**Figure 6-15: Plan view of spoiler baffle arrangement within a 1.35 m culvert.** Rectangles represent wooden spoiler baffles (0.25 m length, 0.12 m width and 0.12 m height). Dotted lines signify the culvert edges where the array was installed to (1.32 m). Rows of baffles are staggered and alternate in rows of five and six spoilers. All dimensions are in metres.

Stevenson and Baker (2009) recommended using alternate rows of 3 and 4 baffles for culverts 1.3 m in diameter, and rows of 5 and 6 baffles for culverts of 2 m in diameter. It is recommended that alternate rows of 5 and 6 baffles be installed on the culvert apron at Upper Kingston because the apron has less curvature and therefore more wetted width than the 1.5 m culvert. This arrangement is supported by measurements taken after baffling the apron with boulders as the wetted width of the channel increased approximately three-fold to 1.6 m (Figure 6-14). The recommended configuration and spacing of the spoiler baffles is depicted in Figure 6-15. Each baffle should measure 0.25 m in length, 0.12 m in width and 0.12 m in height. Baffles should be secured to the apron using stainless steel anchor bolts (Figure 6-16).

It is recommended that the first row of baffles contains 5 spoilers and is set up against the culvert outlet. Either 4 or 5 rows of baffles will be able to be installed down the apron before reaching the top of the rock-ramp.

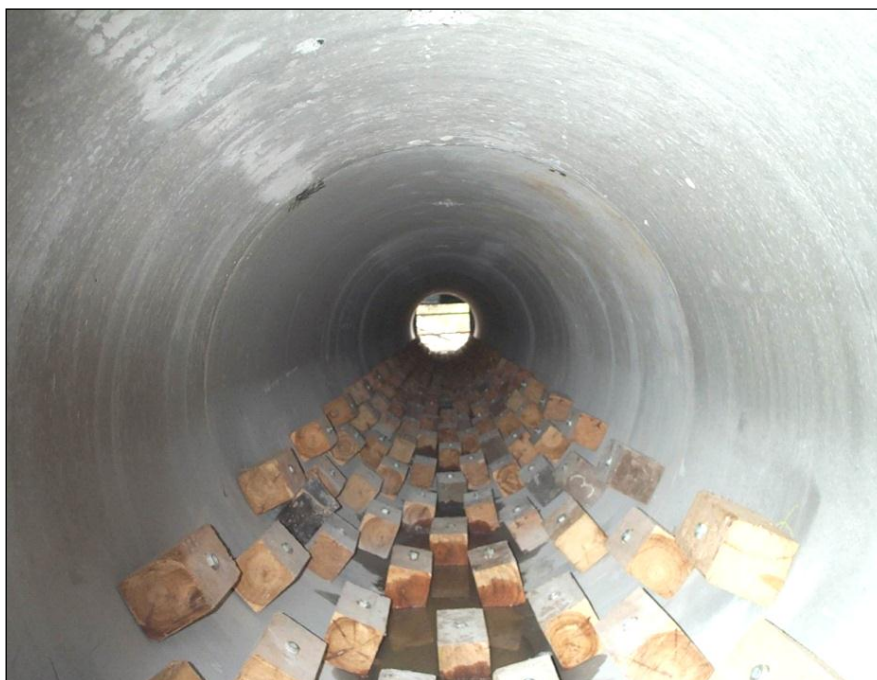
**Figure 6-16: Wooden spoiler baffles (0.25 m length, 0.12 m width and 0.12 m height) installed in a 1.3 m diameter culvert. Spoiler baffles are attached to the concrete with stainless steel bolts.**
