**Assessment of the use of differencing satellite imagery as a tool for quantifying landslide impacts from significant storms – a case study in the Uawa catchment, Tolaga Bay**

**GNS Science Consultancy Report 2019/93  
May 2019**

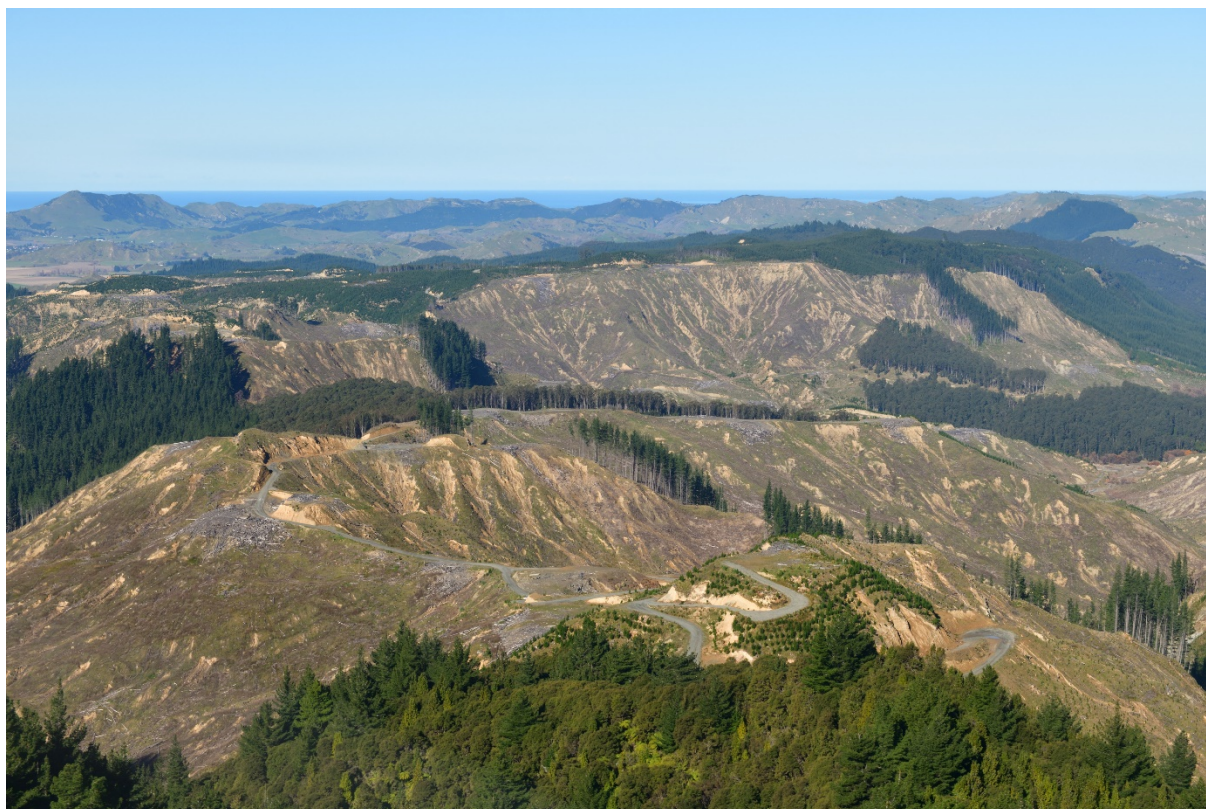
Figure 4.1 Extensive shallow soil slides, debris slides and debris flows, on newly harvested areas in the headwaters of the Mangatoitoi (Uawa Forest) (D. Townsend, GNS Science; 11 July 2018; D85\_7882).

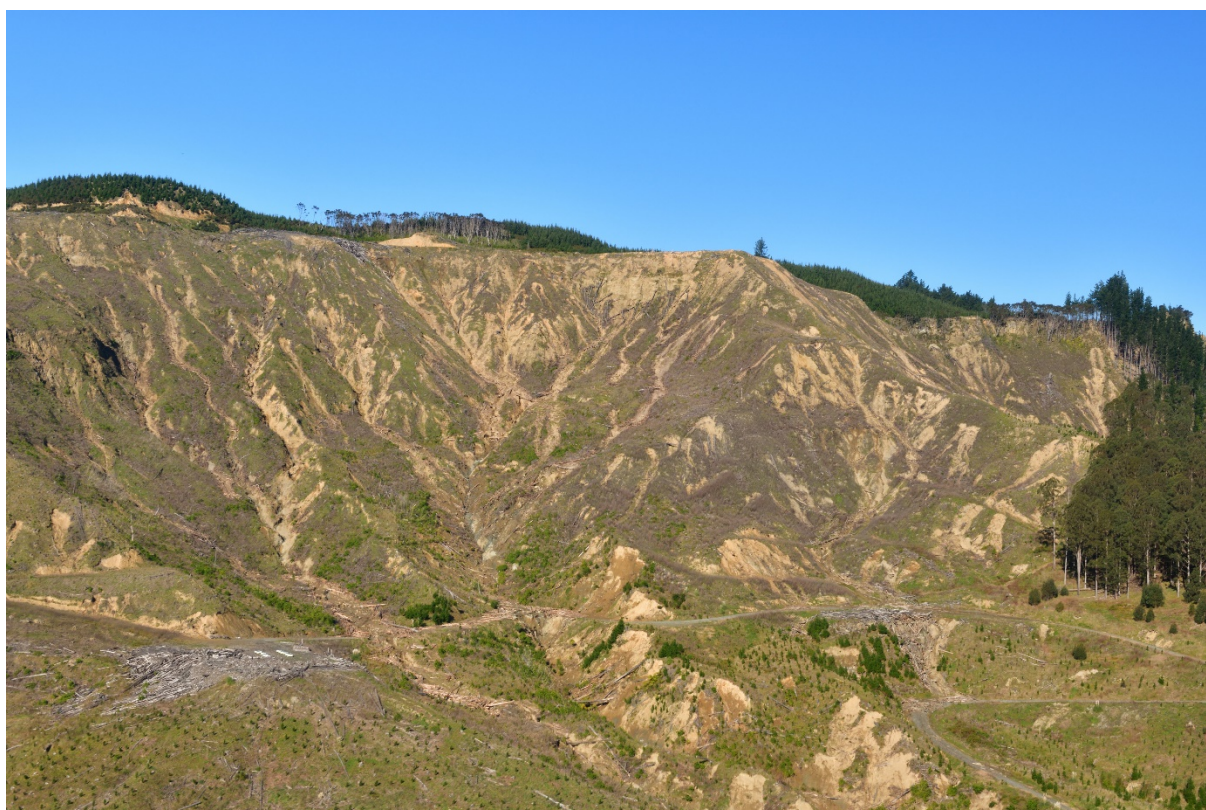
Figure 4.2 Extensive shallow soil slides, debris slides and debris flows in a newly forested area in the Mangatoitoi stream tributary of the Mangaheia River (Uawa Forest) (D. Townsend, GNS Science; 11 July 2018; D85\_8017).

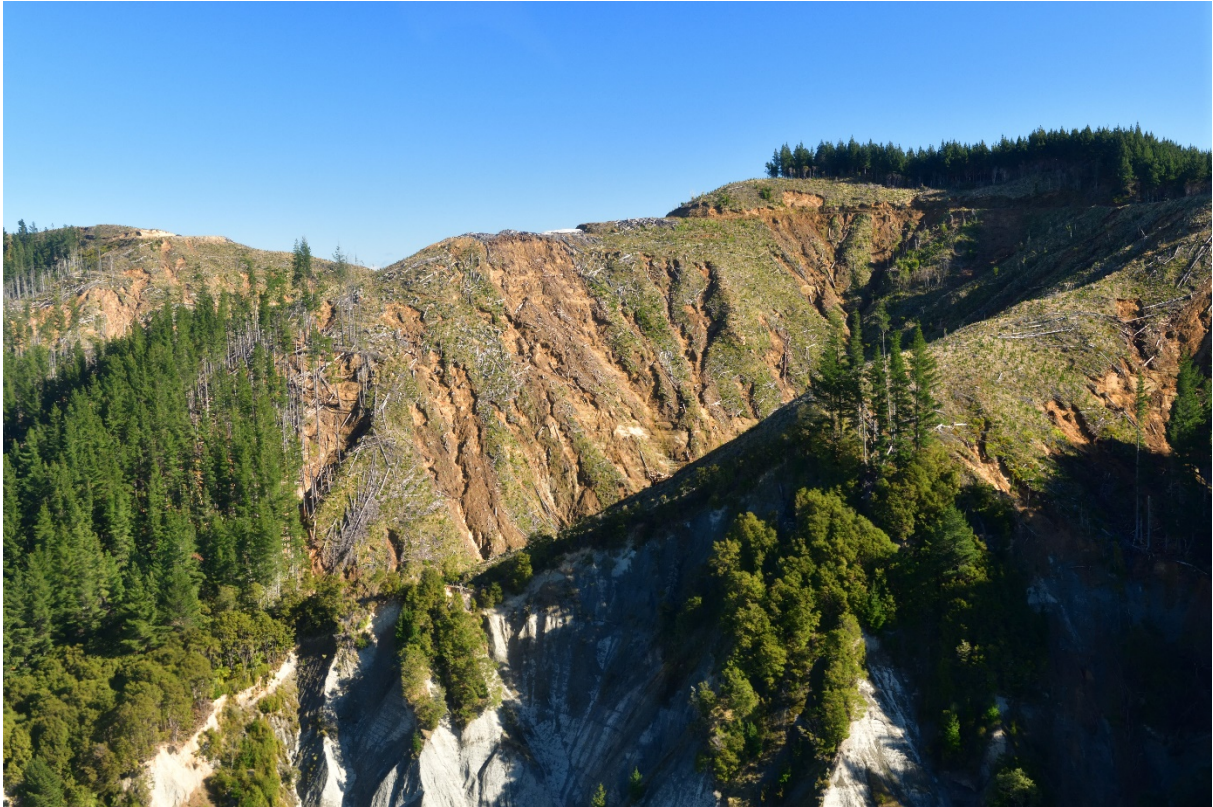
Figure 4.3 Extensive shallow soil slides, debris slides and debris flows in a newly forested area in the upper Takamapohia Stream, Te Mauranga Forest, Mangatokerau catchment (D. Townsend, GNS Science; 11 July 2018; D85\_7844).

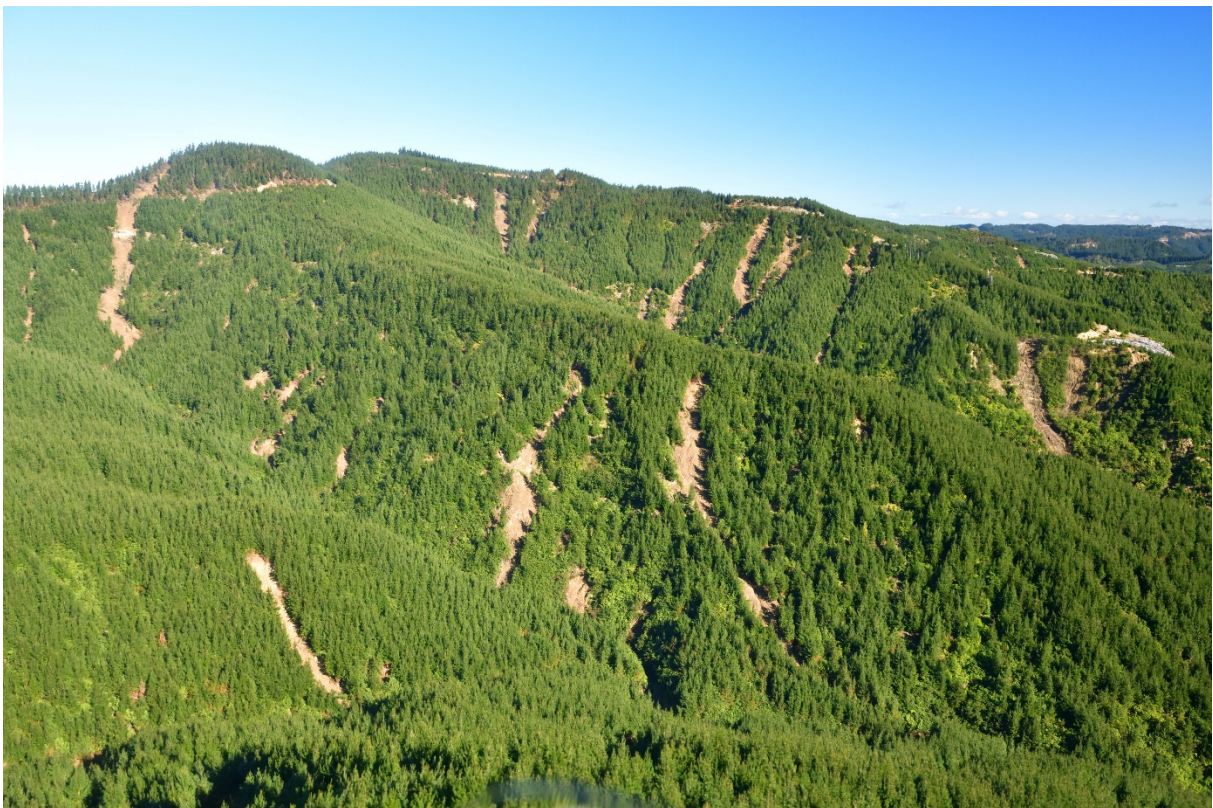
Figure 4.4 Debris slides and debris flows in established maturing forests in the headwaters of the Waiau River (tributary of the Hikuwai River). Some of these may have their source areas associated with forest harvest infrastructure such as roads and landings (D. Townsend, GNS Science; 11 July 2018; D85\_7830).

A GeoNet landslide response was undertaken by Brenda Rosser and Dougal Townsend of GNS Science, and Murry Cave of GDC on 11<sup>th</sup> July 2018. The following photos taken during the reconnaissance flight document the landslides caused by both events. The predominant landslide types triggered were shallow (~1m depth) translational soil slides, debris slides and debris flows, in areas recently harvested (Figure 3.4). The landslides mostly initiated in gully heads or along ridge crests (Figure 4.1 and Figure 4.2). The highest number of landslides were observed in recently harvested or re-planted areas (Figure 4.1 to Figure 4.3), but landslides also occurred in established pine plantations (Figure 4.4). Landslide terminology used here is as described by Hungt et al (2014).

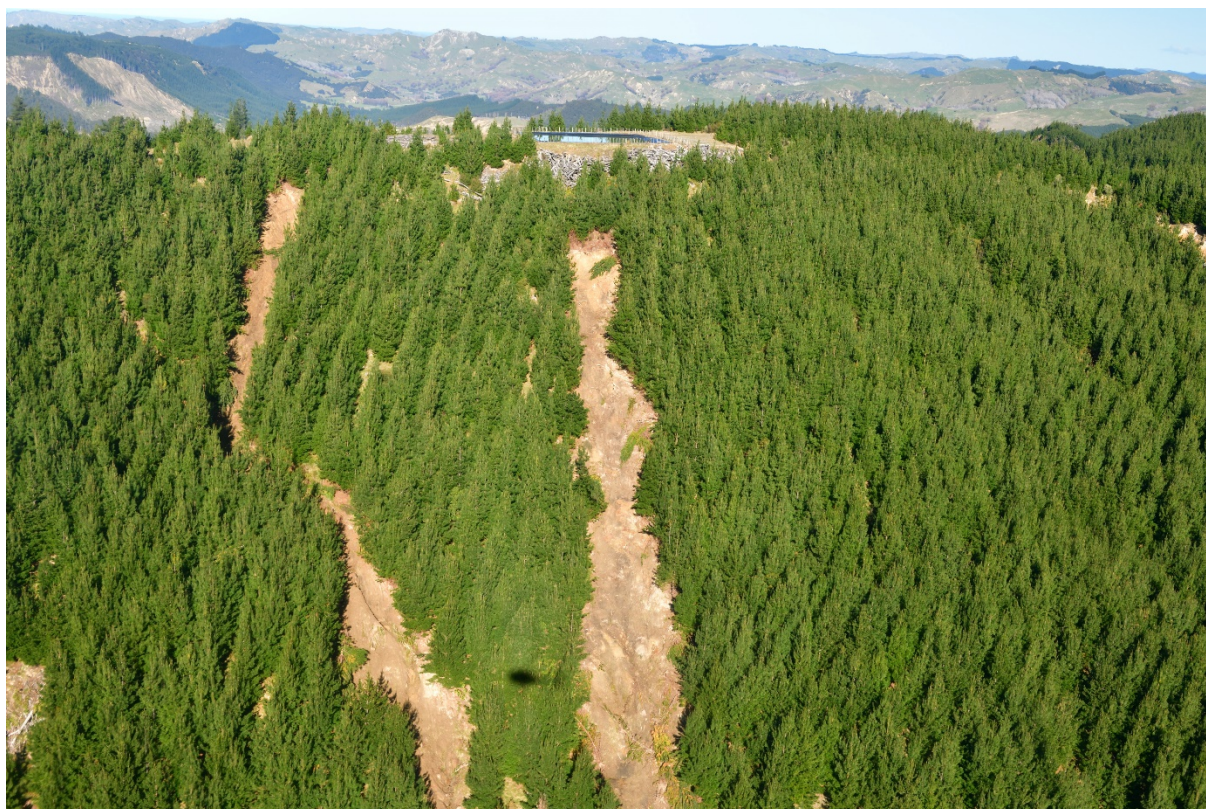
Figure 4.5 Debris flows initiated in established pine plantations in the headwaters of the Mangatokerau River (Te Mauranga Forest). The right-hand debris flow may have initiated in fill associated with the water reservoir visible on the ridge crest (D. Townsend, GNS Science; 11 July 2018; D85\_7879).

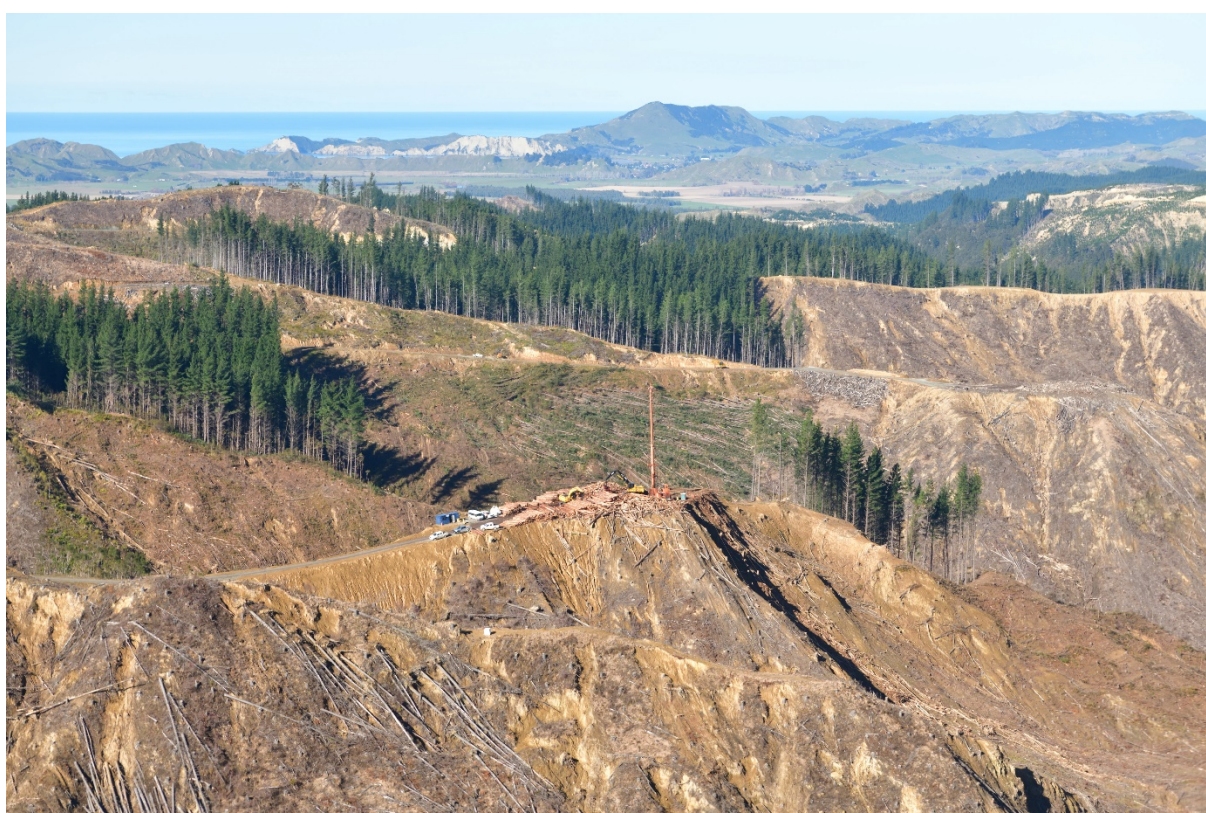
Figure 4.6 Skid haul operation in a newly harvested area in the head of Tapuae Stream, Paroa Forest, Uawa catchment. Shallow soil slides have initiated in the fill slopes constructed for landings and roads built to facilitate harvesting operations (D. Townsend, GNS Science; 11 July 2018; D85\_7887).

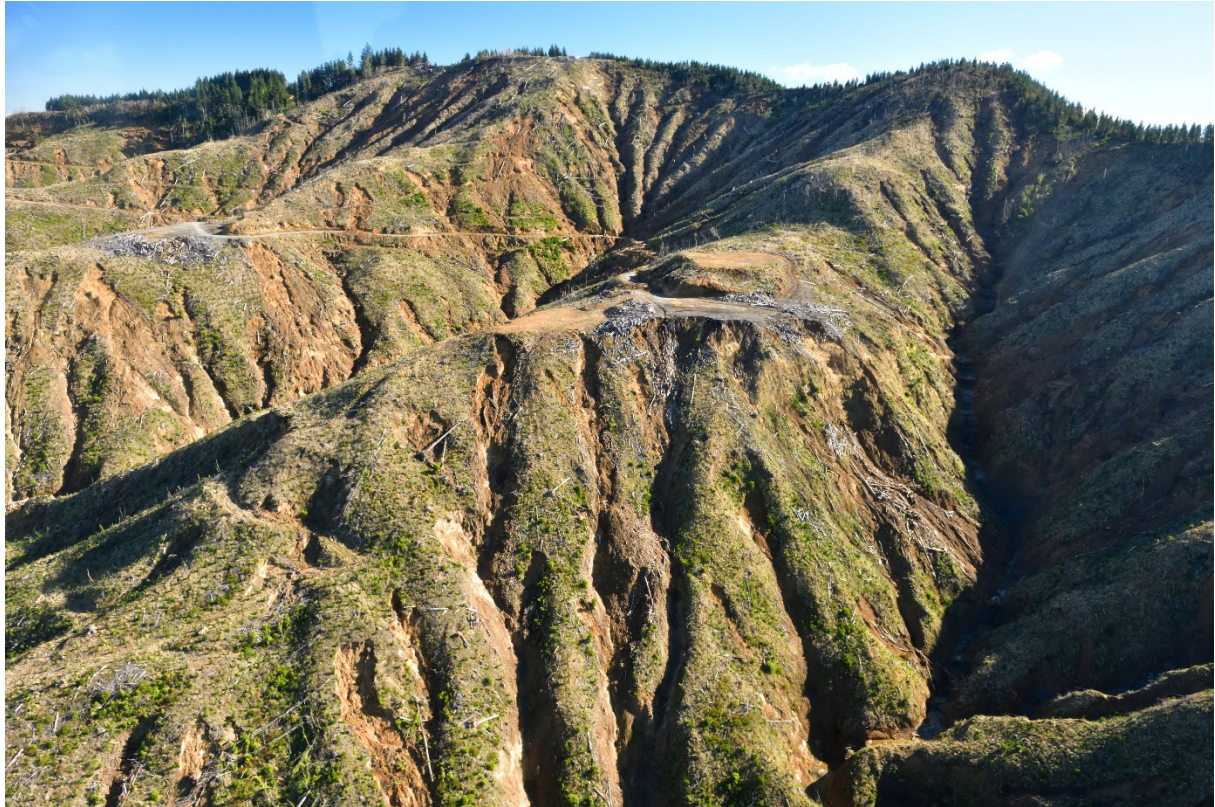
Figure 4.7 Shallow soil slides and debris flows with source areas in fill slopes below a landing on recently logged slopes in the headwaters of Takamapohia Stream, tributary of the Mangatokerau River (Te Mauranga Forest) (D. Townsend, GNS Science; 11 July 2018; D85\_7836).

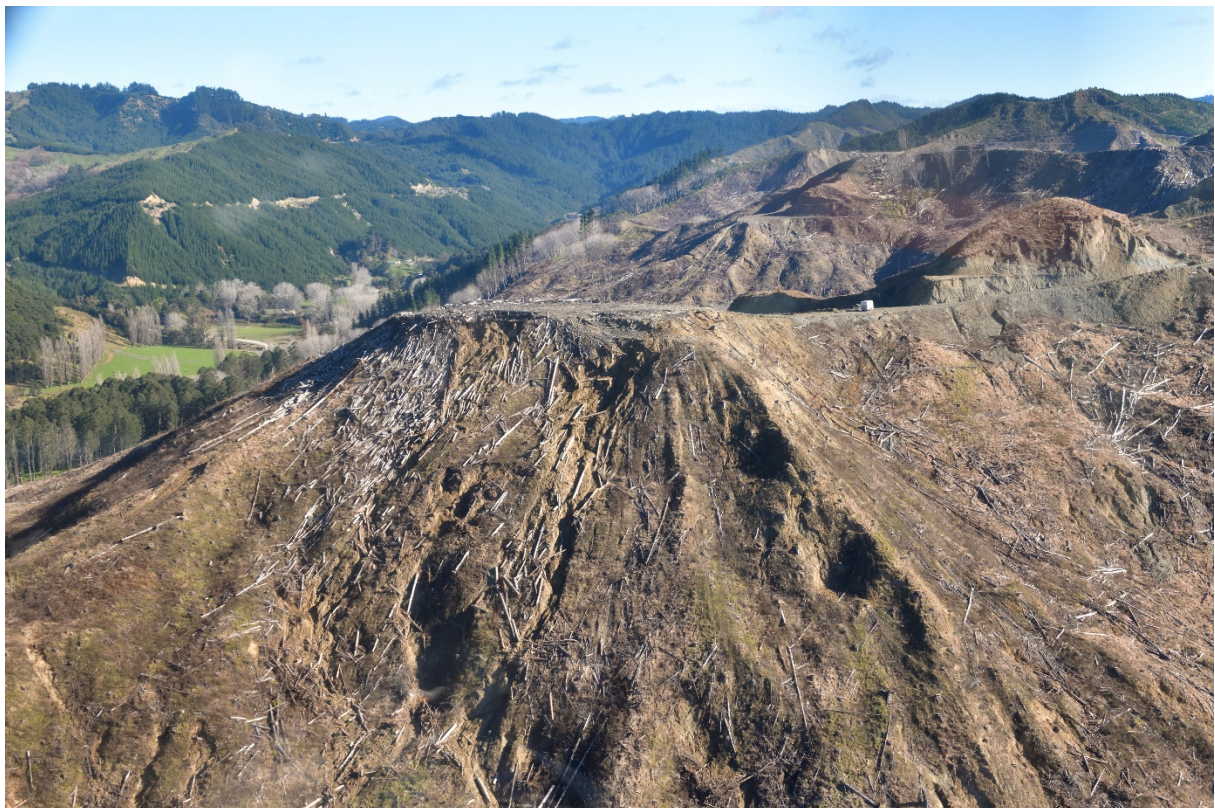
Figure 4.8 Soil slides and debris flows with source areas in fill used to construct a landing in the Mangatoitoti Stream, Mangaheia catchment near Five Bridges (Uawa Forest) (D. Townsend, GNS Science; 11 July 2018; D85\_8035).

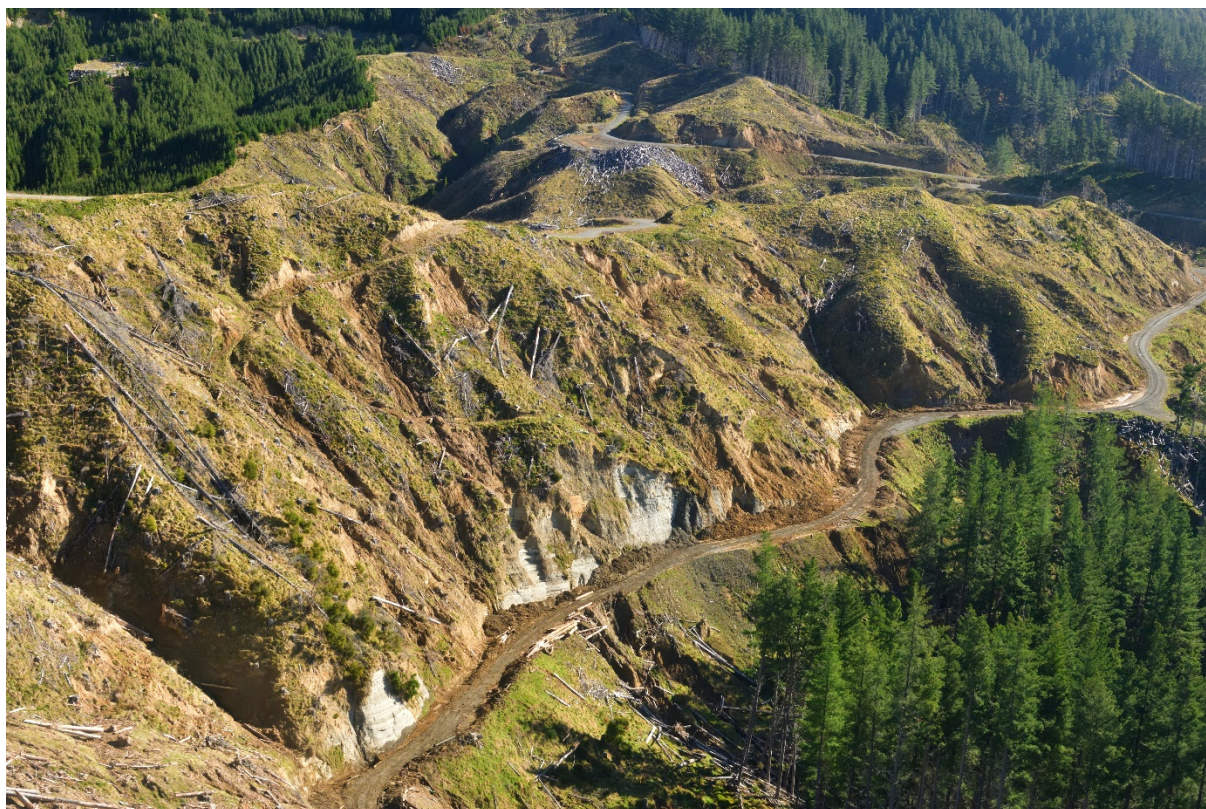
Figure 4.10 Soil and rock falls, soil and rock slides, and soil flows originating on or above cut slopes above Tirohanga forestry road between Kaimonona and Te Kokokakahi Streams in the headwaters of Mangatokerau River (D. Townsend, GNS Science; 11 July 2018; D85\_7872).

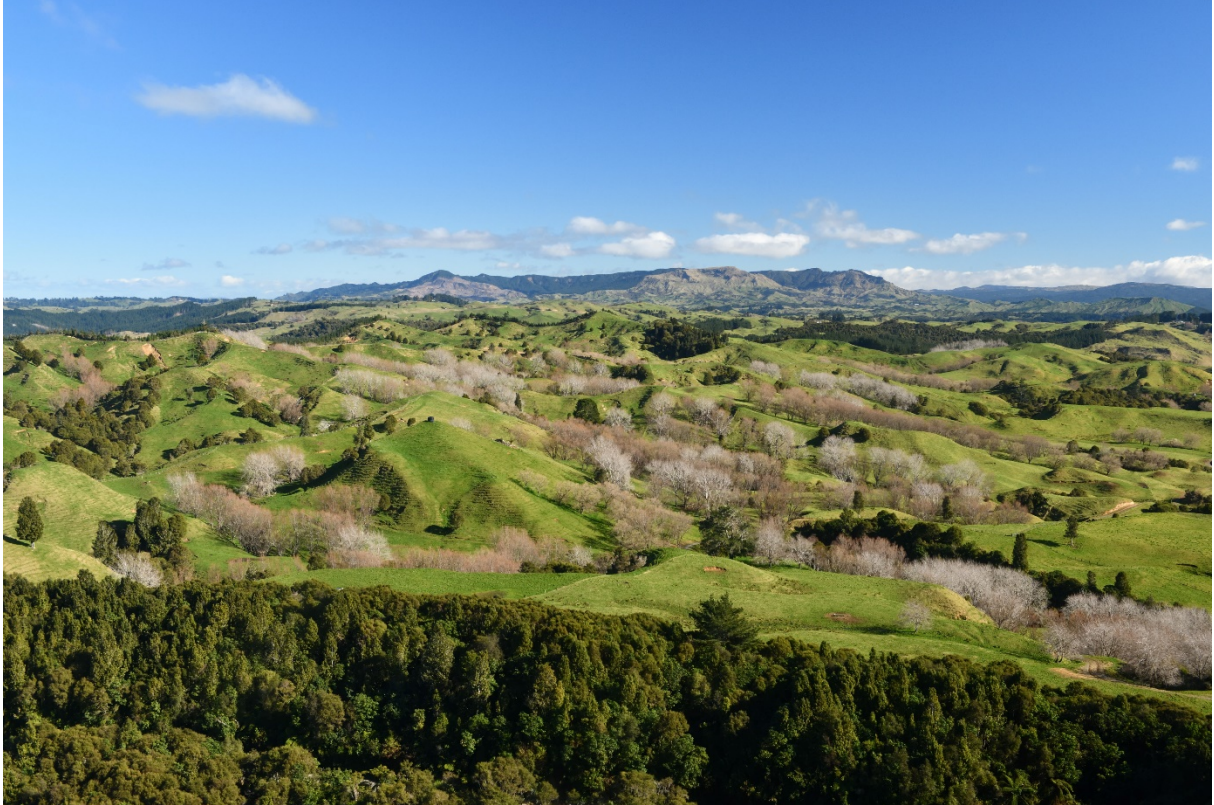
Figure 4.11 Largely unaffected pasture on hilly steep lands developed on cohesive, generally weak to moderately strong Tertiary-aged rocks in the headwaters of the Waiau River west of Fernside Road (D. Townsend, GNS Science; 11 July 2018; D85\_7816).

There were some shallow soil slides on pasture but areas in pasture were visibly less affected than areas of recently harvested forest (Figure 4.11). There were a few larger rotational slumps observed (Figure 4.14), however, this failure mechanism was not identified regularly across the study area. In some cases, sediment and woody debris generated by landslides was delivered directly to stream channels (Figure 4.15). In other locations, some landslide material remained stored on the slopes. Lots of woody debris was observed stored in first order stream channels (Figure 4.16). There was some bank erosion observed in the downstream reaches of the Mangaheia and Uawa Rivers (Figure 4.17). No survey of the river and stream channel erosion was undertaken so no estimate can be made of the amount of sediment generated by bank erosion.

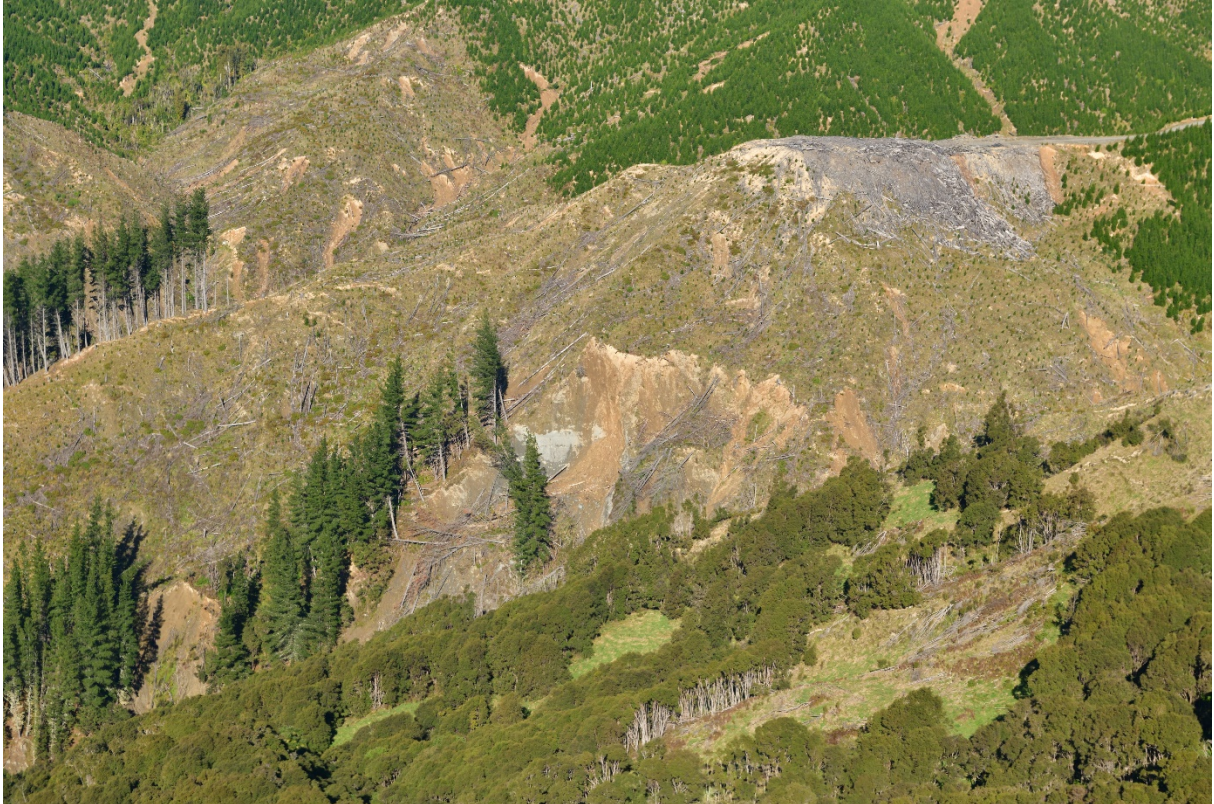
Figure 4.12 Large rotational slump in the headwaters of Waiau River east of Fernside Road (tributary of Hikuwai River) (D. Townsend, GNS Science; 11 July 2018; D85\_7817).

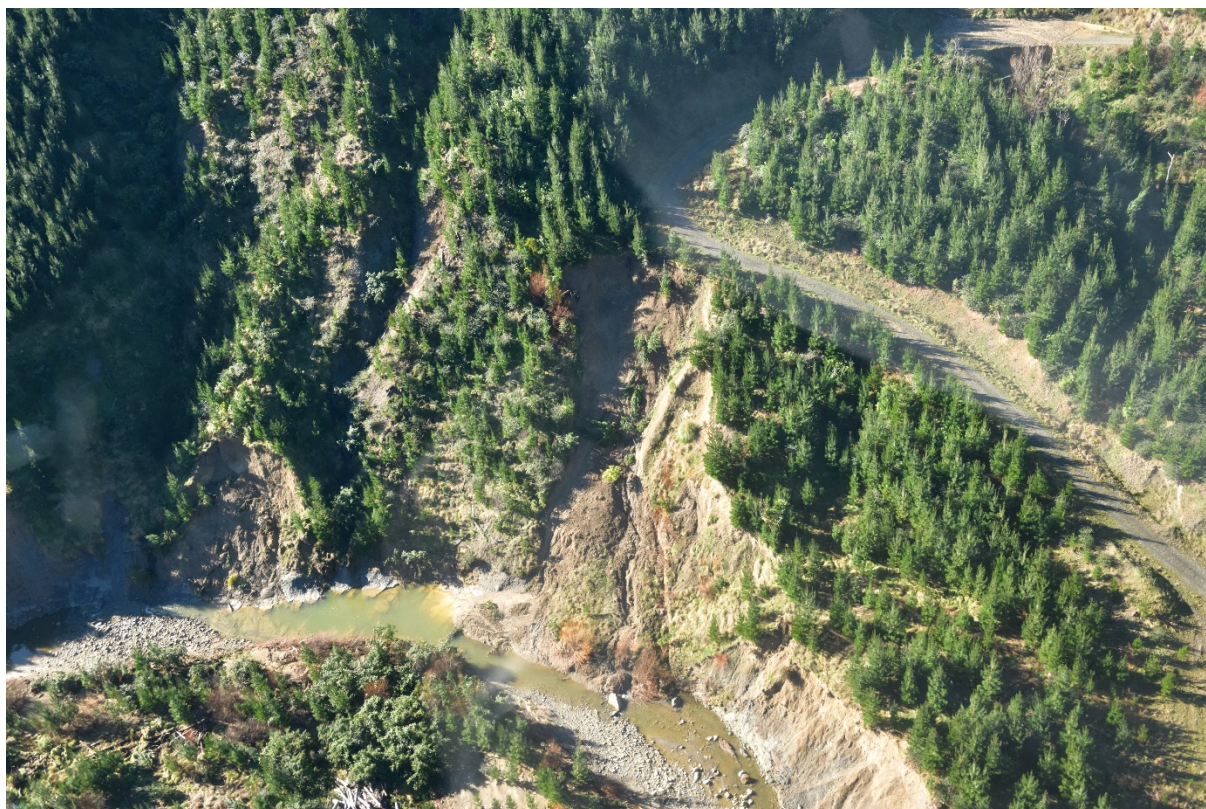
Figure 4.13 Debris slide directly coupled to the channel of the Mangaheia River, on Drysdale forestry road above Five Bridges. Sediment and woody debris have been delivered directly to the channel (D. Townsend, GNS Science; 11 July 2018; D85\_8043).

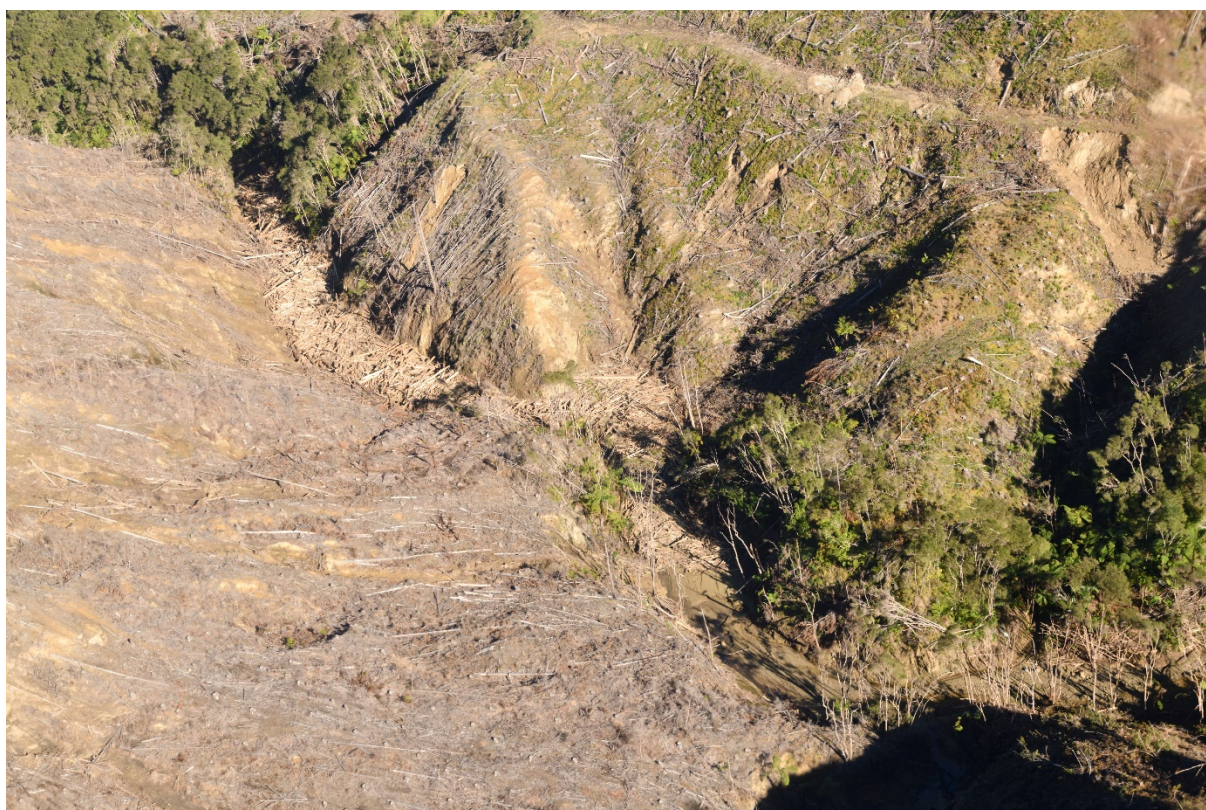
Figure 4.14 Woody debris generated from logging activities and transported by shallow soil slides, debris slides and debris flows stored in first order stream channels in the headwaters of Tapaue Stream, Paroa Forest, Uawa Catchment. (D. Townsend, GNS Science; 11 July 2018; D85\_7894).

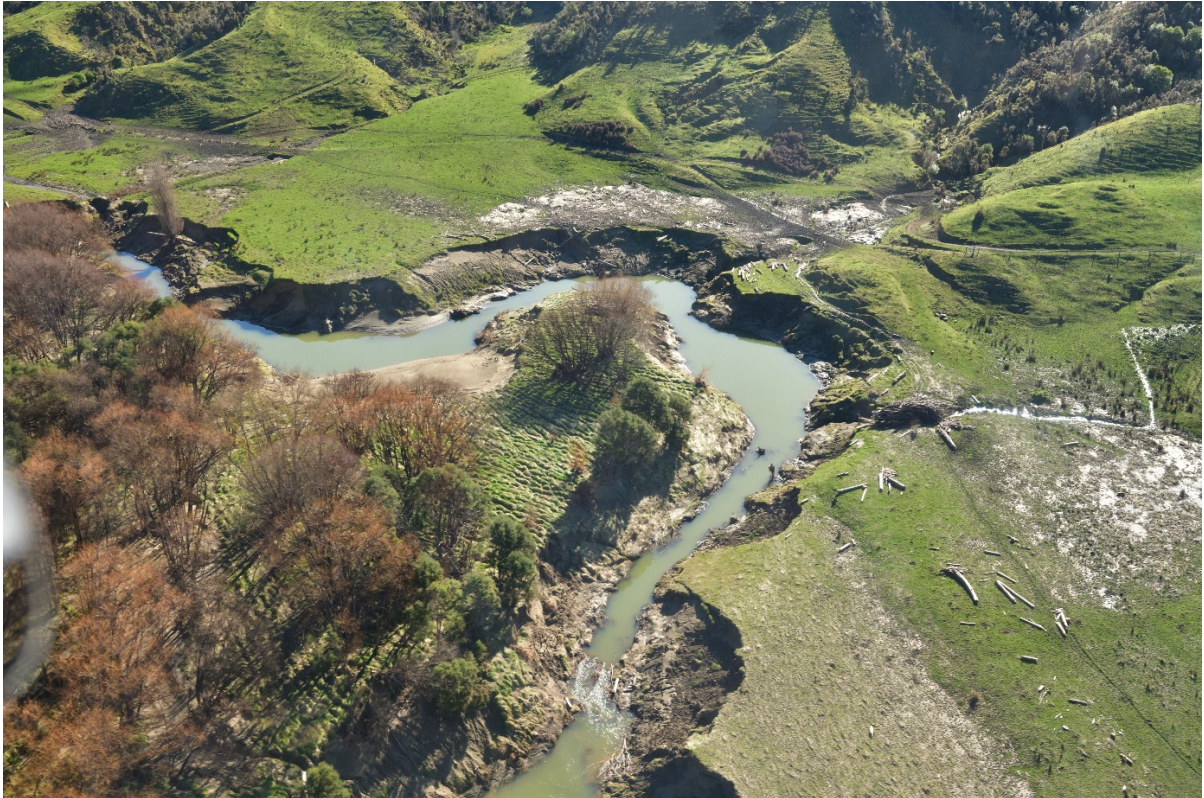
Figure 4.15 Bank erosion in the middle reaches of the Mangaheia River, downstream of Takapau Road/Wigan Bridge (D. Townsend, GNS Science; 11 July 2018; D85\_7970).

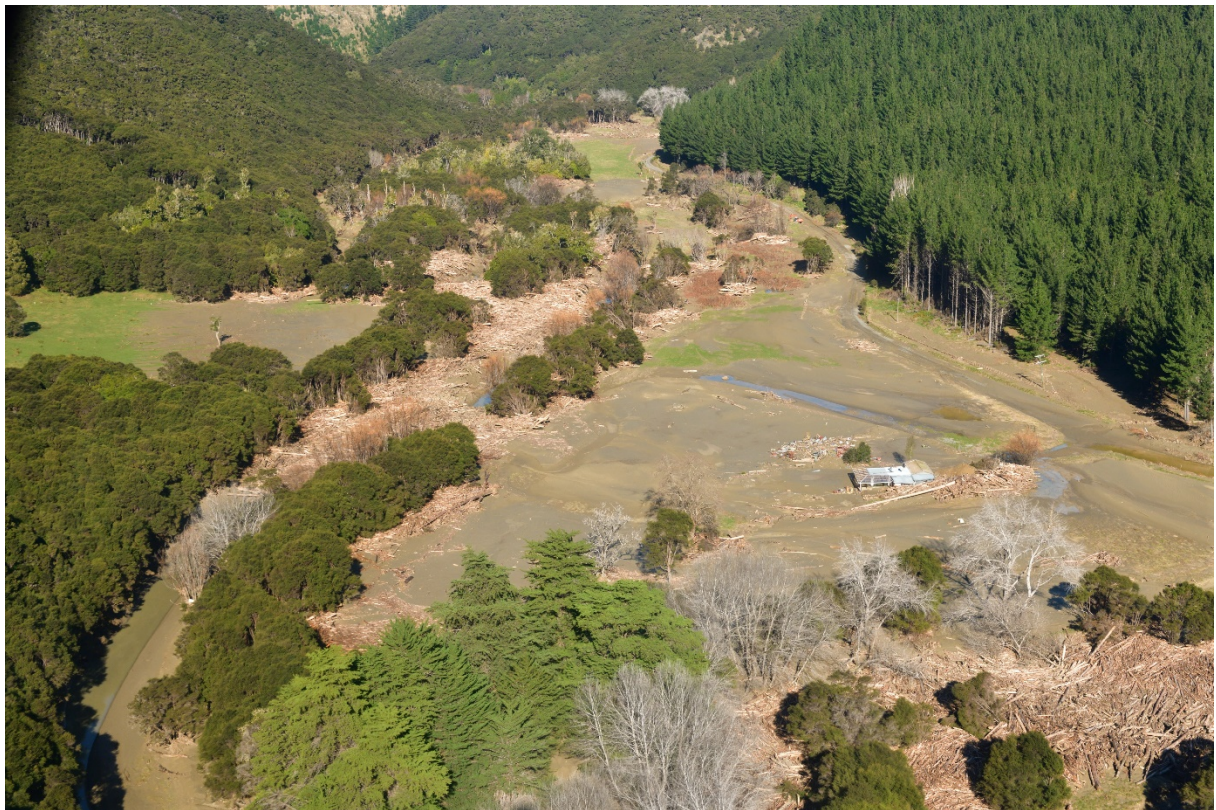
Figure 4.16 Woody debris deposited on the floodplain of the Mangatokerau River upstream of the Paroa Road Bridge showing Mangatokerau Road where 3 people were rescued during the Queen's Birthday Storm (D. Townsend, GNS Science; 11 July 2018; D85\_7913).

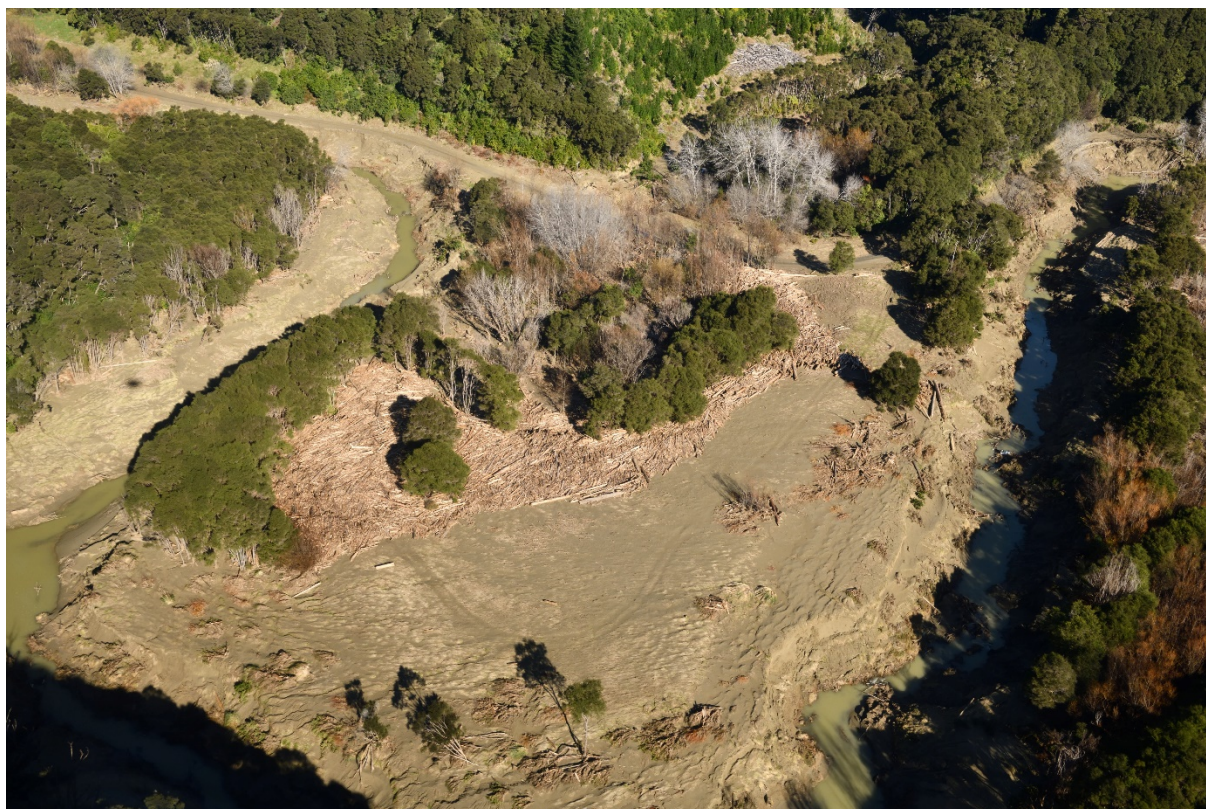
Figure 4.17 Woody debris deposited on the floodplain of the Mangatokerau River downstream from Mangatokerau Road (D. Townsend, GNS Science; 11 July 2018; D85\_7932).

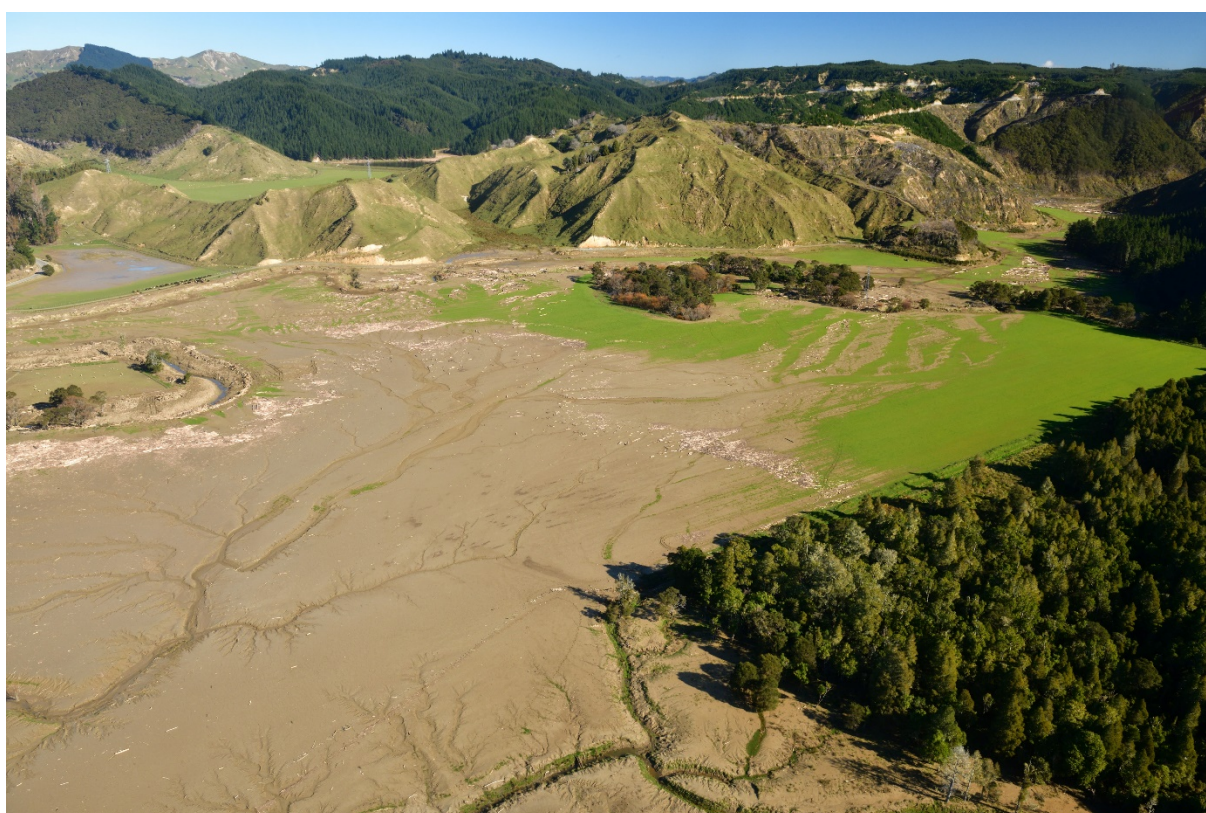
Figure 4.18 Sediment and woody debris deposited on the Tapaue Stream floodplain on Paroa Station (D. Townsend, GNS Science; 11 July 2018; D85\_7946).

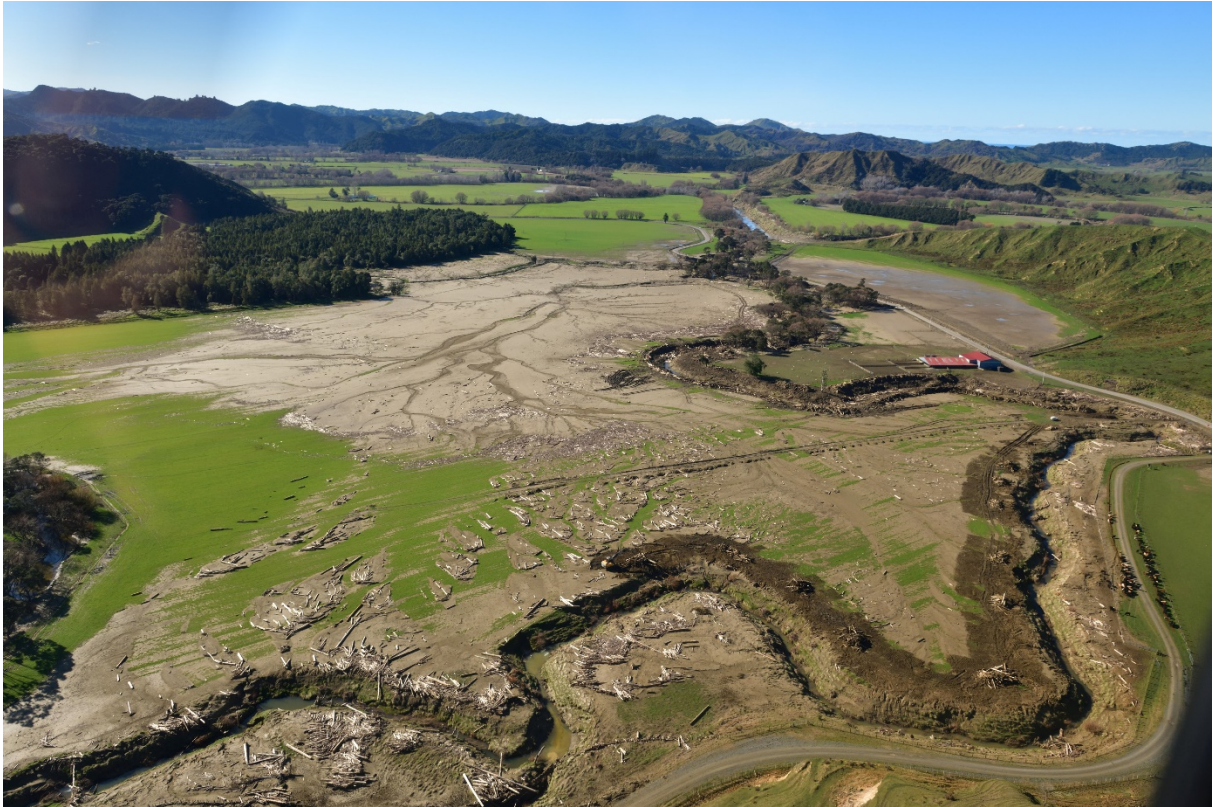
Figure 4.19 Sediment and woody debris deposited on the Tapuae Stream floodplain, Paroa Road (D. Townsend, GNS Science; 11 July 2018; D85\_7960).

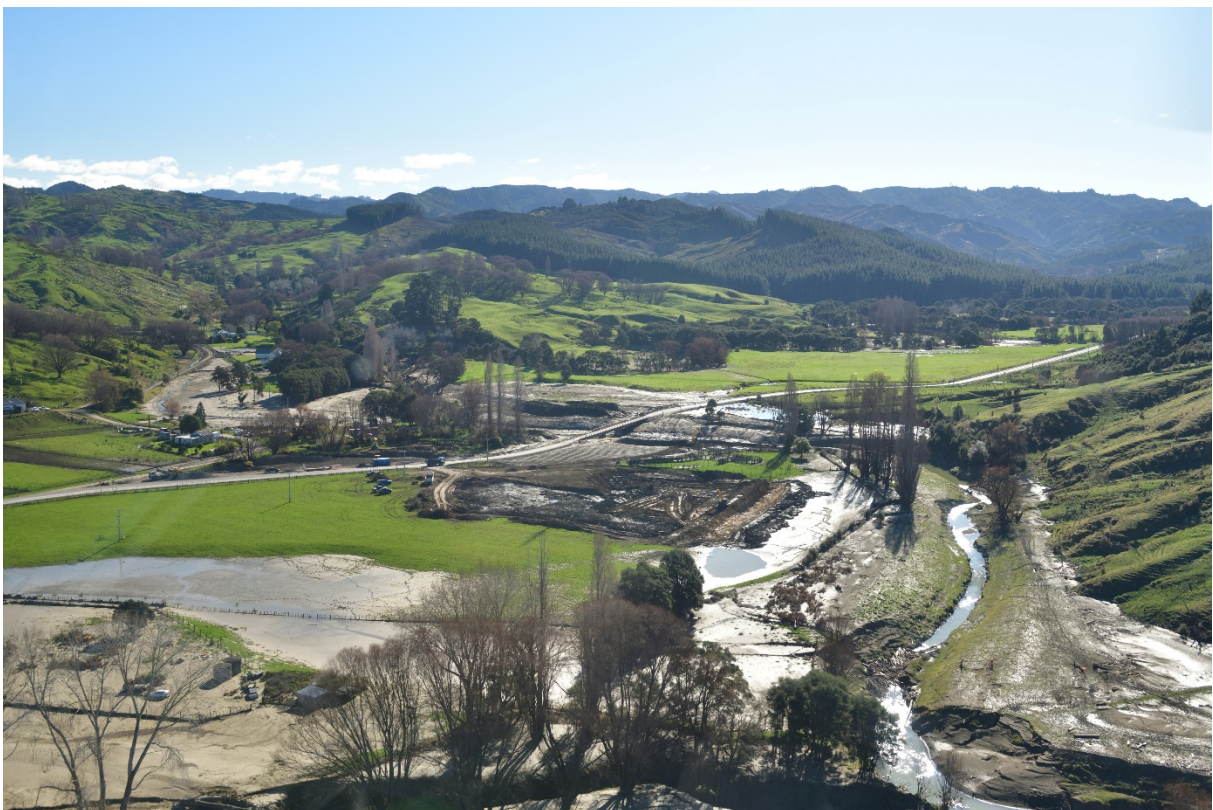
Figure 4.20 Sediment deposition on the floodplain of the Mangaheia River at Wigan Bridge (D. Townsend, GNS Science; 11 July 2018; D85\_7978).

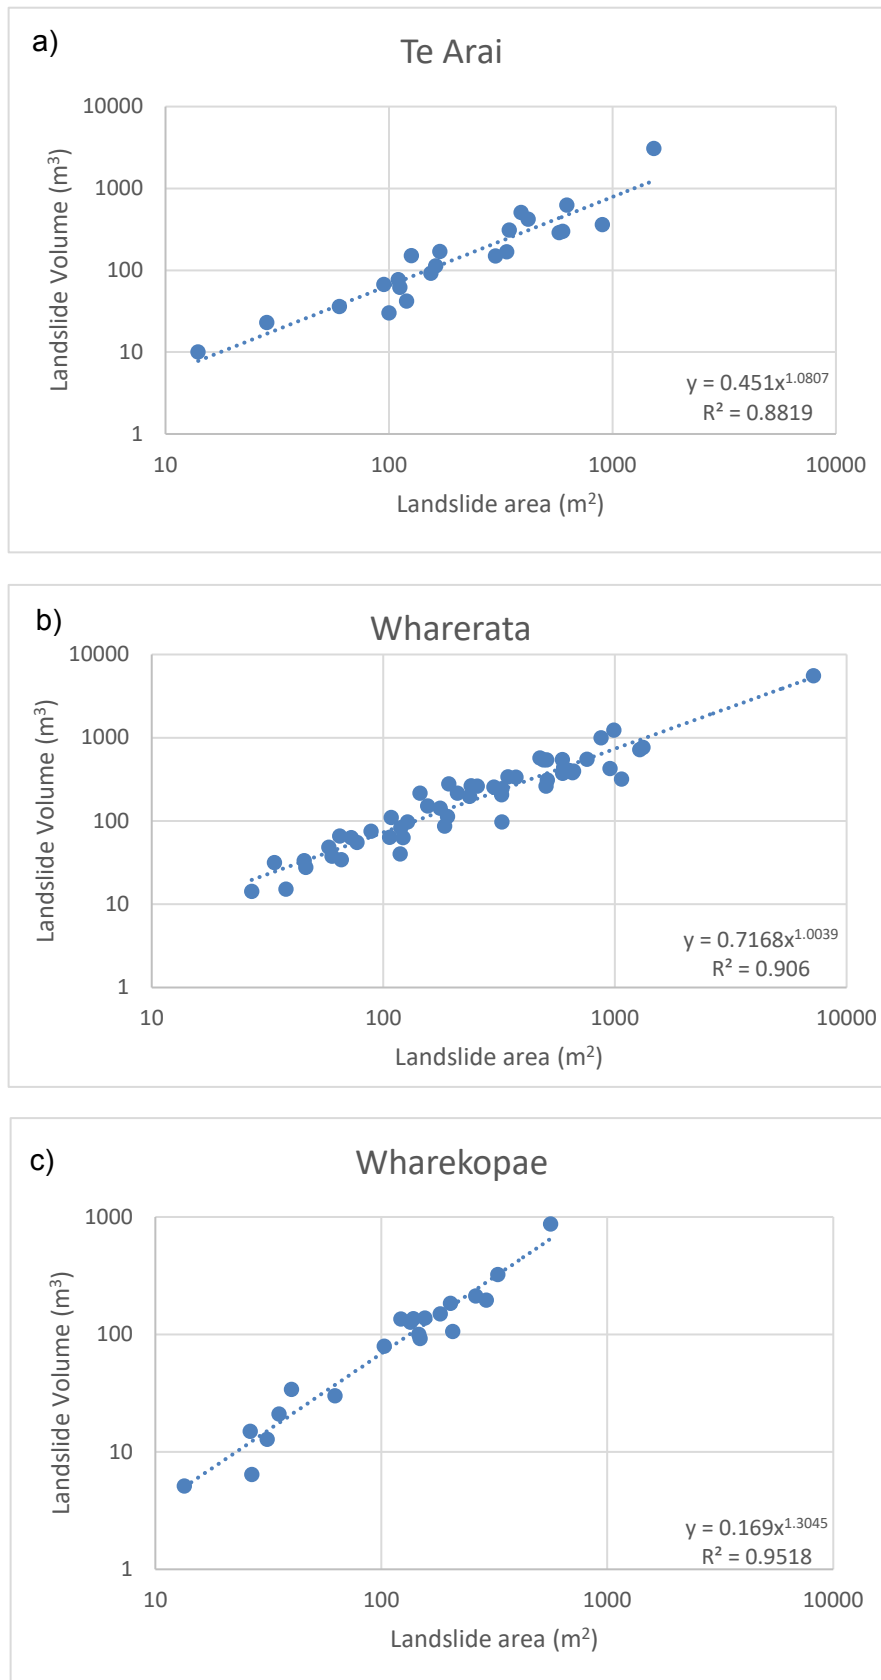
Figure 6.1 Area to volume scaling relationships for landslides in the Waipaoa catchment triggered by Cyclone Bola (1988) in the a) Te Arai, b) Wharerata and c) Wharekopae erosion terrains. Data from M. Page, Pers. Comm.

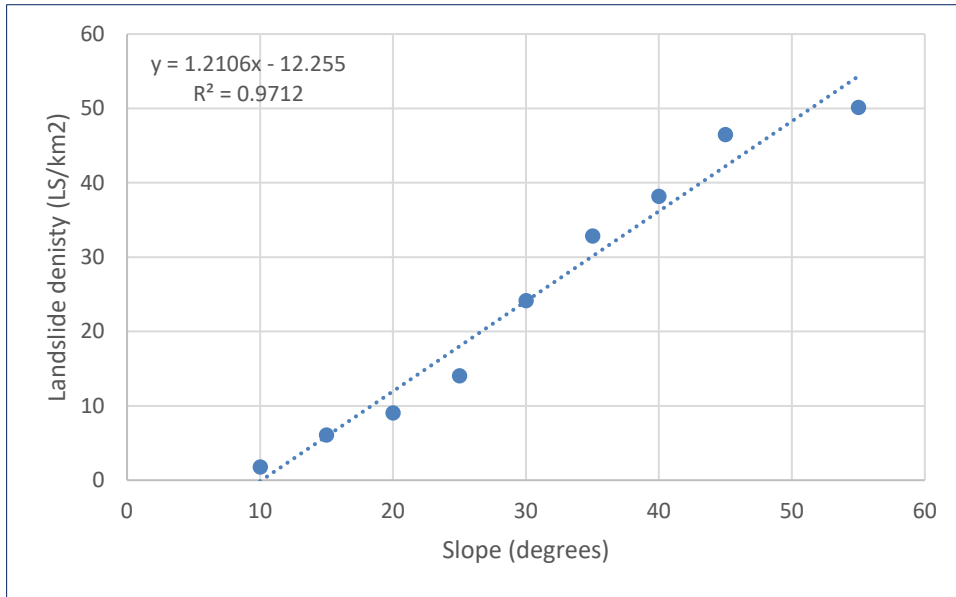
Figure 7.3 Relationship between slope and landslide density.

There is a direct correlation between slope and landslide density. Landslide density increased as a function of slope, so there were more landslides on steeper hillslopes (Figure 7.3).

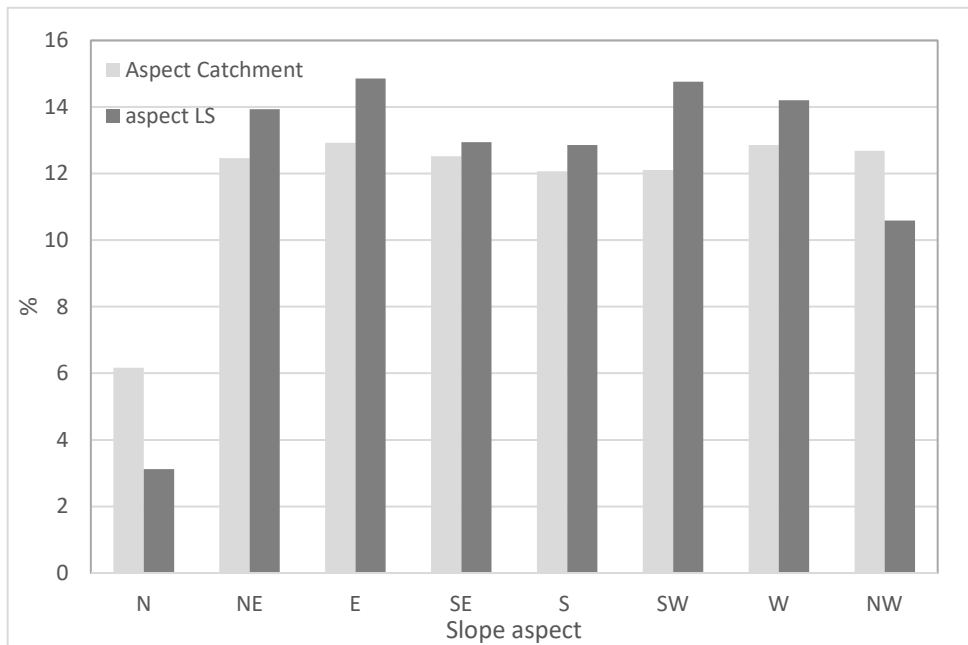
Figure 7.4 Slope aspect of hillslopes that landslides were triggered on compared to the aspect of hillslopes in the Uawa catchment

The slope aspect where landslides occurred generally reflects the distribution of slope aspect within the catchment (Figure 7.4). This shows slope aspect of the hillslopes had a strong influence on the location of landslides in the June 2018 rainstorms and the distribution of landslides was not influenced by the direction of the prevailing winds during the storm (from the north-west).
