REPORT NO. 3805

**ADVICE ON THE IMPACT OF FORESTRY SLASH  
ON KAIMOANA IN THE ŪAWA CATCHMENT –  
TOLAGA BAY**

OLIVIA JOHNSTON, DON MORRISEY AND JOHANN VOIGTLANDER

Prepared for Gisborne District Council  
Envirolink 2211-GSDC168 (CAWX2103)

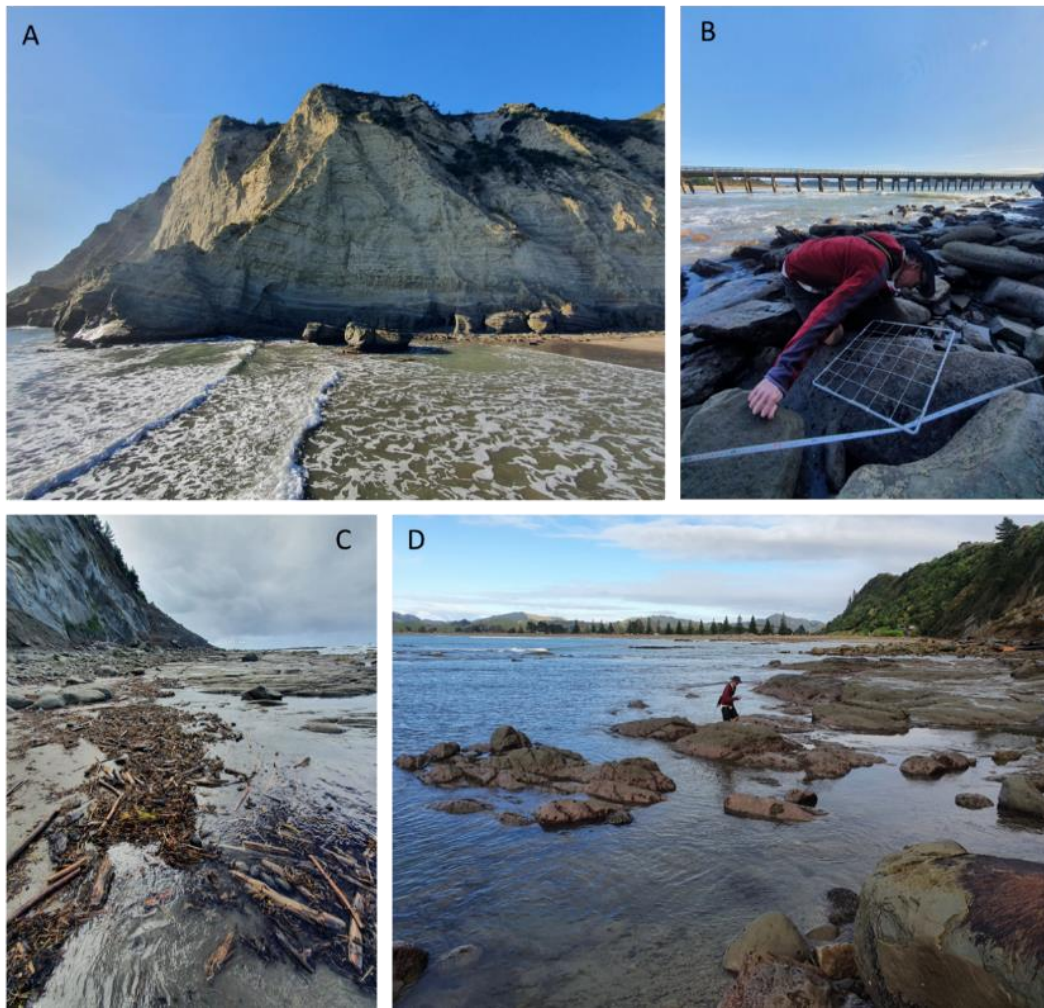
Figure 3. Representative images of the Tolaga Bay southern shoreline (A, B) and northern shoreline (C, D) intertidal survey areas.

- Most taxa were present in cracks and protected reef; exposed reef was either bare or only had biofilm present.
- Empty limpet attachment points and weathered pock marks, possibly indicating that limpets had been dislodged.

- Wood entrained among boulders, on sand and in cracks / holes in bedrock (notably on the northern shoreline).
- Shelly-sand and silt layers present on sessile organisms (notably on the northern shoreline).

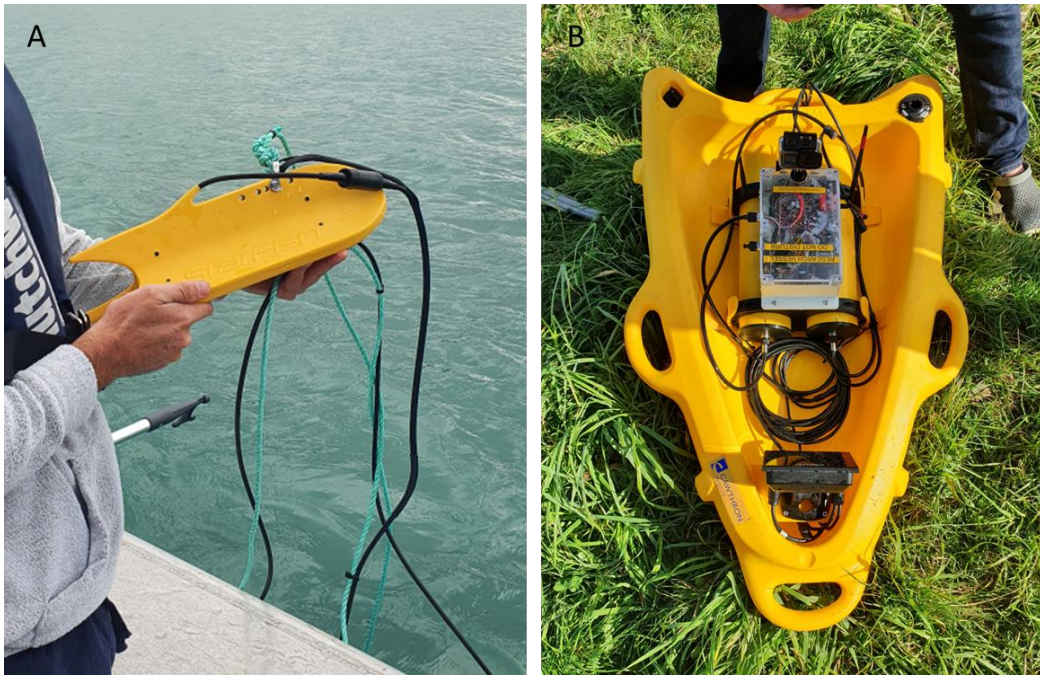
Figure 4. A) The towable sidescan system 'Blueprint Subsea StarFish' and B) the autonomous sidescan system.

The Blueprint Subsea StarFish 425F PRO<sup>9</sup> towable sidescan was used to map the subtidal seabed in Tolaga Bay (Figure 4a). The system featured a 450kHz CHIRP operation with up to a 200-m swath width (100 m port and 100 m starboard)—apart from Transect 1 (Figure 5), which was set to a 60 m swath width. The unit had a GPS antenna to allow geotagging of items observed. The length of the cable / tether was adjusted to change the height of the sidescan above the seabed to improve and maintain imaging quality. Approximately 4 m of tether was out for most of the survey, and it was submerged to approximately 1.5 m (although was readjusted during some turns). The topside GPS unit was a GlobalSat BU-353-S4, which is typically accurate to 2.5 m (in worst case conditions it is accurate to < 15 m). There was no option in the software to offset where the GPS unit was relative to the location of the sidescan. However, given the accuracy of the GPS unit and the relatively short length of tether used, it is unlikely to have much of an impact on positioning accuracy.
