# Mangahauini Geomorphology and Tokomaru Bay legacy landfill

## Envirolink Report Gisborne District Council 2216-GSDC169

Prof. Ian Fuller

August 2022

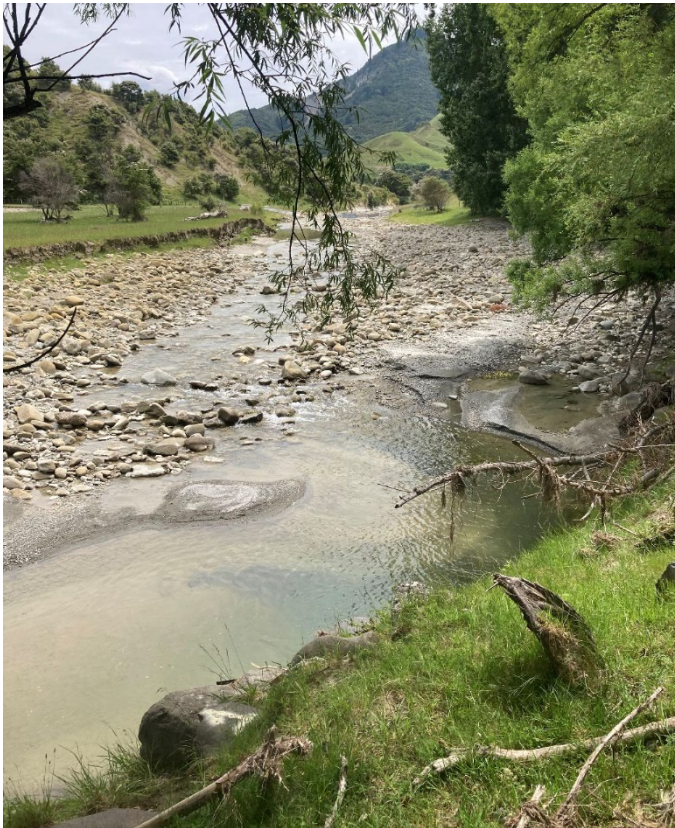
**Figure 2.** Sandstone cobbles and shale-dominated fines<sup>1</sup> in the lower Mangahauini, looking upstream from reinforced bank at northern edge of landfill site. The bottom of the pool in the foreground is notably soft, filled with fines, in contrast with the cobbly substrate of the higher bar and channel platform in the middle distance.

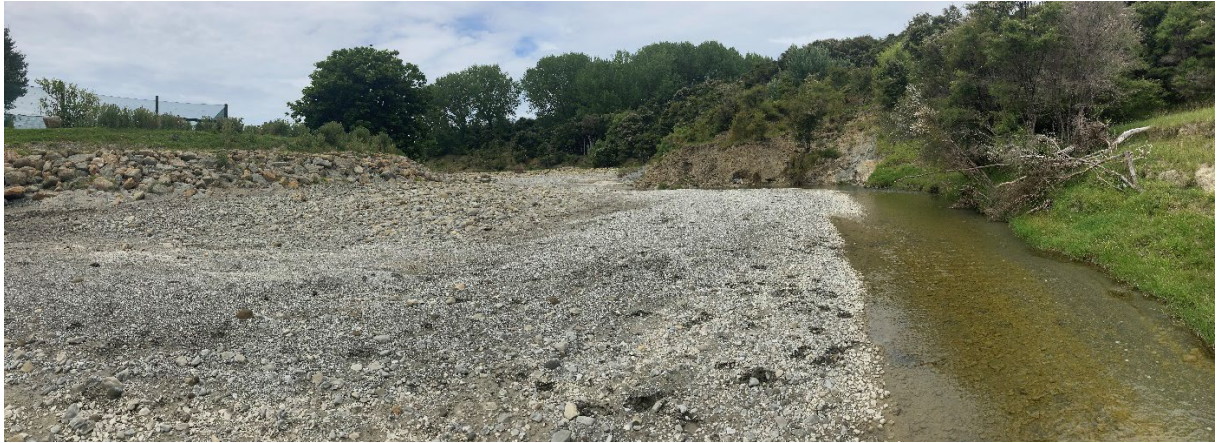
**Figure 3.** Finer-grained bedload, with lack of surface structuring immediately upstream of the landfill (rock revetment to the left of the image). Note protruding earthflow lobe in middle distance.

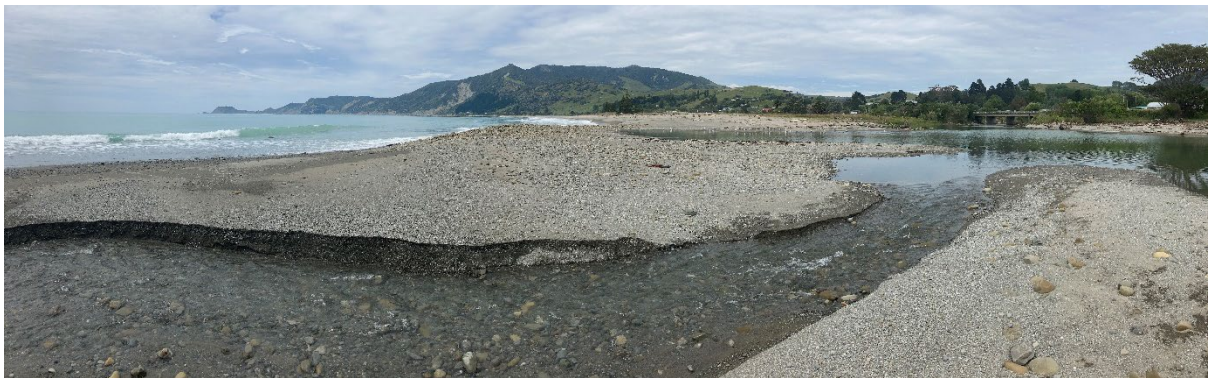
**Figure 4.** Mangahauini river mouth: gravel and cobble-sized bedload visible in the channel where it crosses the beach.

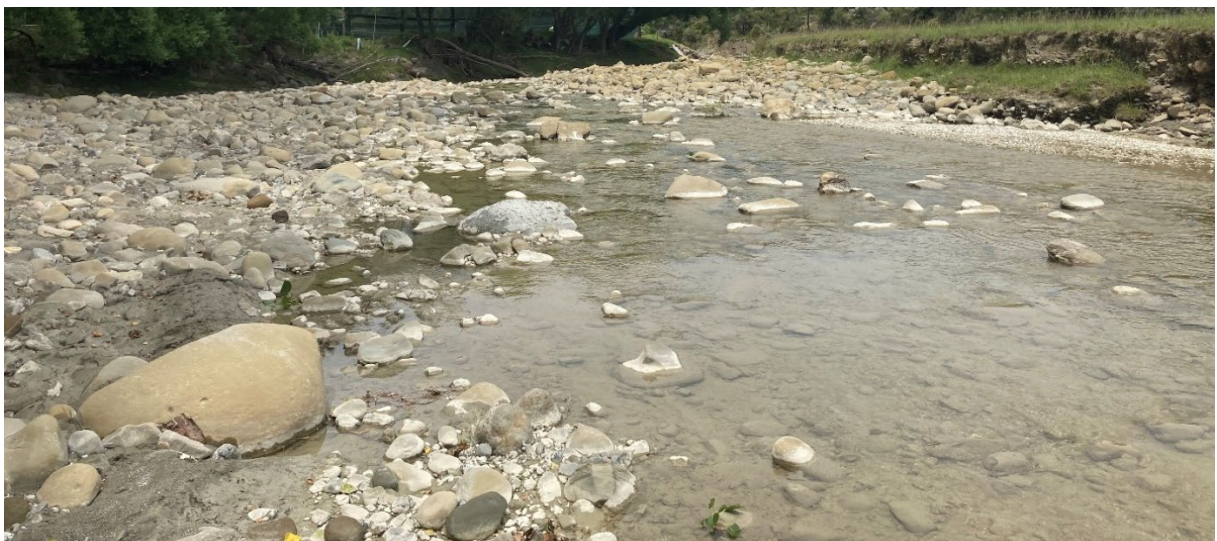
**Figure 5.** Bed sediment in the lower Mangahauini: photo looking downstream, located ~100 m upstream from the landfill site. Note the presence of several sandstone boulders, as well as a high proportion of fines (sand and silt), which also mantle the cobbles in the wetted channel. Boulders

likely to be sourced from localised slope sources and / or nearby short, steep tributaries draining steep sandstone terrain in the catchment.

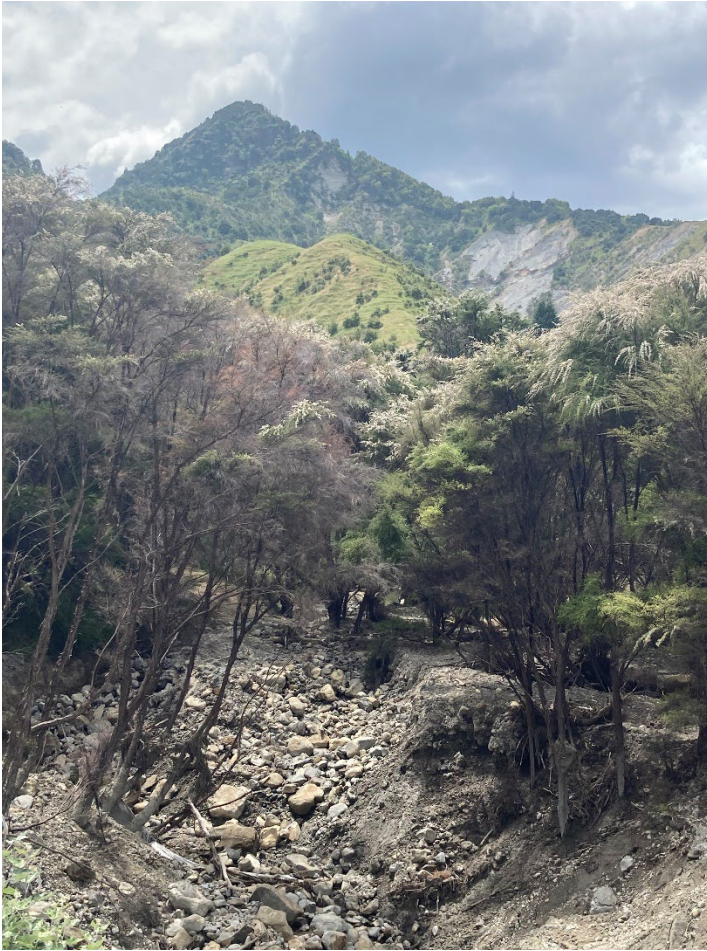
**Figure 6.** Mākarangū Stream, principal left-bank tributary. Catchment relief rises to 490 m in under 2 km. Slope erosion visible is on upper slopes below trees on ridgeline, exposing underlying Tolaga Group mudstones. Debris flood deposits (boulders, cobbles, fines) visible in the channel in the foreground, indicating some sandstones are present in the catchment. Sediment load in this tributary had blocked the culvert underneath SH 35, forcing flow over the road and into Tokomaru Bay township during the June 2021 storm (Cave, 2021) (photo 30 November 2021, ICF).

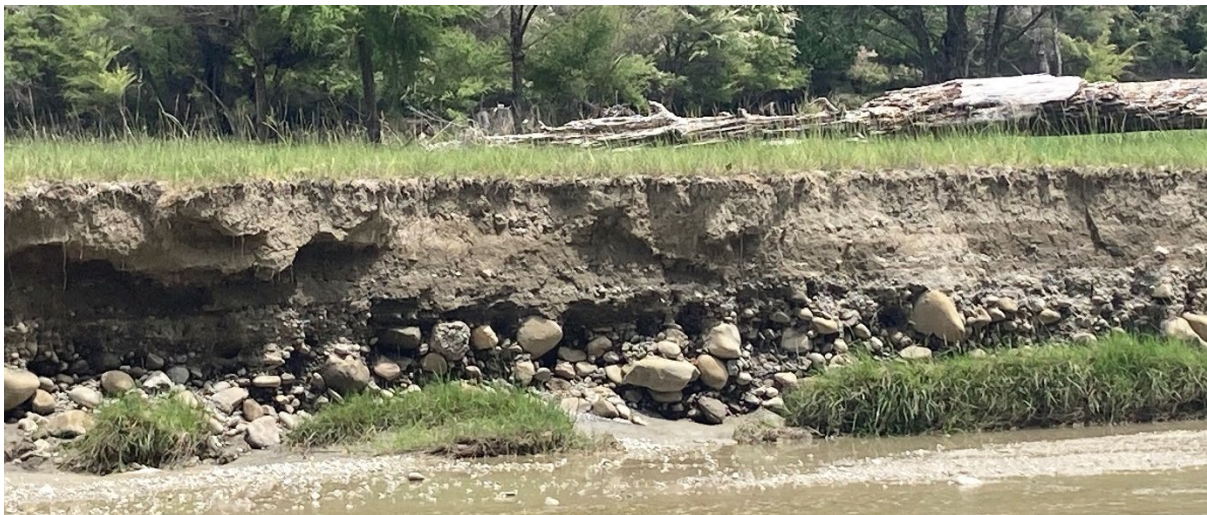
Much of the Mangahauini valley floor is narrow, significantly confined by valley sides and characterised by pockets of floodplain alluvium where local valley widening permits sediment storage (cf. Figure 1). Floodplain sediments are coarse grained, with cobbles and boulders overlain by sands, silts and gravels (Figure 8).

**Figure 8.** Floodplain sediments, lower Mangahauini, looking across to the true right (flow right to left in photo) in the vicinity of Figure 5. Very coarse material (cobbles and boulders) is overlain by predominantly sands and silts, with some gravel clasts evident in these finer alluvial deposits. The floodplain at this location was part of the active channel until at least 1977 (see historic maps below), indicating rapid rates of floodplain formation and sediment deposition (bank face is approximately 1.5-2 m high).

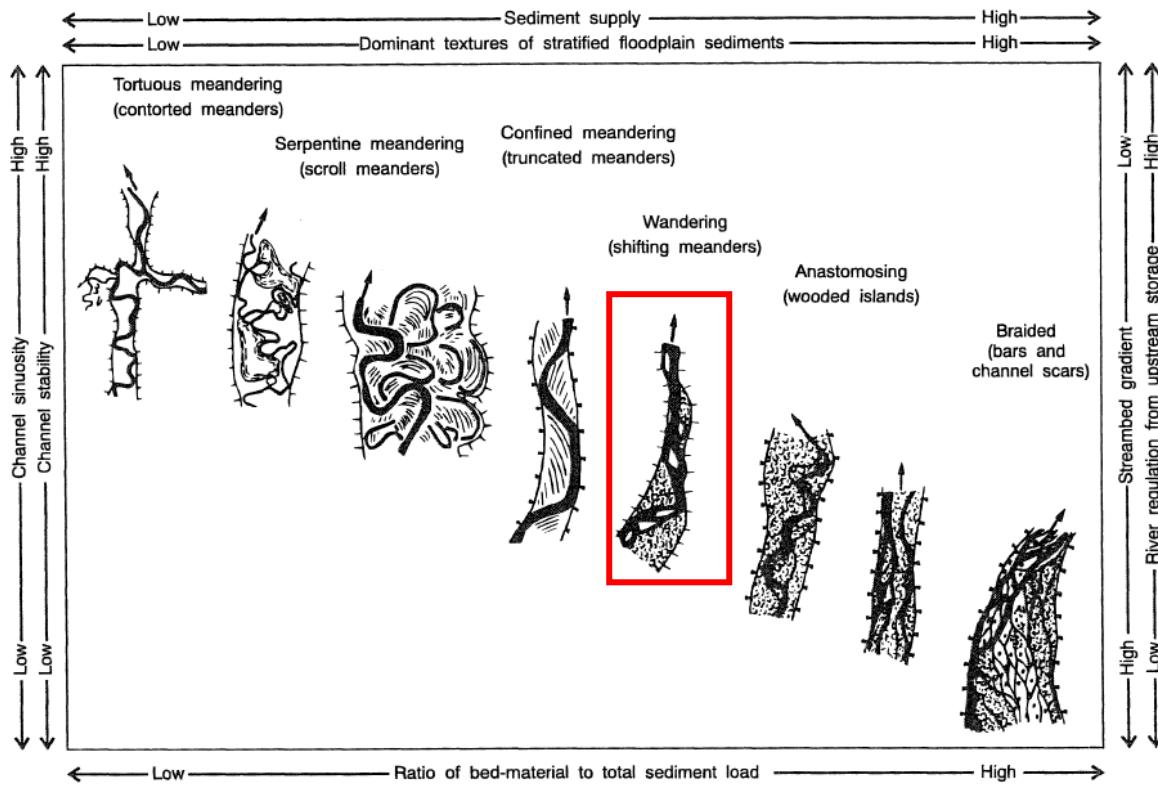
**Figure 11.** Continuum of river channel types and controlling variables, after Mosley (1992). Mangahauini fits the wandering channel type in this scheme (red box).

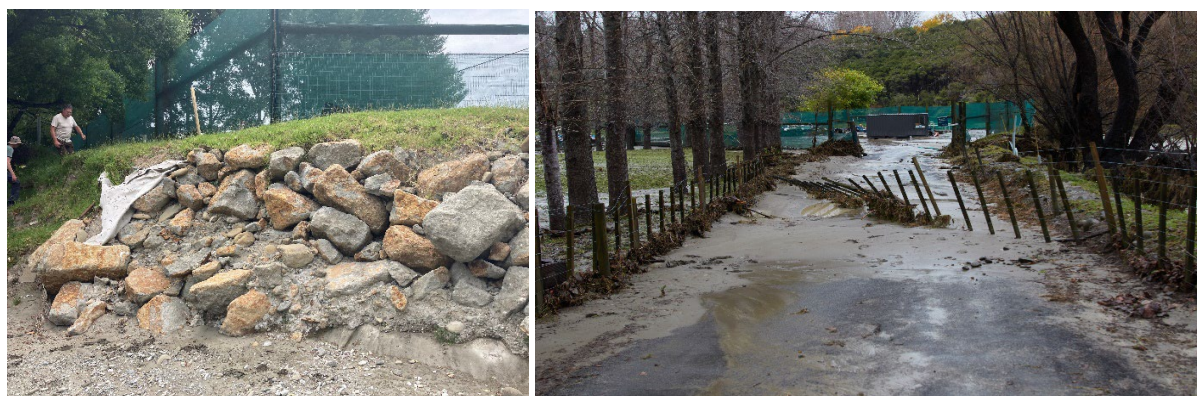
The dynamics and behaviour of the Mangahauini River outlined in Section 2 pose a significant threat to the Tokomaru Bay landfill site located in the river corridor. Construction of rock revetment on the upstream boundary of the landfill is intended to prevent erosion of this left-bank. However, alignment of the channel at this location directs the full power of flow into this bank, and some damage was sustained during the June 2021 storm (Figure 19). In addition, floodwaters washed over the landfill site, recruiting surficial waste into the river and down to the coast (Cave, 2021). Prior to the June 2021 storm, an assessment report on the Tokomaru Bay legacy landfill (GDC 28 May 2021) identified erosion of the landfill and discharge of waste to the environment.

**Figure 19.** Left: damage to rock revetment protecting landfill site, photo: 30 November 2021 (ICF); right: washover of approach road to landfill site, photo: 20 June 2021 (Murry Cave).

Discharge in the Mangahauini River is not gauged, so the quantum of flow contributing to the damage in Figure 19 and flood spread in Figures 17 and 18 is not known. However, assessment and analysis of rainfall in the catchment during the event by Cave (2021) suggests that the local 12-hour rainfall accumulation of 160 mm recorded informally in Tokomaru Bay had a recurrence interval of 13.5 yr. This ARI statistic could be used tentatively to inform the likely ARI for flow in the Mangahauini during this event, although it is difficult to extrapolate from a single rainfall statistic to discharge, but if this is approximately correct, it suggests that the Mangahauini flood was not particularly extreme. The geomorphic evidence would certainly corroborate this interpretation, because erosion of the channel margin was generally localised: floodplains were inundated, but not eroded. This contrasts with the geomorphic impacts of much larger ARI floods that have been described in scientific literature, where channel changes in rivers of similar nature to the Mangahauini (steep, coarse-grained, wandering) have been significant, even catastrophic (Fuller, 2008, Milan, 2012, Buraas et al., 2014, Surian et al., 2016, Scorpio et al., 2018). The inference for the Mangahauini and the risk it poses to the landfill is that a small-to-moderate flood as occurred in June 2021 is sufficient to damage the site and recruit waste into the river system. The report on the landfill (GDC May 2021) corroborates this interpretation: small floods erode the landfill site. When a larger flood occurs, the frequency of which is likely to increase with climate change projections, far more significant damage and distribution of waste to the river and adjacent coast can be expected. Erosion of the Fox Glacier landfill during a flood

The risks posed to the environment by the location of the landfill are not confined to the waste and contaminants contained therein. Rock revetment at the landfill deflects flow essentially at a right-angle towards the true right of the river corridor. This deflection means flow is directed to the base of the earthflow on that slope. Erosion of the earthflow toe by the river over time (which occurs during flood events) continues to debuttreass this slope, facilitating further failure and delivery of material into the river corridor, pushing flow back towards the landfill. It is perhaps notable that when the approach of the river around this bend in 1945 was more oblique, there was no evidence for fresh earthflow deposits in the river corridor and apparently less evidence of activity on the slope, at least compared with 1966 (cf Figures 12 and 13). The presence of the landfill, which requires flow to be directed into the toe of the earthflow will continue to propagate slope instability and delivery of this sediment to the channel. Earthflow deposits are fine grained sands and silts (Figure 7), which likely further degrade water quality in the Mangahauini River, as well as increasing erosion risk to the downstream part of the landfill site, which was acknowledged by GDC (2021).

Improving site flood defences as suggested by Options One and Two in GDC (2021) could be used as a short-term measure to shore-up protection, but these approaches only realistically defend against small-medium size floods and have a limited lifespan.

I suggest that defensive options are simply not realistic in this location. The alternative is landfill removal, discussed below.

GDC (2021) reports removal of the landfill as a viable option (Option Three), noting the river will gain more width and reduce pressure on the banks, reducing the rate of erosion, with which I agree. It is also noted that removal of the landfill will also remove any further threat of contamination and leachate being discharged into the Mangahauini River and the Pacific Ocean, with which I also agree.
