# Assessment of the health and the restoration potential of the Putere Lakes, Hawkes Bay

Report prepared for the Hawkes Bay Regional Council: August 2022

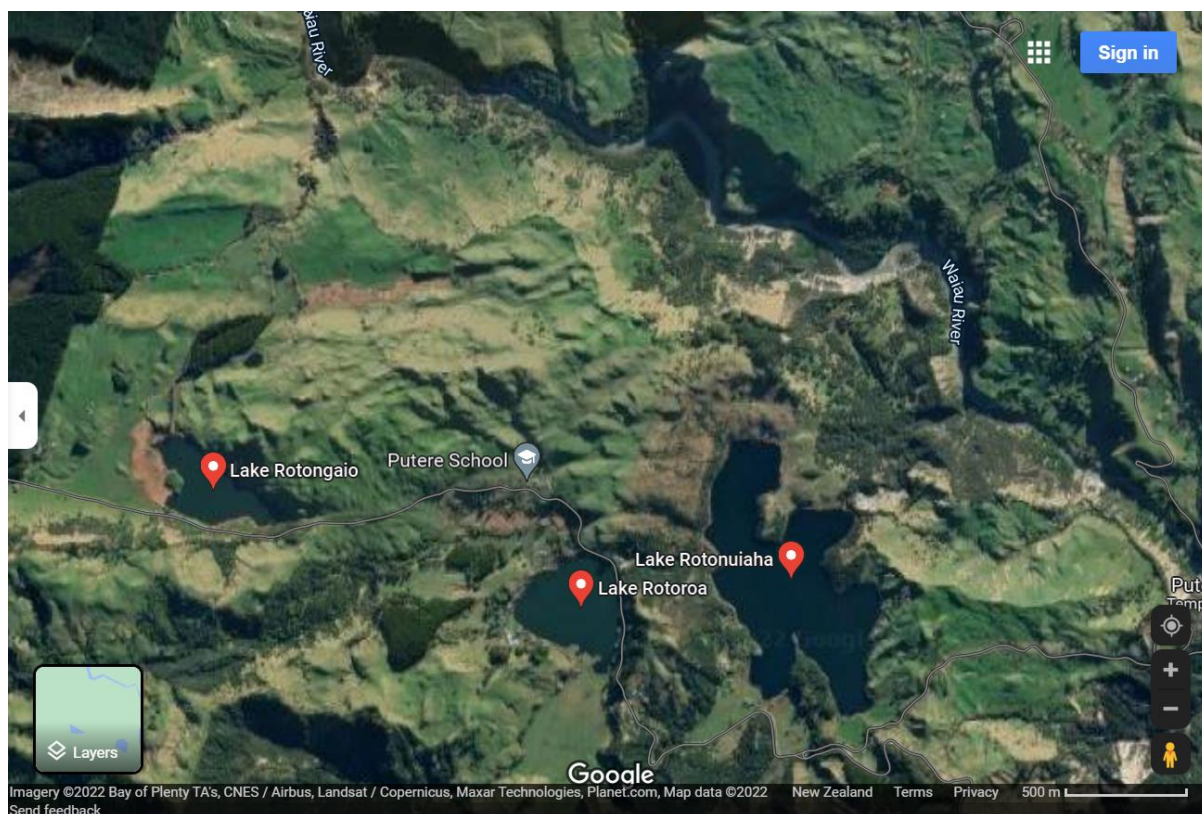
**Figure 2.** Satellite image of the Putere Lakes showing typical land cover in the region.

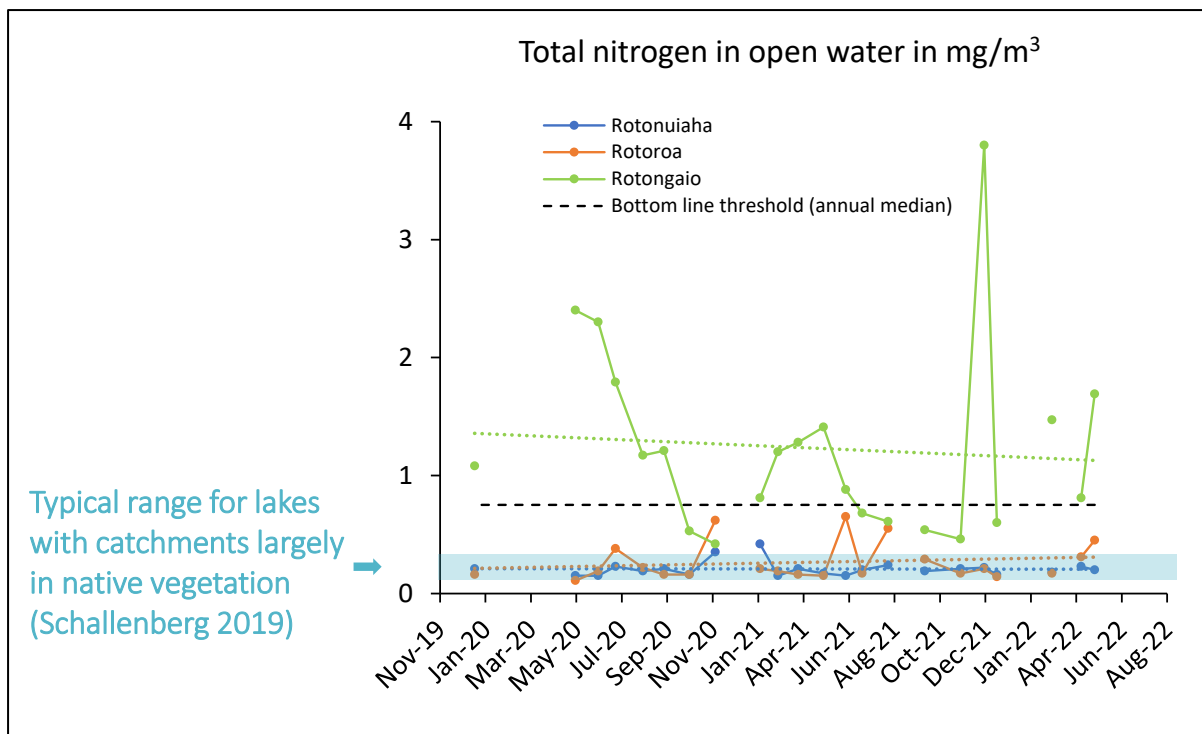
**Figure 6.** Time series of total nitrogen concentrations. The horizontal dashed line is the national bottom line for annual median total nitrogen concentration from the National Objectives Framework. Lakes that exceed the national bottom line must be managed to undergo improvement. The shaded blue area indicates the expected range for unimpacted shallow lakes. The dotted coloured lines are the linear trends over time. None of these are statistically significant.

Similar patterns were observed for total phosphorus and total nitrogen (Figs 5 and 6), where Rotongaio often exceeded the national bottom lines, while Rotoroa and Rotonuihā rarely exceeded the bottom line for total phosphorus and never exceeded the bottom line for total nitrogen. The water clarity of the lakes, as measured by the Secchi depth, was higher in Rotoroa and Rotonuihā (averaging approximately 2.5 m) than in Rotongaio (averaging approximately 1.5 m)(Fig. 7). The data time series for these water quality variables were not extensive enough to be able to show any statistically significant trends over time.

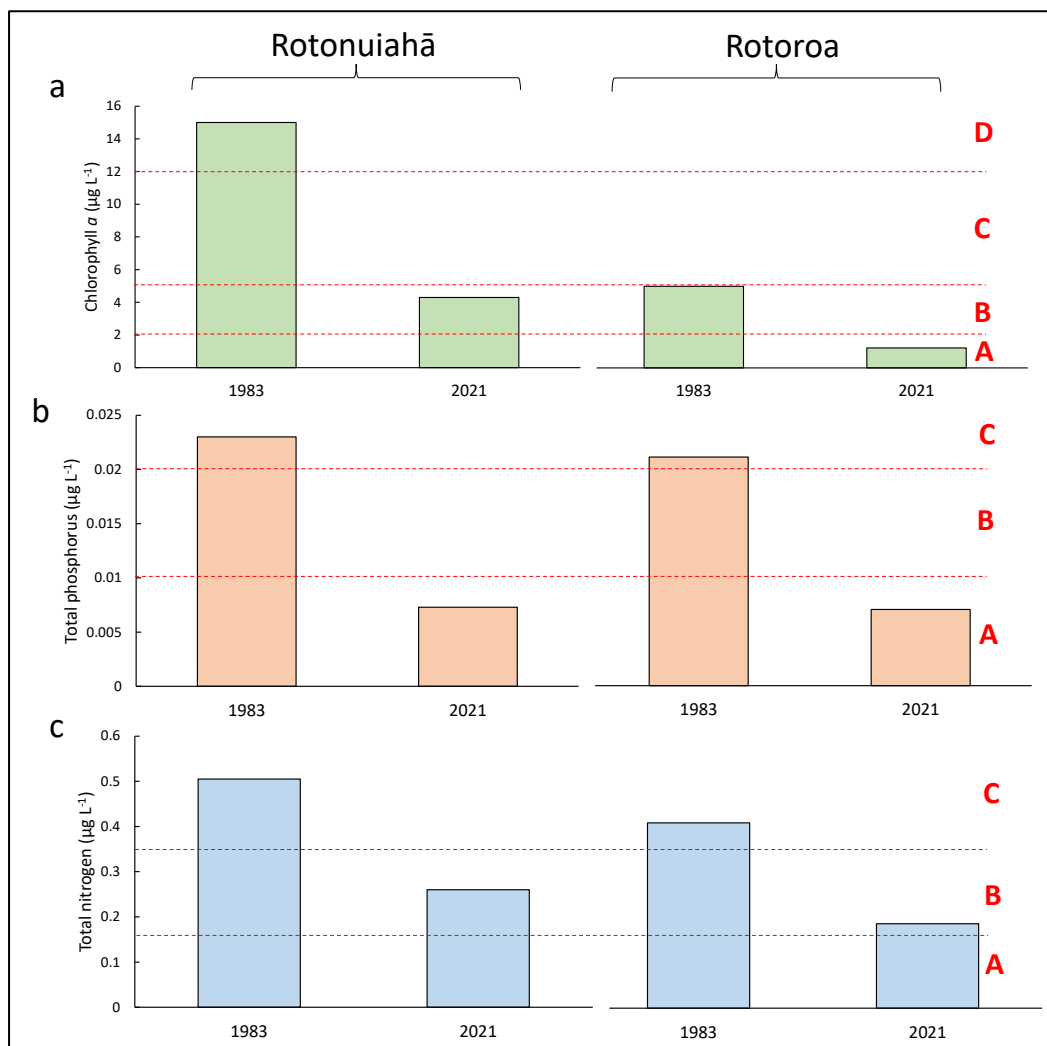
**Figure 8.** Comparison of summer water quality of Rotonuihā and Rotoroa between 1983 and 2021. The lines and letters in red indicate the water quality bands from the National Objectives Framework (MfE 2020a). These bands are based on the annual median concentrations, and so the lake data are only suggestive of placement in NOF bands. Band A is generally considered to be excellent, band B is good, band C is fair, and band D is unacceptable.

The study carried out on Rotonuihā and Rotoroa in the summer of 1983 by Howard-Williams et al. (1983) allows the comparison of summer concentrations of chlorophyll *a*, total phosphorus, and total nitrogen in the surface waters of the lakes between 1983 and 2021 (Figure 8).

The data indicate that the water quality of both lakes has improved markedly since 1983, as measured using all three water quality attributes.

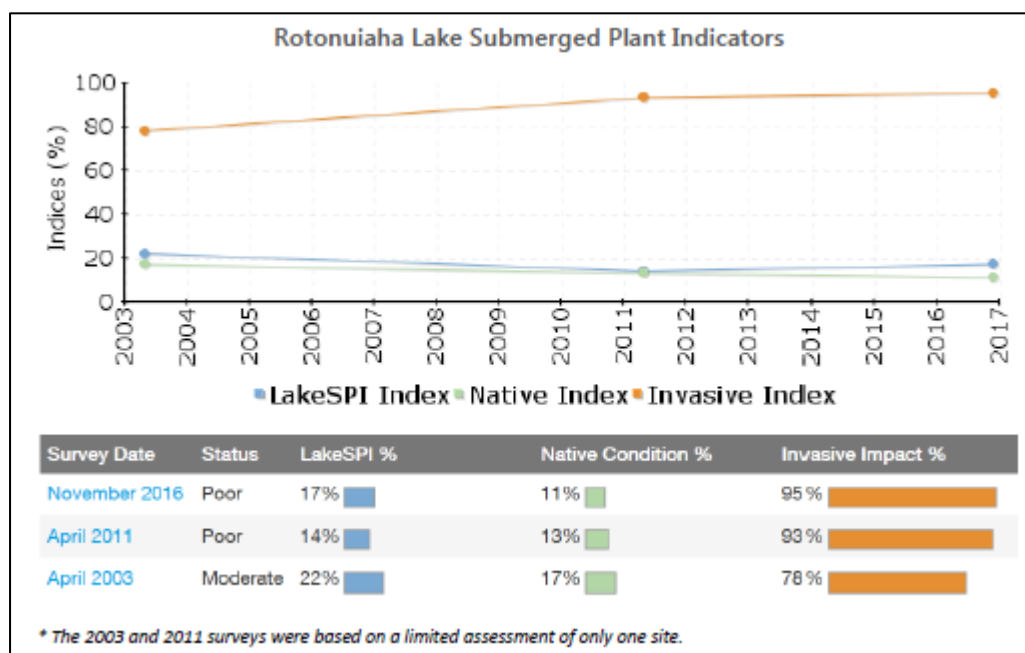
**Figure 9.** Trends in LakeSPI indicators of Rotonuihā from Burton (2017).

Burton (2017) also summarised the trends in the macrophyte health of the lakes by comparing their current condition to their conditions during previous investigations and assessments of macrophytes (Figs 9 to 11).

It's apparent from these assessments that LakeSPI indicators in Rotonuihā and Rotoroa have been relatively stable since 2003 with very high invasive impact scores since 2011, whereas the invasive impact score for Rotongaio declined markedly from 2003 to 2016 with no sign of recovery of the native macrophytes. Burton's (2017) concern that Rotongaio appeared to be on a trajectory towards
