Review of sand extraction impacts for Miller's Bank, Kaipara Harbour

Executive Summary

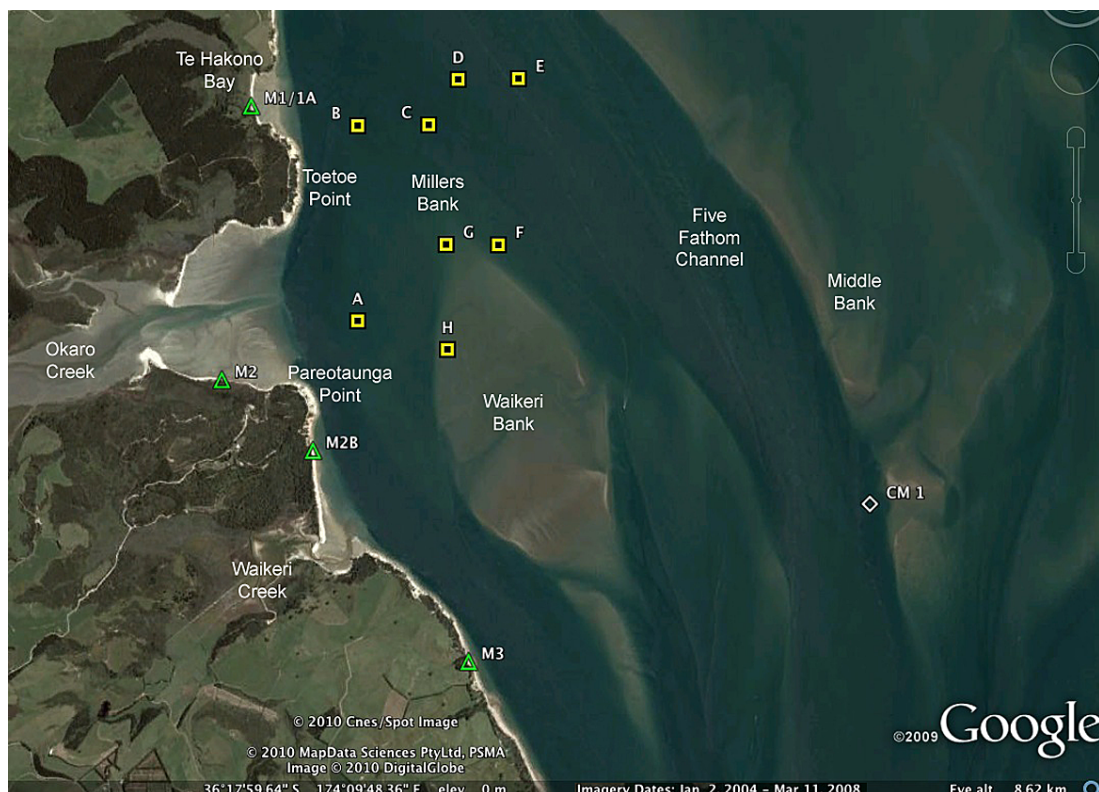
Figure 1 – Location map showing the positions of the consent boundaries (A-H), shore profiling sites (M1-3), and the InterOcean S4ADW measurement station (CM 1).

As part of the consent conditions, the consent holder has undertaken monitoring at four shore profile locations – M1, M1A, M2, M2B and M3 (Figure 1) – and along the coast to assess shoreline changes. An annual bathymetric survey of the extraction area including a 100 m marginal buffer, and the channel to the west, is also required.

The most recent report indicates that the total volume of beach sediment is increasing at the three sites (M1/1A, M2 and M2B) established to monitor areas that could be directly affected by sand extraction, and decreasing at the control site (M3) further south (Figure 1).

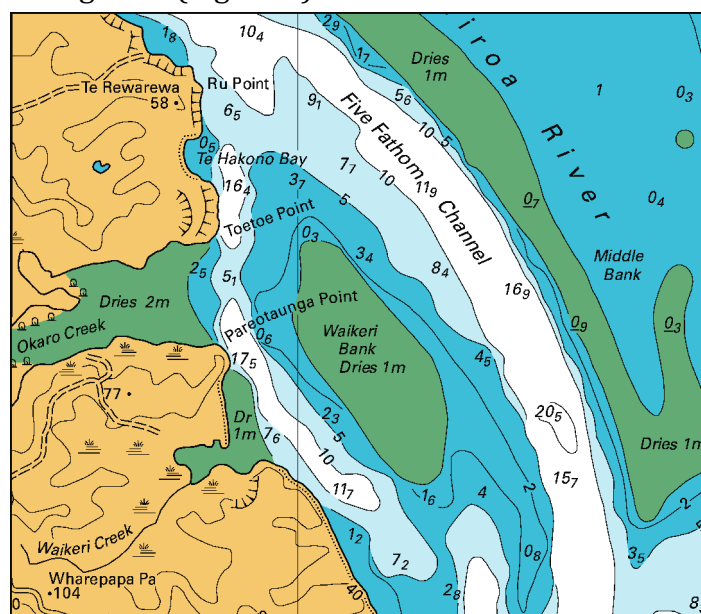
Figure 2 – Enlargement of Waikeri Bank region of Chart 4265 (2010 edition) based on the 1993 RNZN hydrographic survey.

chart NZ4265 (Figure 2), approximately covering the area defined by the 2 m contour. The channel on the western side of the bank appears deeper, particularly at the southern end, than the more recent chart.

A 1923 chart incorporating a geological map is presented in the Kaipara Harbour Sediments report (Reeve et al, 2008). This chart shows the intertidal Waikeri Bank as consisting of 5 separate shoals (Figure 3) and suggests that the northern end of the western channel has narrowed and shoaled. By the time of the 1993 hydrographic survey, which is the basis of the current chart for this region, the intertidal Waikeri Bank had reformed as a single shoal (Figure 2).

Google Earth images (Figures 1 and 4) taken on 2 January 2004 show the development of a new shoal at the southern end of Waikeri Bank as reported by Mr Forest. This extension involves shallowing of the sub-tidal ridge extending south from the Waikeri Bank in the 1993 hydrographic survey (Figure 2).

The proposed boundaries overlie the shoal area at the northern end of Waikeri Bank, and the deep channel passing Toetoe Point (Figure 2). As noted in the previous section, there is likely to be sufficient sediment accumulating in this area to replenish the volumes being extracted.

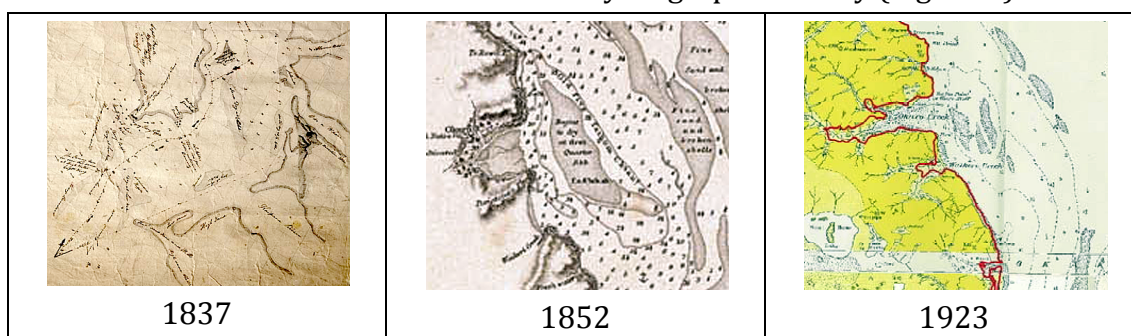
Figure 3 – Enlargements of charts of Kaipara Harbour from 1837, 1852, and 1923. See text for sources of the images.

There are few surveys of the region prior to the commencement of sand extraction. The earliest located were partial charts of the channels at the entrance of the Kaipara Harbour drawn in 1836 by Capt Wing and in 1837 by Mr Turner, accessible from the Te Ara online encyclopaedia article on New Zealand shipwrecks (<http://www.teara.govt.nz/en/shipwrecks/2>). The 1837 Turner chart shows a shoal area consistent with Waikeri Bank and navigable channels on either side leading towards Dargaville (Figure 3).

The 1852 chart shows Waikeri Bank extending further southeast (Figure 3) than evident in the most recent hydrographic

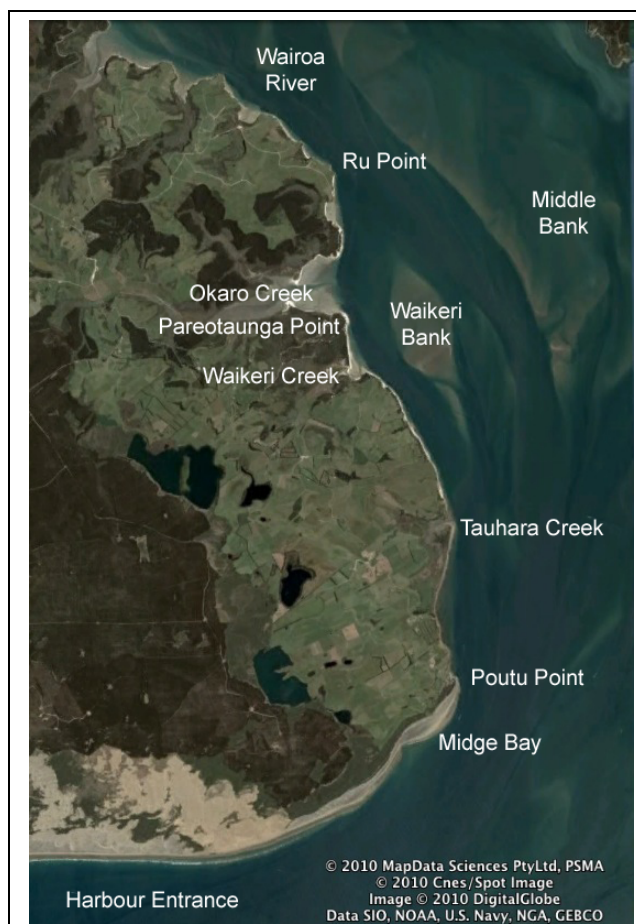
Figure 4 – Google Earth image of North Kaipara Head and channels connecting to the Wairoa River.

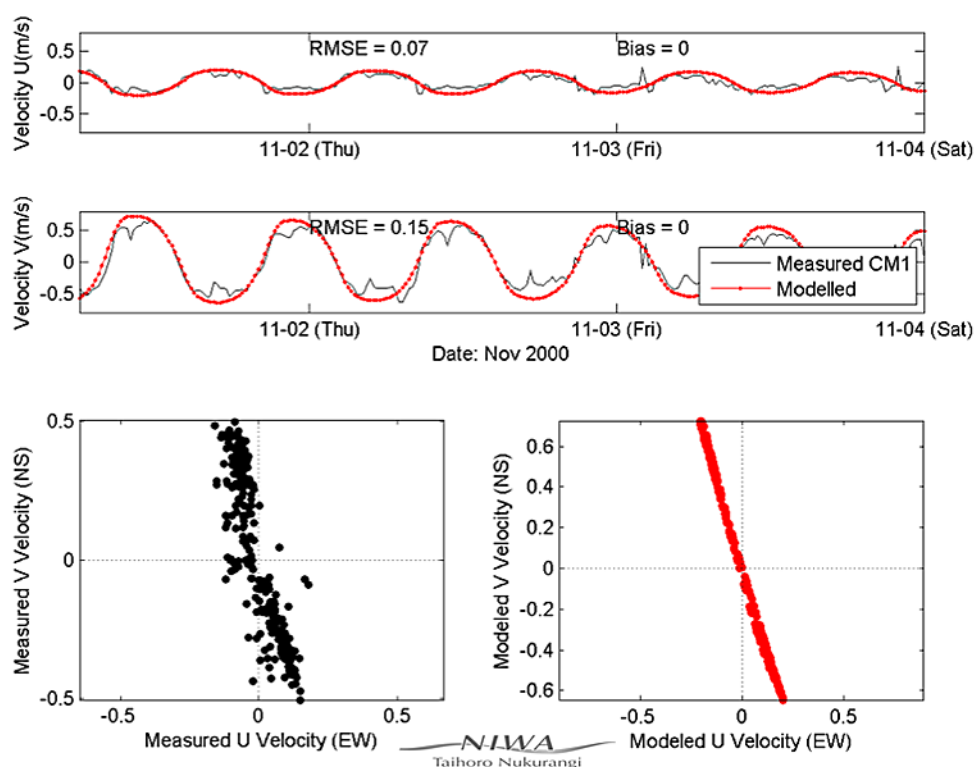
Figure 5 – Measured and modelled current velocity data for site CM 1 (Stephens et al, 2009). These data indicate slight ebb dominance for this location in Five Fathom Channel.

From the numerical modelling undertaken by Stephens et al (2009), some of the sand transported around the flood tidal delta reaches the Waikeri Bank, but it is difficult to assess the volume involved. A short time series of current measurements is available for the Five Fathom Channel at site CM 1 (Figure 5). These data indicate that there is a slight asymmetry in the tidal flows, leading to a minor ebb dominance and, hence, a residual transport towards the south-southeast. It is likely that this is balanced by slight flood dominance in the channel to the west of Waikeri Bank. Overall, the numerical modelling suggests that Waikeri Bank is at the boundary of major tidal recirculation of sediment associated with the Kaipara flood delta.

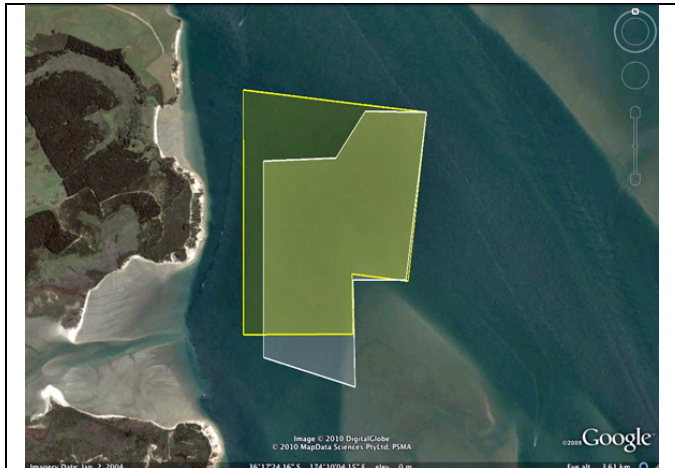
Figure 6 – Proposed adjustment to consent region (yellow) and original consent region (white).

It has been suggested that the boundaries of the consent region be adjusted to move the dredged area northwest (Figure 6). This brings the western boundary closer to Toetoe Point, and moves the southern boundaries away from the intertidal areas to Waikeri Bank.
