Management options for Modellers Pond, Tahunanui, Nelson

NIWA Client Report: HAM2011-001 November 2010

Nelson City Council

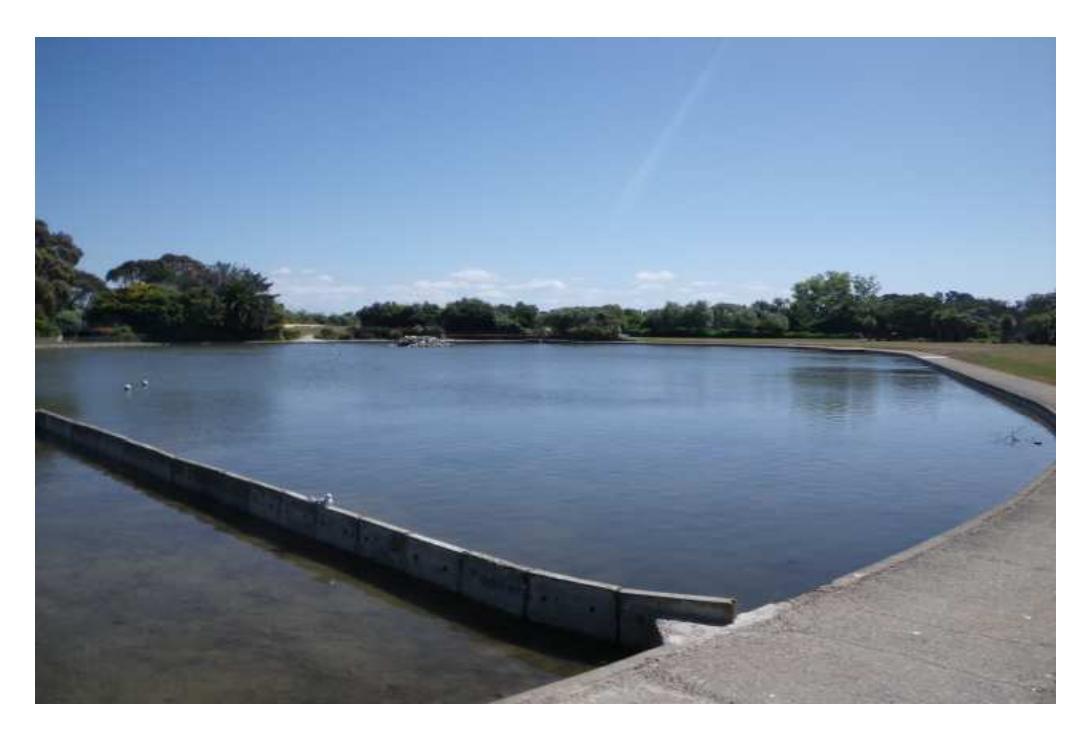
Figure 4: Modellers Pond showing part of the enclosed area (foreground) for radio controlled boats, and the remainder of the pond (some 0.8 ha) for larger boats with a raised stone storm water inlet structure (far end).

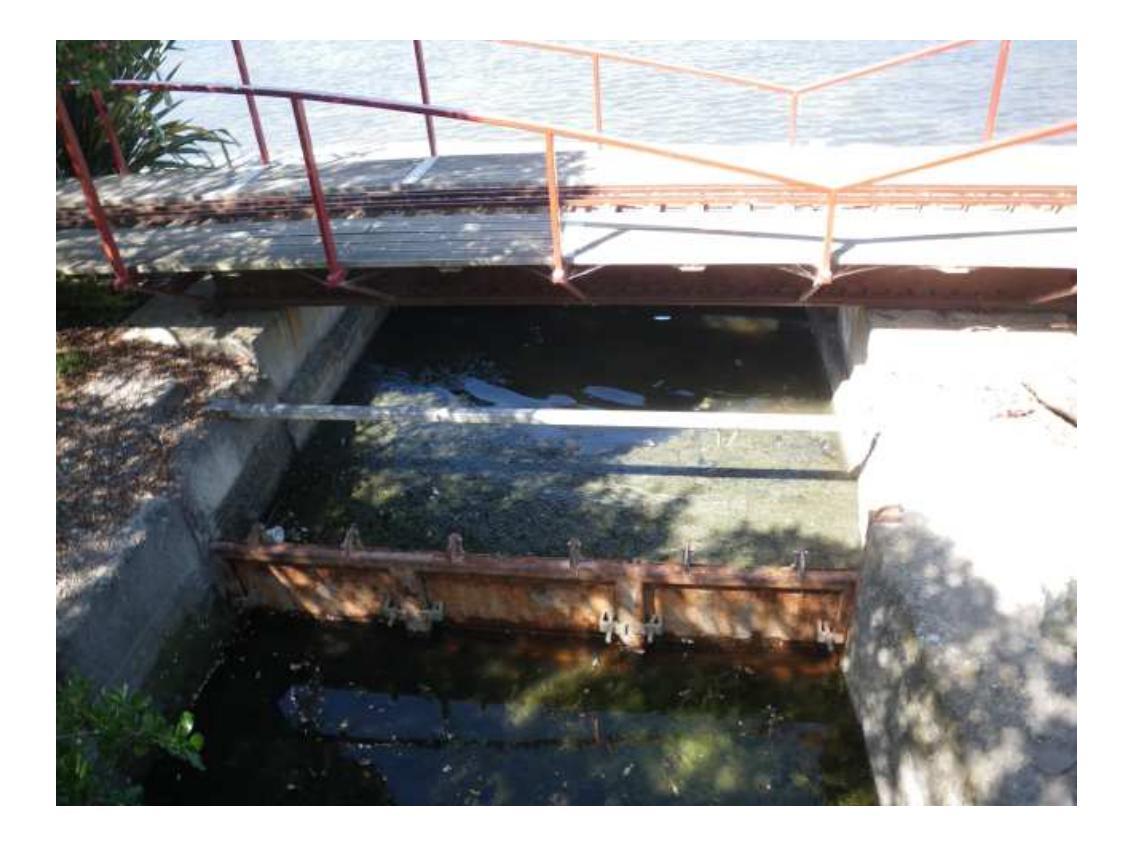
Figure 5: Outlet gates at Modellers Pond, Tahunanui, bolted shut to retain water.

The pond water is usually 'super' saline being filled with sea water during spring high tides above 4.3 m. Water is held and released by operating manual metal gates with rubber seals (Fig. 5) and is lost through evaporation and percolation through the bottom sediment at a rate of up to 11 mm day⁻¹ (John Caldwell, Modellers Society, pers. comm.). Supplementary water can be added from the city water supply, but its use is now limited by Council to maintaining a maximum depth of 150 mm below full at times when there are no water restrictions and not within one week of a high spring tide.

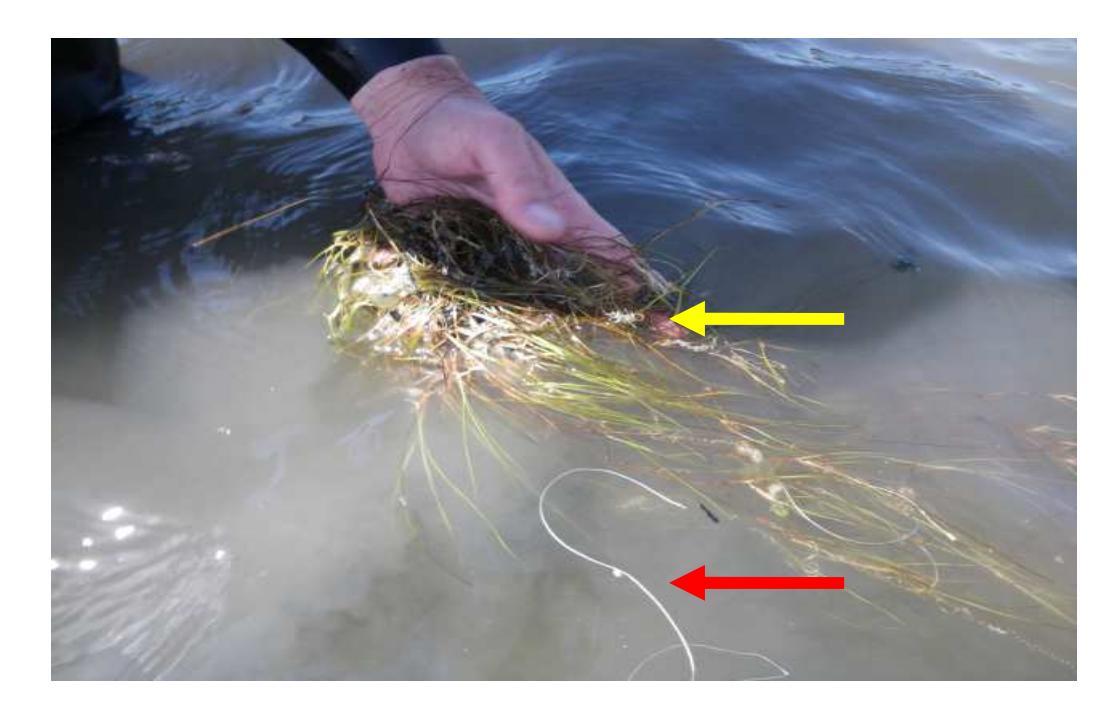
Figure 6: *Ruppia megacarpa* was the only macrophyte present in Modellers Pond. The plant has small flowers that are terminal on white stalks (red arrow) which reach the water surface. Following pollination the flower stalk retracts in a characteristic coil with the maturing fruit (achenes) as shown (yellow arrow).

Ruppia megacarpa was the only macrophyte present (Fig. 6). *R. megacarpa* (sometimes called horse's mane) is a native (though not endemic) coastal species growing in brackish water or saline ponds and lagoons. Much of its habitat has been modified and lost in New Zealand so it is now uncommon though abundant at some sites such as Waituna Lagoon, Bluff. *R. megacarpa* was present throughout the pond but was of low abundance due to the pond being drained and treated with glyphosate just three weeks prior to our visit (Fig. 7). Less than 1% of the pond had surface-reaching *R. megacarpa* and algae at the time. The surface algal accumulations were present in downwind areas and were comprised of Chlorophyta or filamentous green algae (Fig. 8). They included the genera *Cladophera*, *Ulothrix*, *Ulva* (syn. *Enteromorpha*) and *Spirogyra* (*Spirogyra* at one location only), all common algae well known for forming nuisance blooms.

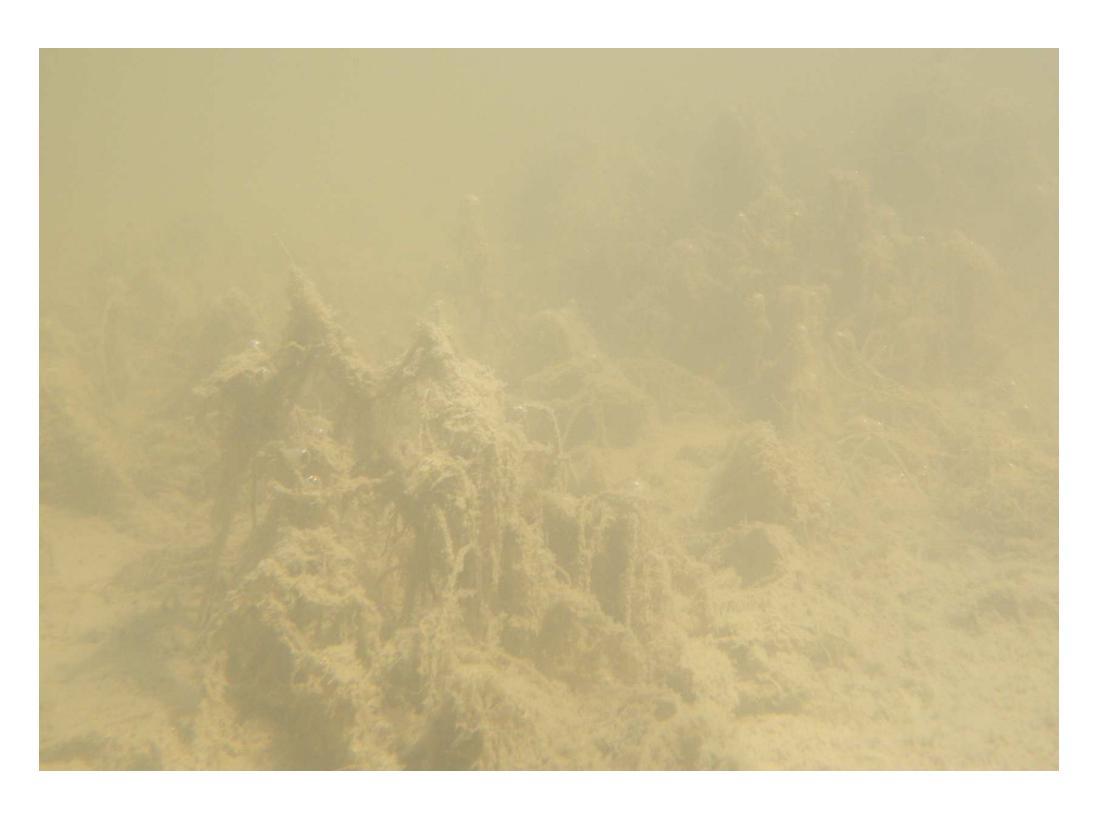
Figure 7: Under water photograph of *Ruppia magacarpa* (covered in flocculent sediment) and hard hit by glyphosate applied when the pond was drained about 3 weeks previously.

Glyphosate (Roundup[®]) was used when the pond was drained at the beginning of November 2010, and when inspected on 24^{th} November this treatment had apparently controlled the *R. megacarpa* and algae to a high level (Fig. 7) and to the satisfaction of the Modellers Society and the Council.

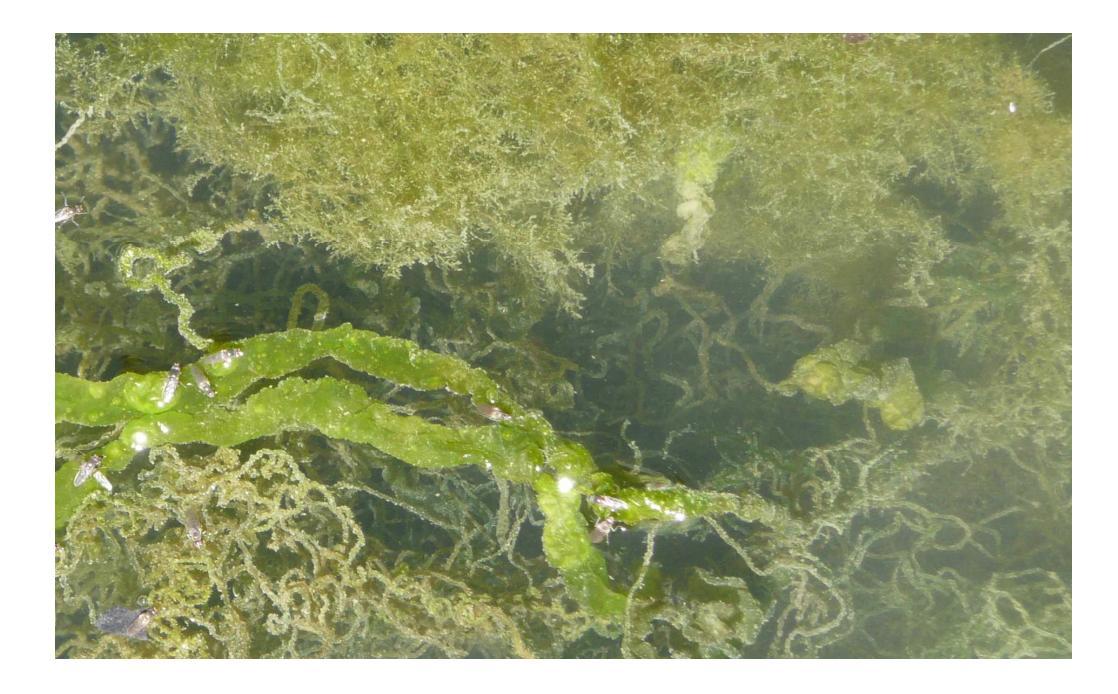
Figure 8: Algae at the pond outlet. The large green one is *Ulva intestinalis*, a smaller *Ulva* species is below and *Cladophora* is the main species present in the top of the picture.

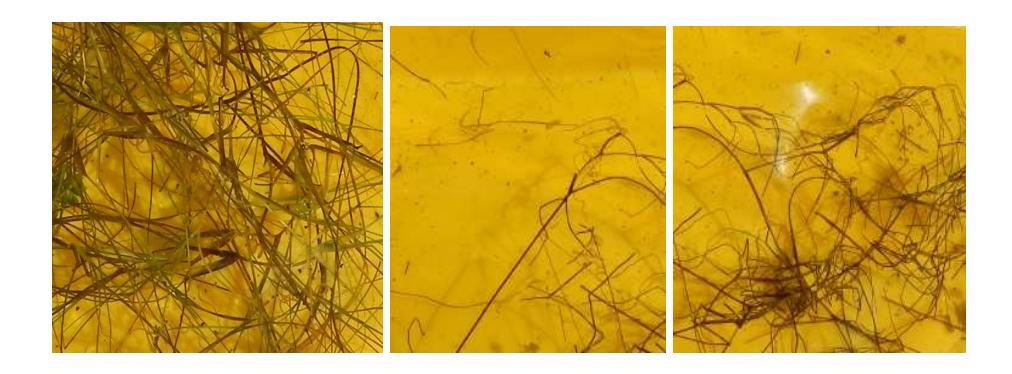
Figure 9: *R. megacarpa* herbicide treatment test results after 2 weeks: left untreated control, middle diquat 1ppm, right glyphosate 1%. What little remained in the two herbicide treatments was flaccid and mostly dead.

R. megacarpa was collected and tested for susceptibility to diquat and glyphosate. In the un-replicated test *R. megacarpa* shoots were subject to a 2 week treatment of 1 ppm diquat, 1% glyphosate and a control which had no herbicides. Both the diquat and glyphosate were confirmed to have herbicidal effects on *R. megacarpa* with fragmentation and loss of plant biomass (Fig. 9).

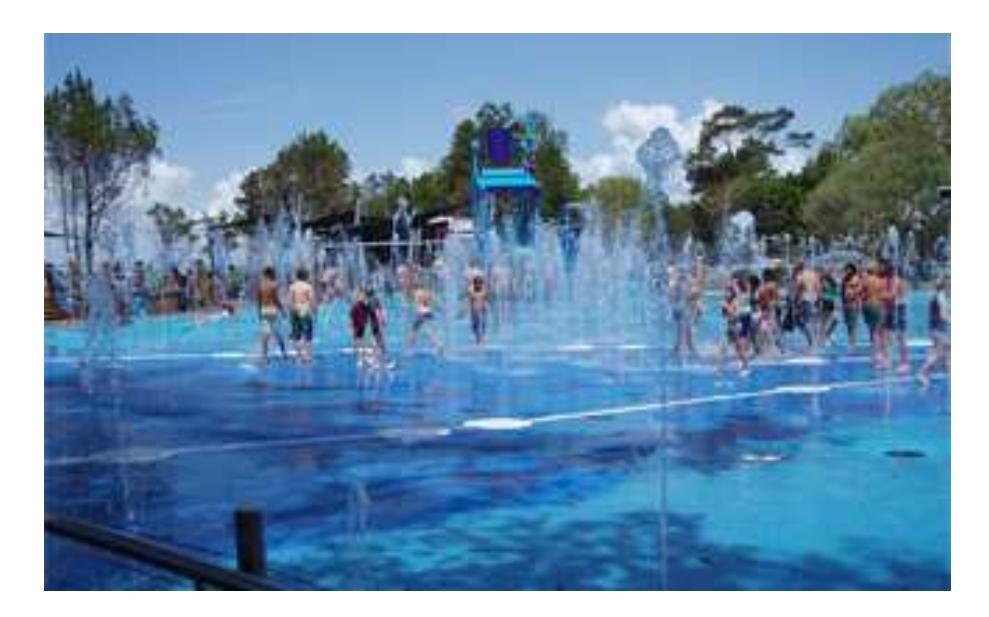
Figure 10: At the other end of the spectrum from do nothing, the pond could be lined, and the water filtered and chlorinated to swimming pool standards. An example is the Hervey Bay water park, Australia and is typical of many in coastal Australian towns.
