Impacts of gravel removal from the coastline between Paroa and Blaketown

This brochure has been produced by NIWA for West Coast Regional Council with support from the Foundation for Research, Science and Technology Envirolink Fund, September 2006.

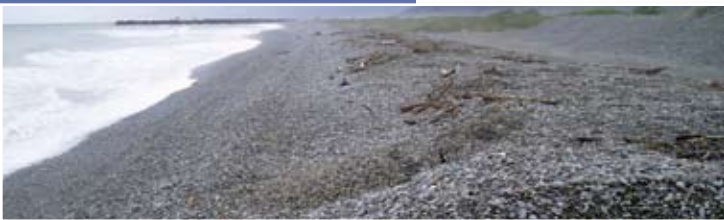
Typical profile characteristics of a gravel beach similar to that in the area, and to the north of Westroads Yard at Blaketown.

(Figure from Goff, J.R., Nichol, S.L., Rouse, H.L. (2003) *The New Zealand Coast. Te Tai O Aotearoa*, Dunmore Press).

Flattening out Blaketown Beach for easier foot travel would likely only assist in the short term. Wave action would tend to sort the sand and gravel, pushing the larger gravel back up the beach and reforming the beach profile as shown in the figure above. This may take a number of successive storms but ultimately the steeper beach slopes and steps will reform.

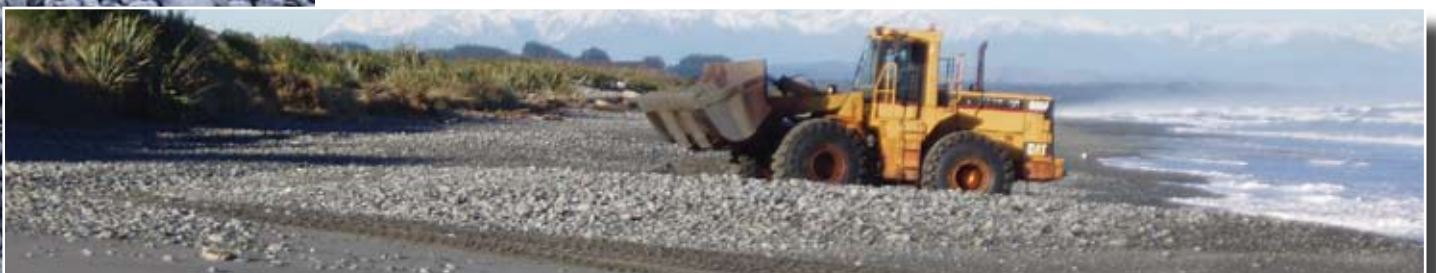
The exception is where unwanted sand/gravel is pushed back over the beach in front of Westroads Blaketown yard (noted on a previous visit in November 2005). This activity creates a very steep and 'cliffed' seaward face, i.e., a vertical face, as the waves 'eat' in at the base, and which takes some time to be reworked by waves in to a more naturally occurring profile. Ensuring that the return material is not just simply pushed back over the beach but profiled to a safer slope for other beach users would not appear to be an unreasonable request.

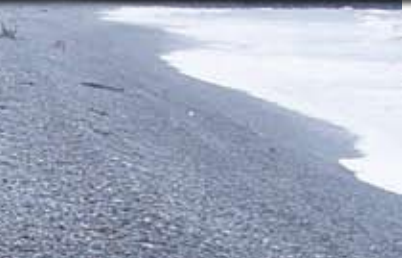
Along the Blaketown frontage there is a wide buffer zone between the beach and the residential housing. The buffer is narrowest at the southern end of Doyle Street, but has still increased in width since the late 1950s and early 1960s when this housing was built.

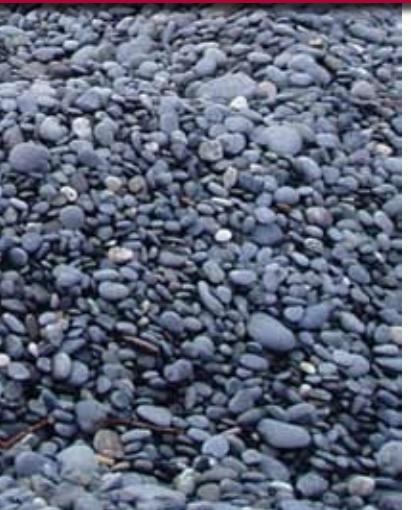
It is difficult to identify why there has been loss of land at the southern end of the airport. Recent aerial photographs show a distinct indentation of the line of the coast. However, it is unlikely that the erosion is specifically due to gravel extraction given that the southern end of the Merrick Street – Karoro Aerodrome licence area is a few hundred metres to the north, and the northern extent of the Karoro Aerodrome – Jacks Road licence area about 1 km to the south, but some impact cannot be ruled out. The cause of this erosion hotspot may be related to changes in the patterns of offshore sand bars which can cause localised erosion and accretion cycles (i.e., over a number of years). It may also be due to the way gravel is moved northwards along this coastline, which tends to be in 'slugs', related to both the supply of gravel to the coastline during episodic large flood events in the Taramakau River, and how gravel is moved northwards along the coast, which again tends to be episodic occurring during larger wave conditions from the south-west.

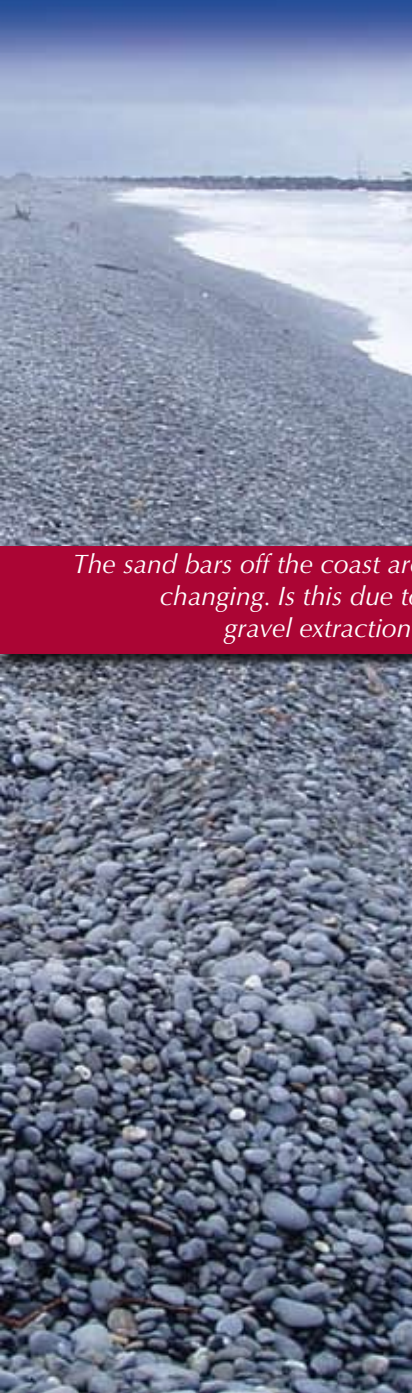
Off the Paroa to Blaketown coast, the location of these bars can be seen where swell waves break seaward of the low tide mark. The interactions between offshore bar movements and beach changes are as yet poorly understood but bars on coastline such as this will be continually shifting both alongshore and offshore due to natural variability in wave conditions.

One characteristic of such bars is that they often tend to migrate offshore over time (which can be over a period of many years). As the bar migrates offshore, a deep channel typically forms between the bar and the beach. As a result larger wave conditions can reach the beach often leading to localised erosion hotspots along parts of the beach corresponding to where a particular bar has migrated offshore (possibly a reason for the localised erosion at the southern end of the aerodrome). Once the bar migrates sufficiently far offshore it gradually disappears and a new bar typically begins to form closer inshore to the beach. This has the opposite effect by reducing the wave conditions reaching the intertidal beach, resulting in beach recovery or accretion. As these bars are all at different offshore positions relative to the beach along the coast, they play an important role in the variation in the response at different locations along the beach under storm conditions. Such patterns are extremely complex occurring over different temporal and spatial scales and one of the primary factors making it difficult to identify and isolate the potential effects due to gravel extraction.
